2085 PINE STREET

HERITAGE
ASSESSMENT
+
HERITAGE
IMPACT
STATEMENT
+
CONSERVATION
PLAN

REVISED APRIL 11 2019

ATA
ARCHITECTS INC.

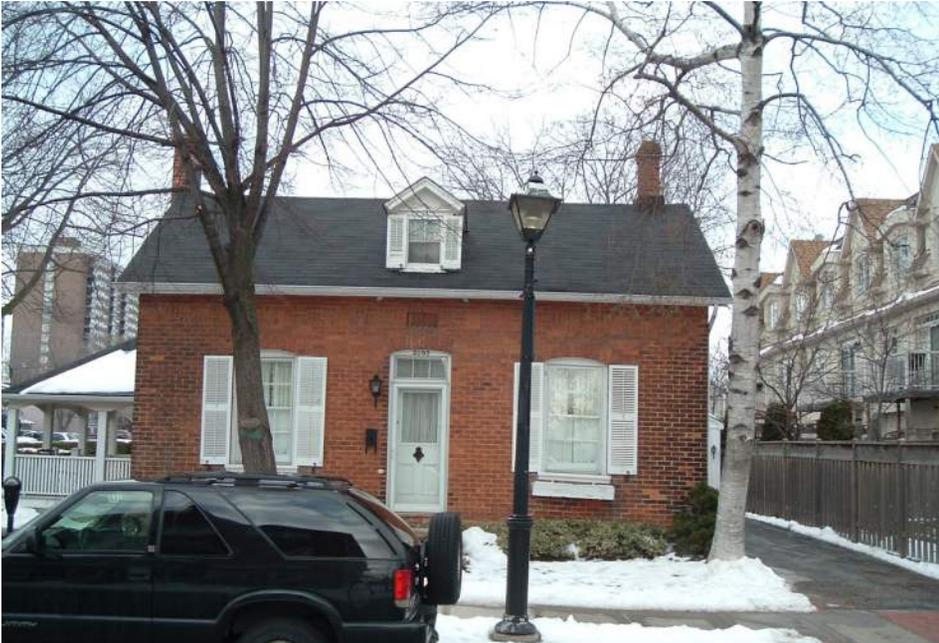
South elevation (below) of 2085 Pine Street. The building is clad largely in brick. It has a gable roof with a central dormer on the south elevation and a symmetrical façade.

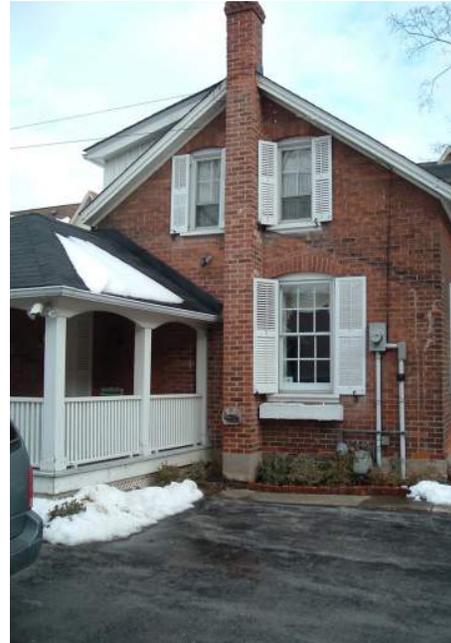
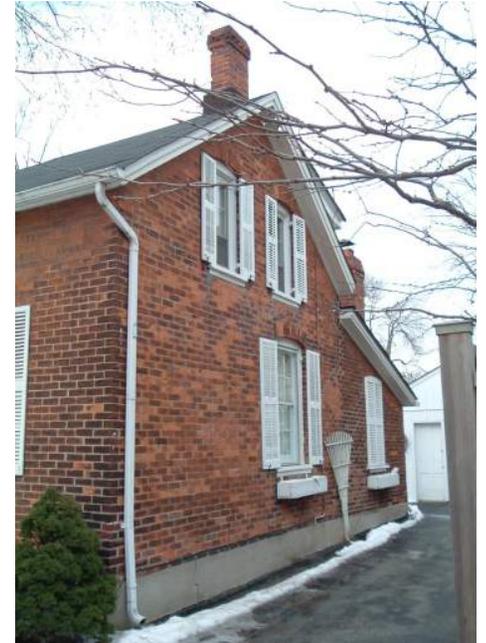
The arrangement of windows on the west façade (bottom left) is mirrored on the east façade (bottom right). A porch added sometime after 1974 wraps along the west and north sides of the kitchen addition.

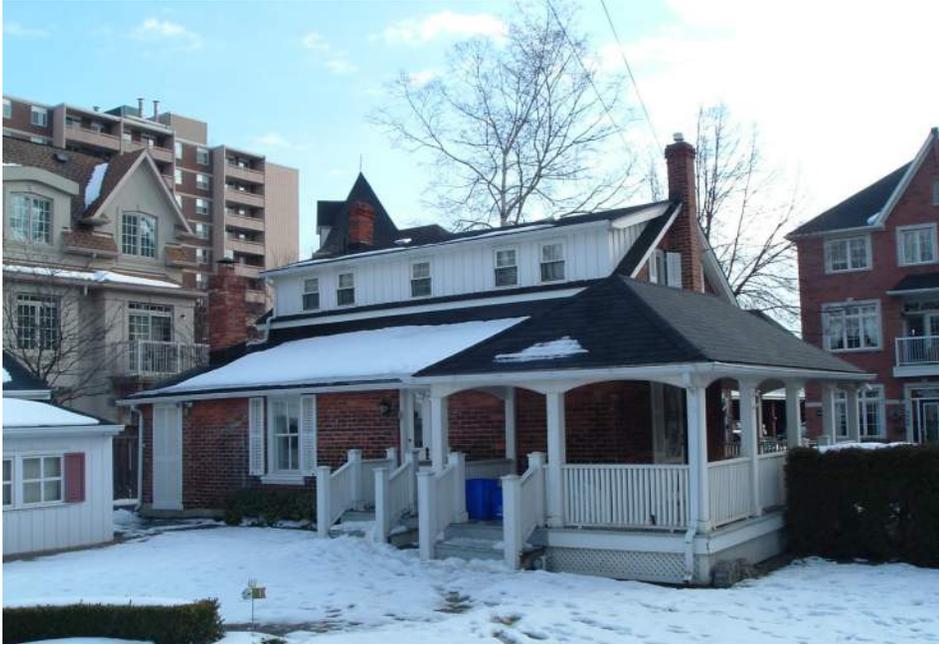
North elevation of 2085 Pine Street. The porch can be seen wrapping around the north west corner. A shed dormer can be seen on the second floor. The windows in the dormers are one over one windows with false muntins.

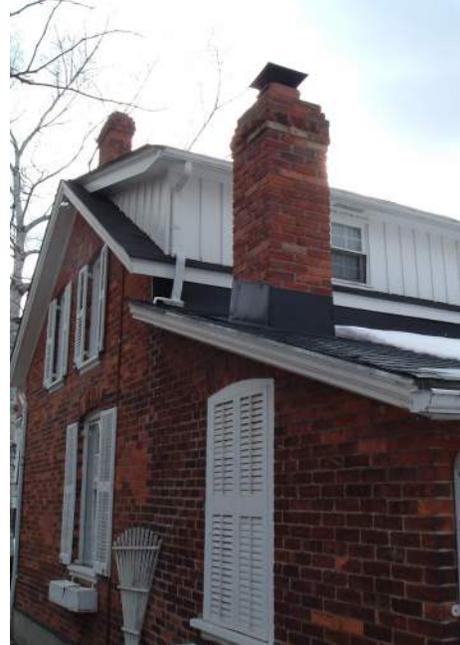
The third chimney is part of the later kitchen addition. An example of a false window is seen here as the "opening" is directly in line with the chimney. The shutters were nailed in place.

The existing shutters are heavily overpainted. Several are in poor condition and beyond restoration. Those that can be salvaged will be stripped and reinstated. All existing hardware to be removed, stripped, repainted and reinstalled. New shutter hardware to match existing where it is missing or not operable. Any new shutters will be operable, clear pine or cedar, shaped and sized to fill the masonry window opening.

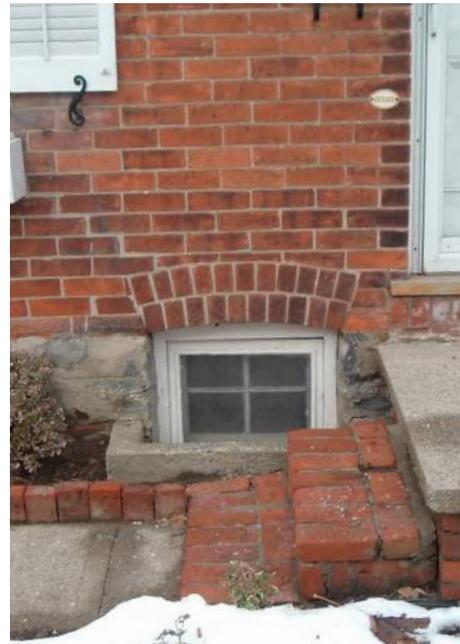
Arched brickwork over basement window.

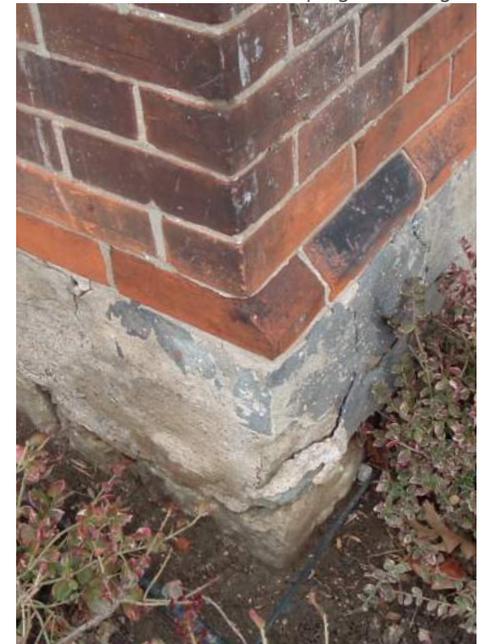
Stone foundation underneath parged coating.

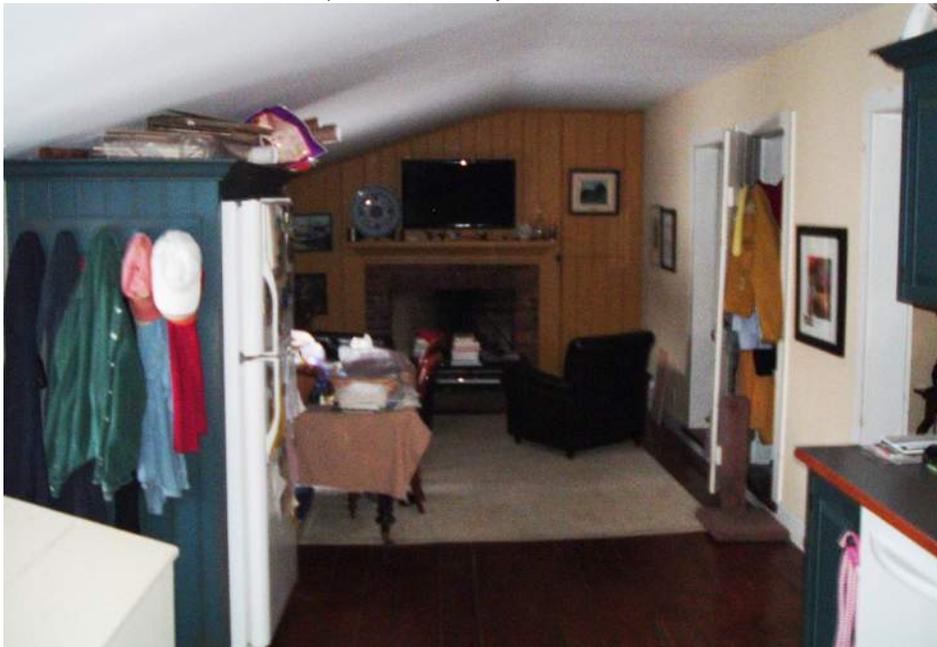
The photographs on this page show the kitchen addition. It is a long narrow addition at the back of the house. At one end is a fire place and chimney.

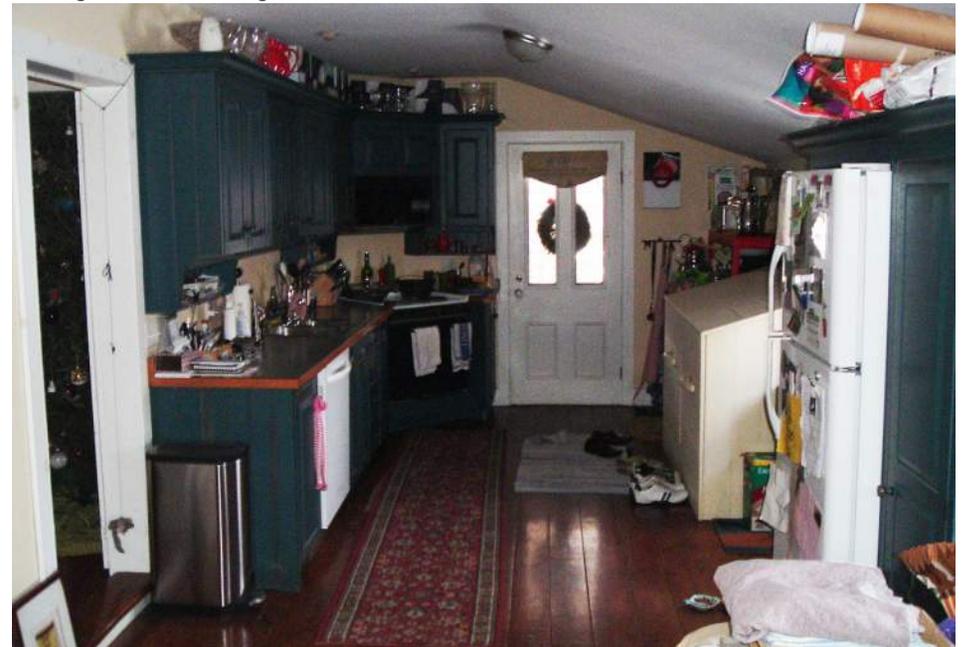
The ceiling of this space drops down drastically towards to north exterior wall. This space was not original to the building.

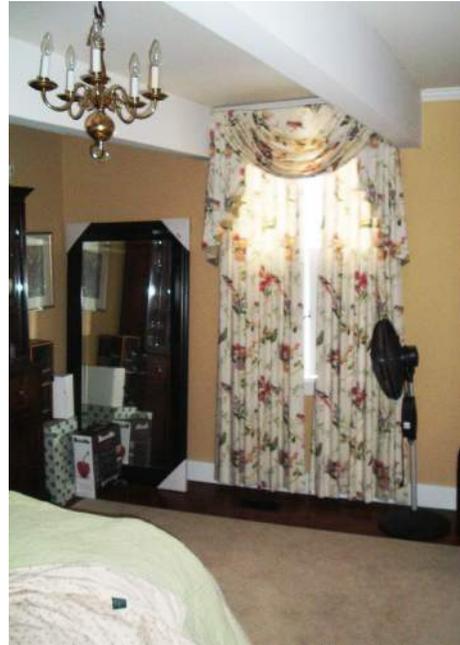
This bedroom on the ground floor is located just off the front entrance to the house. The original wood beams have been enclosed in drywall.

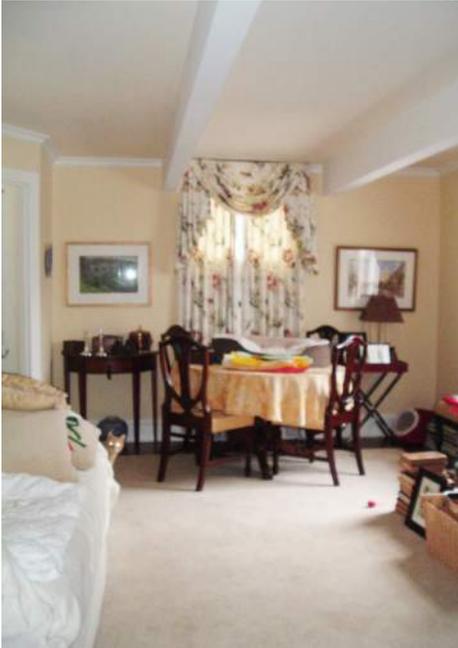
As with the bedroom, the wood beams have been enclosed in drywall.

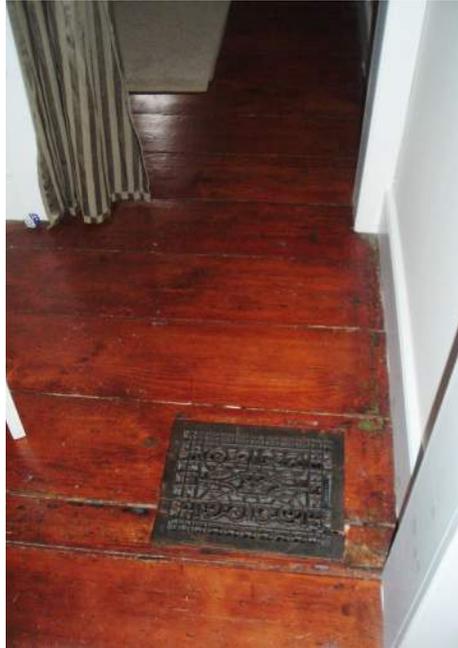
The floor is made of large wood planks original to the building. They have been maintained and are in good condition.

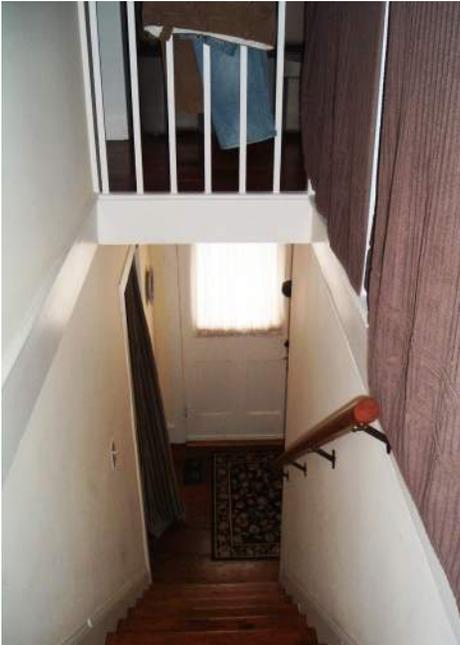
Looking down the staircase to the front door. The railings and panelling are not original

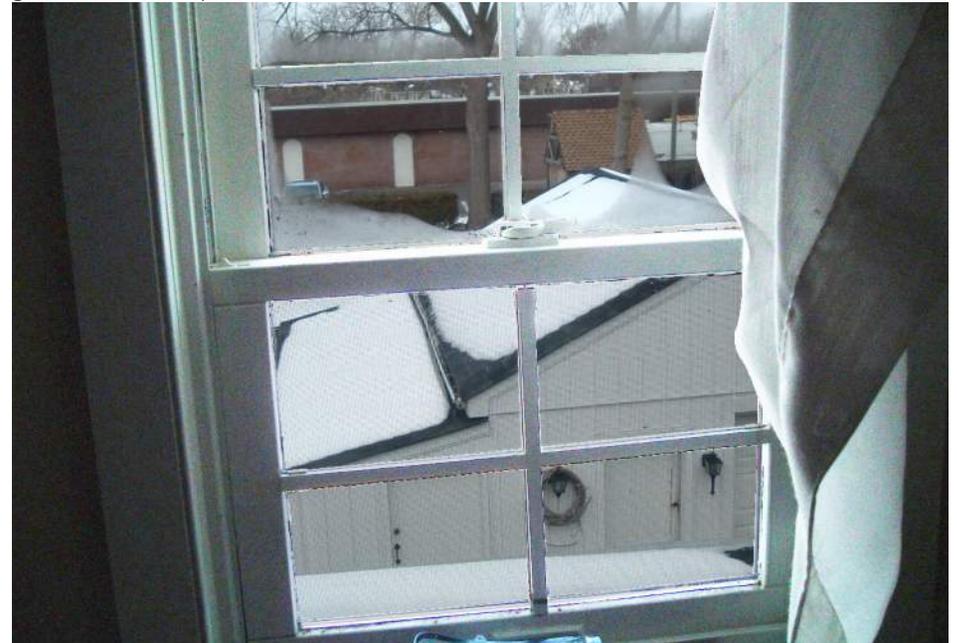
The windows in the shed-dormer roof on the north side of the second floor are single panes of glass with false snap-in muntins.

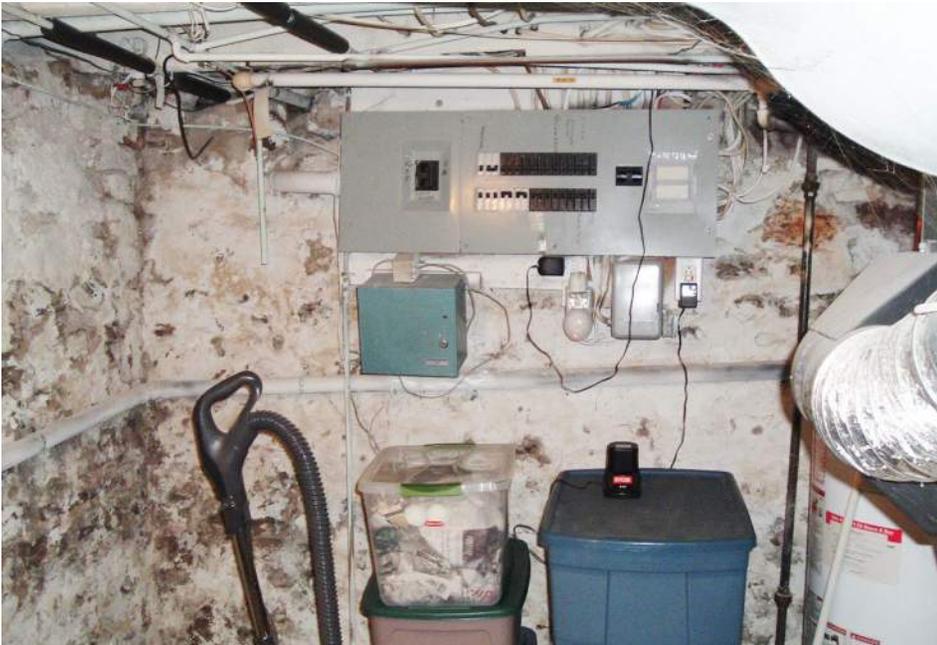
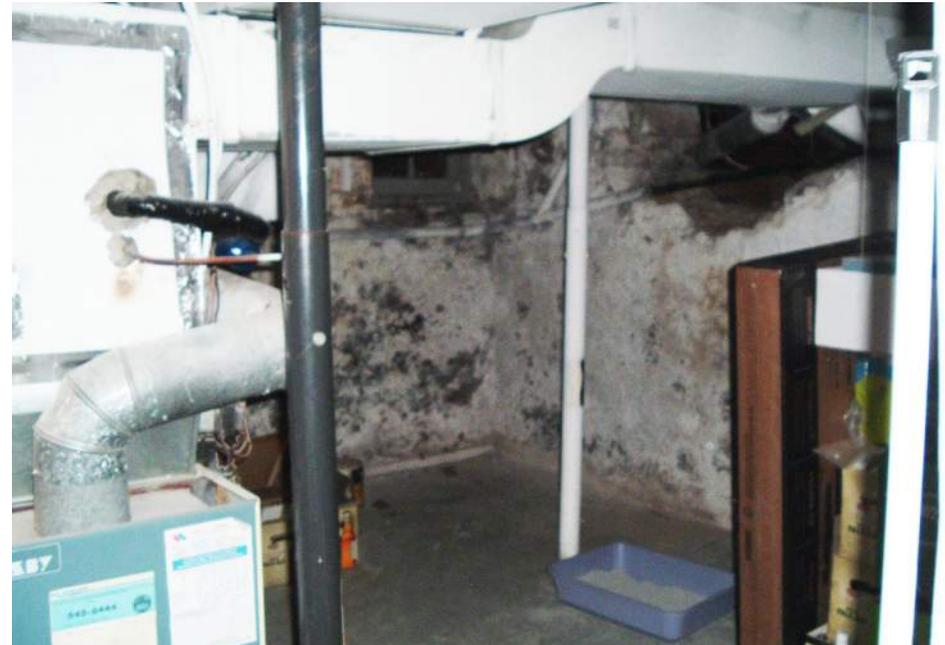
The basement is an unfinished space with low head clearance located under the portion within the north, west and south walls of the original house and the East wall of the stairwell. The room is only used for storage and utilities. The basement has a concrete floor. Water penetration is occurring through the exterior walls. New parging, waterproofing and weepers are recommended. Steel jacks have been added to support beams and maintain level floors.

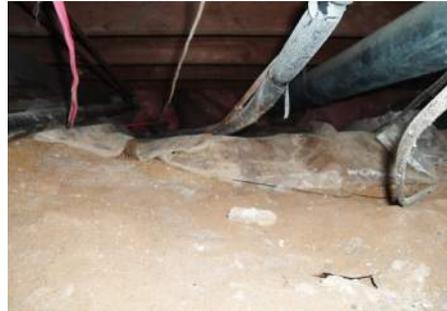
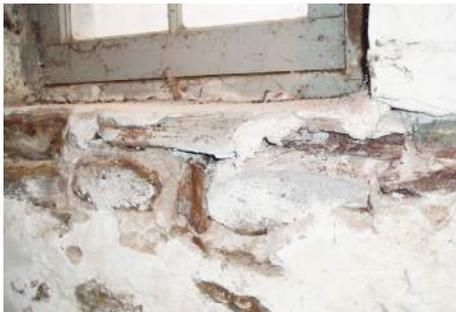
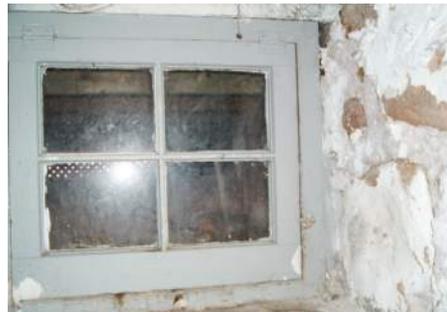
The upper photo below shows the crawlspace which extends under the eastern section of the original house and the kitchen addition. The bottom photo shows one of the wooden basement windows. The staining of the wood on the basement windows indicates moisture and drainage problems.

Existing dormer siding is to be replaced and new flashing installed to a minimum height of 200mm above the roof surface. The existing basement window well is to be widened and formed with dry laid stone. A drainage pipe and gravel bed is to be installed. The basement window is to be restored.

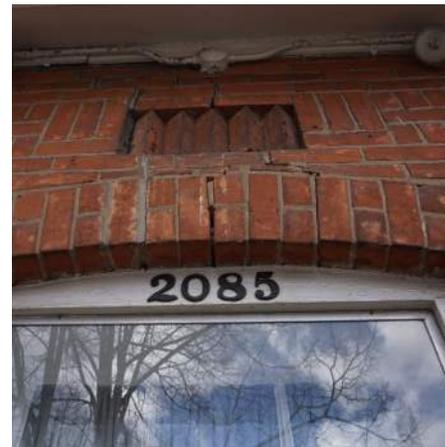
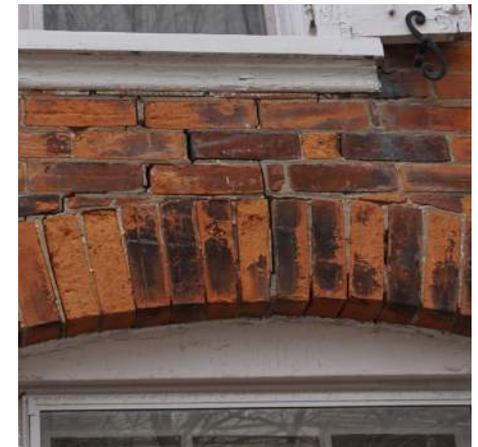
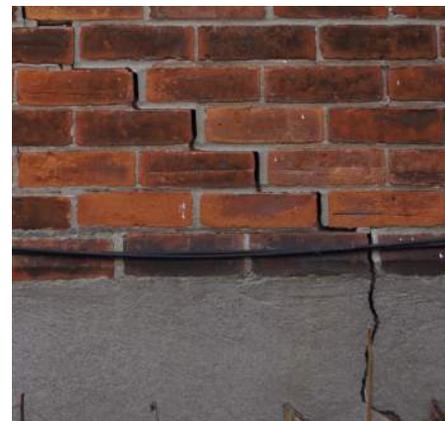
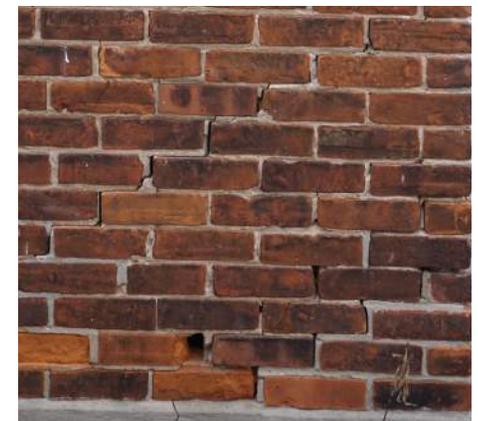
Examples of areas of masonry requiring crack repair and repointing over openings and near the corners of the house.

- Any resulting damage to the brick masonry will be reinforced and regouted.

Attached in the appendix is ATA Architect's masonry + window repair specification.

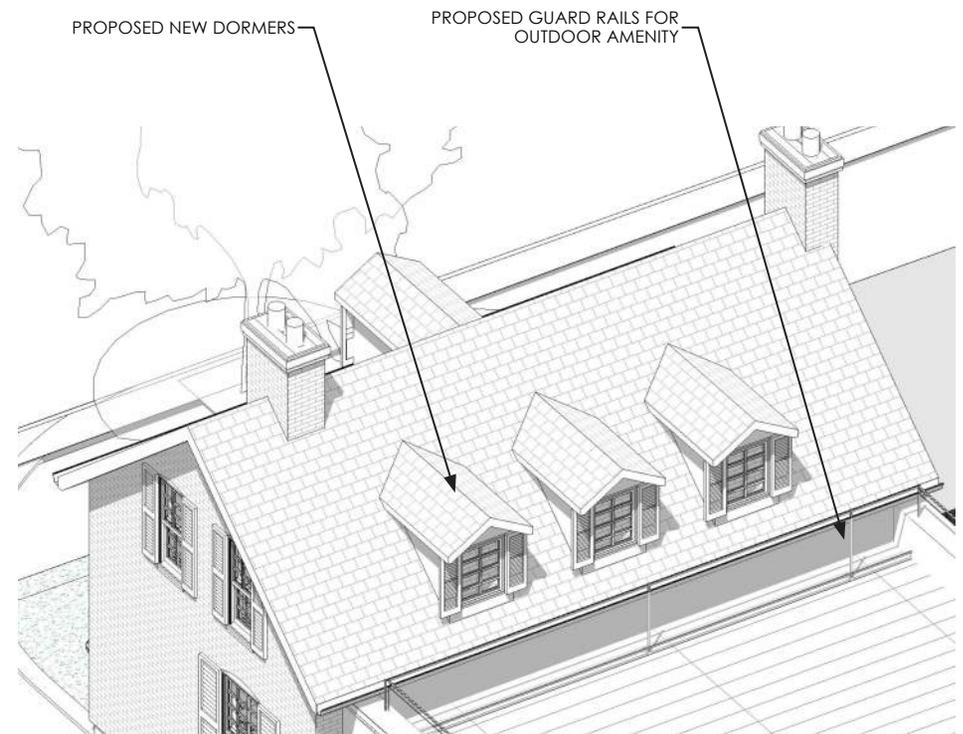
Proposed new dormers to replace the long shed dormer on the rear of the building.

Three individual dormers are proposed to replace the long shed dormer. Several condominium units will have views of the roof and an articulated roof of three dormers will enhance the rear appearance and retain created visibility of the original roof form. Refer to the attached drawing.
