Appendix B: Subject Property Images

Exterior Images of Structures

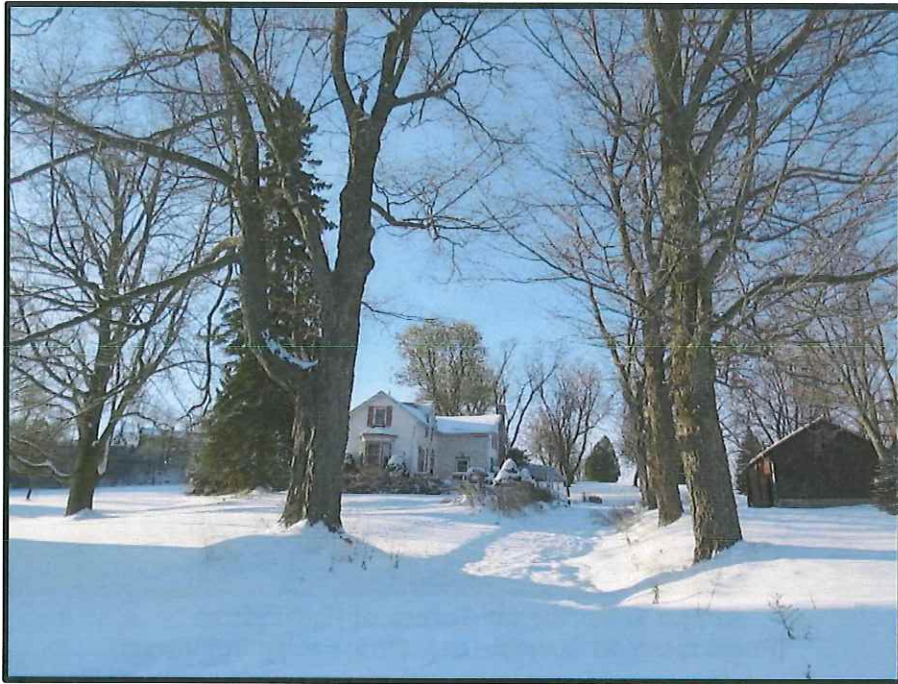
Image 1: View to Subject Property from Cedar Springs Road
(Photo taken on November 13, 2019; Facing South)

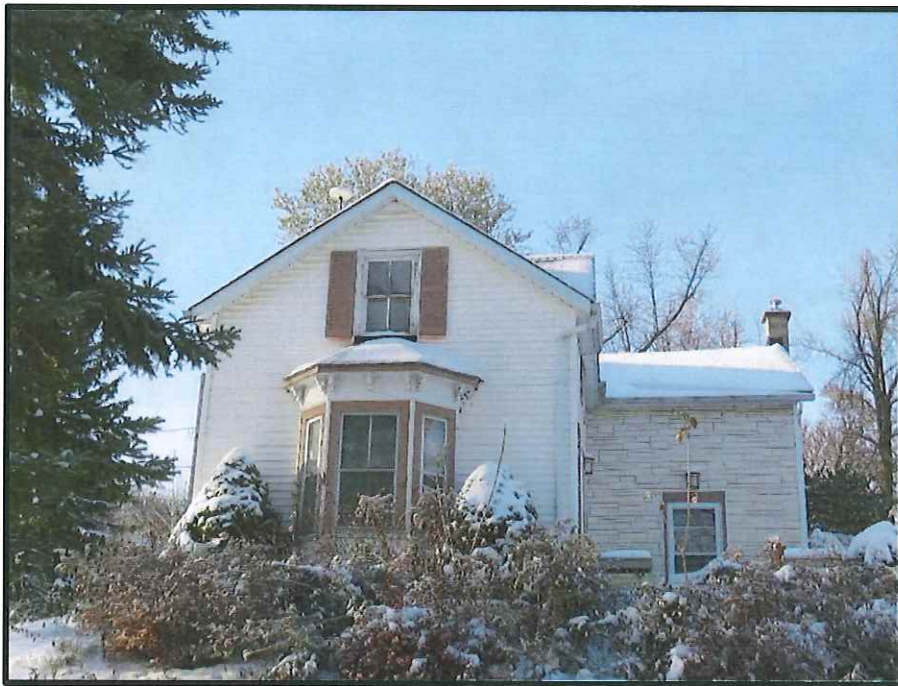
Image 2: Farmhouse Façade, 5780 Cedar Spring Road, Burlington
(Photo taken on November 13, 2019; Facing South)

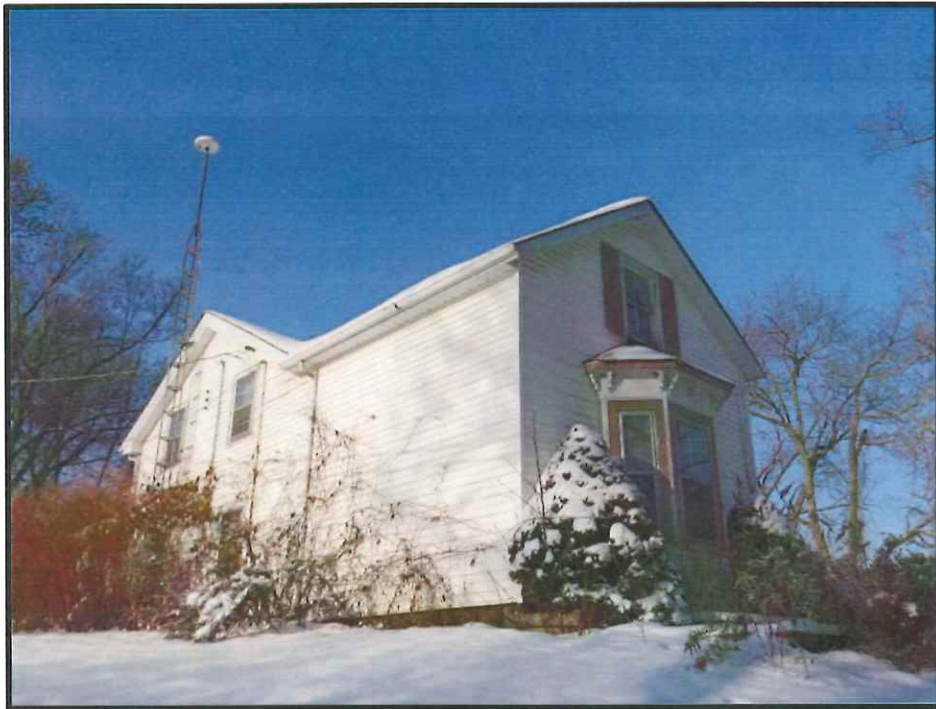
Image 3: Northeast Corner of Farmhouse
(Photo taken on November 13, 2019; Facing Southwest)

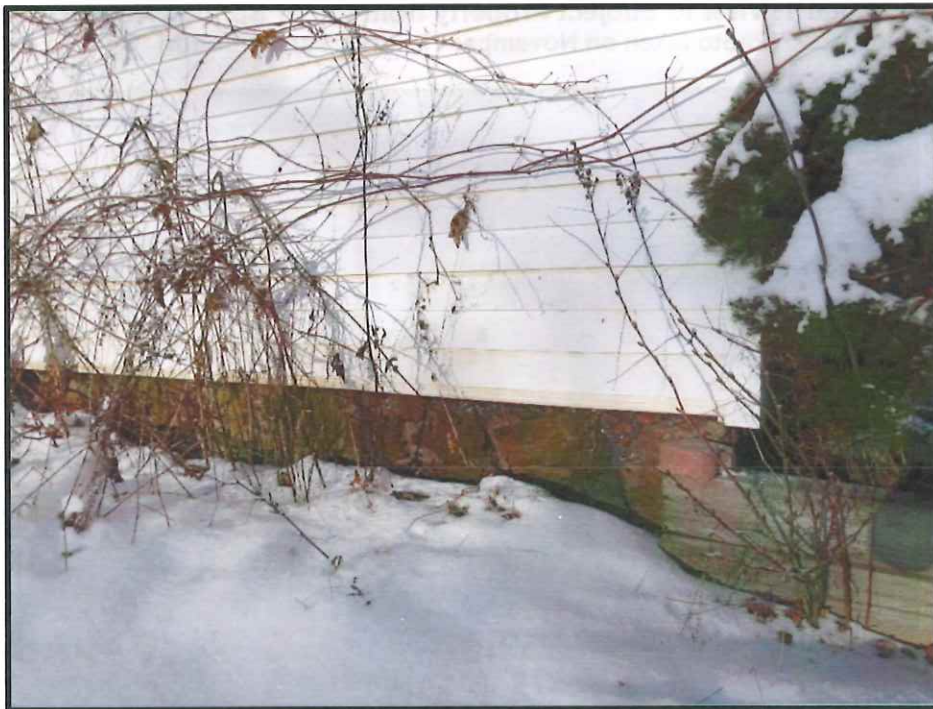
Image 4: Detail of Farmhouse Stone Foundation
(Photo taken on November 13, 2019; Facing Southwest)

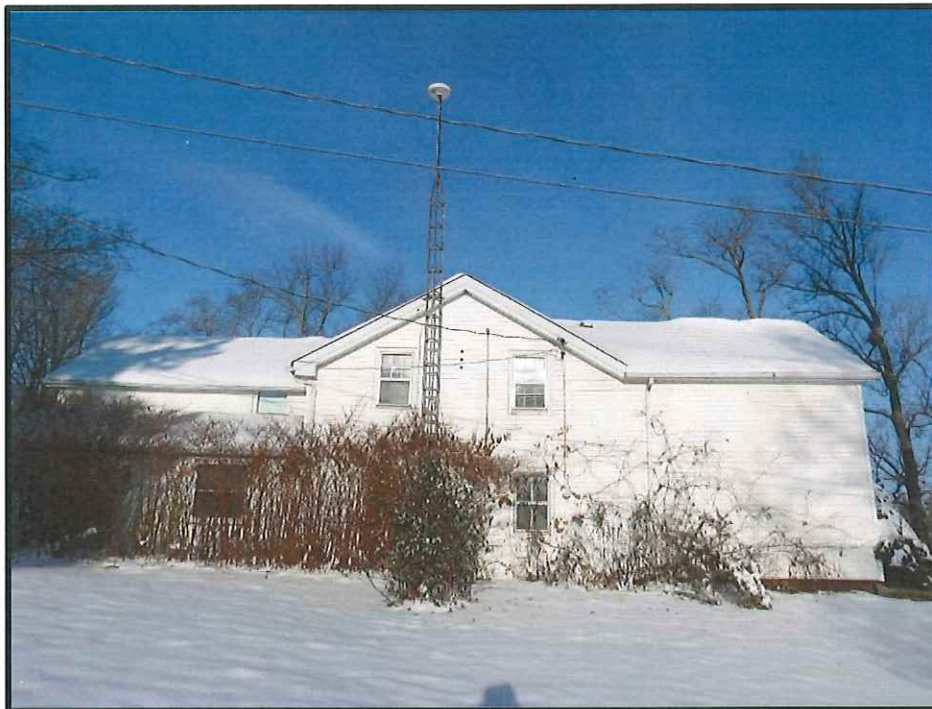
Image 5: East Elevation of the Farmhouse
(Photo taken on November 13, 2019; Facing West)

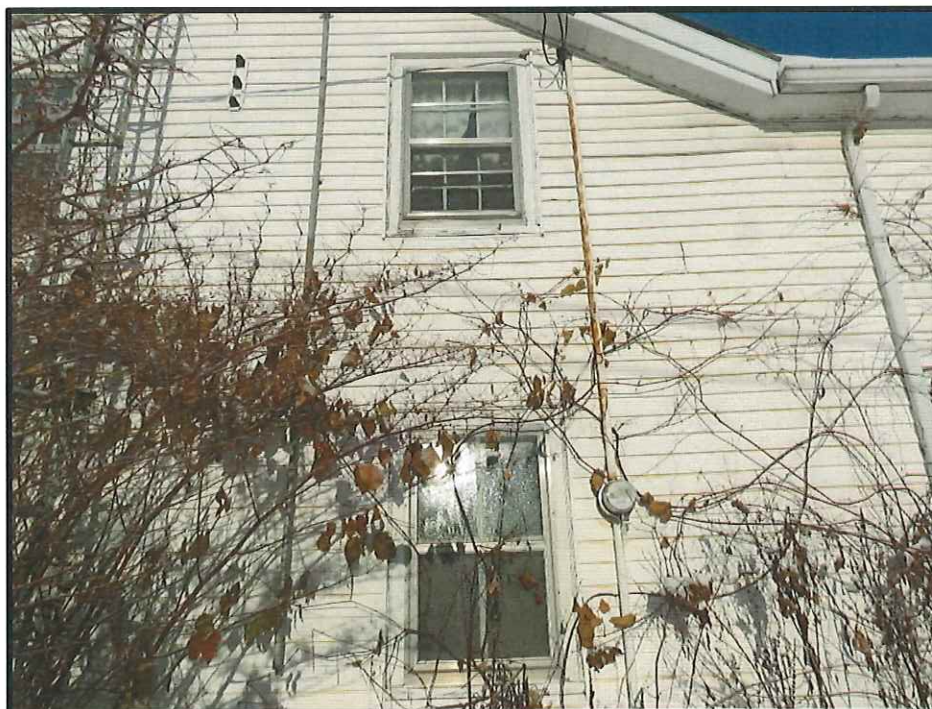
Image 6: Detail of the Farmhouse Windows
(Photo taken on November 13, 2019; Facing West)

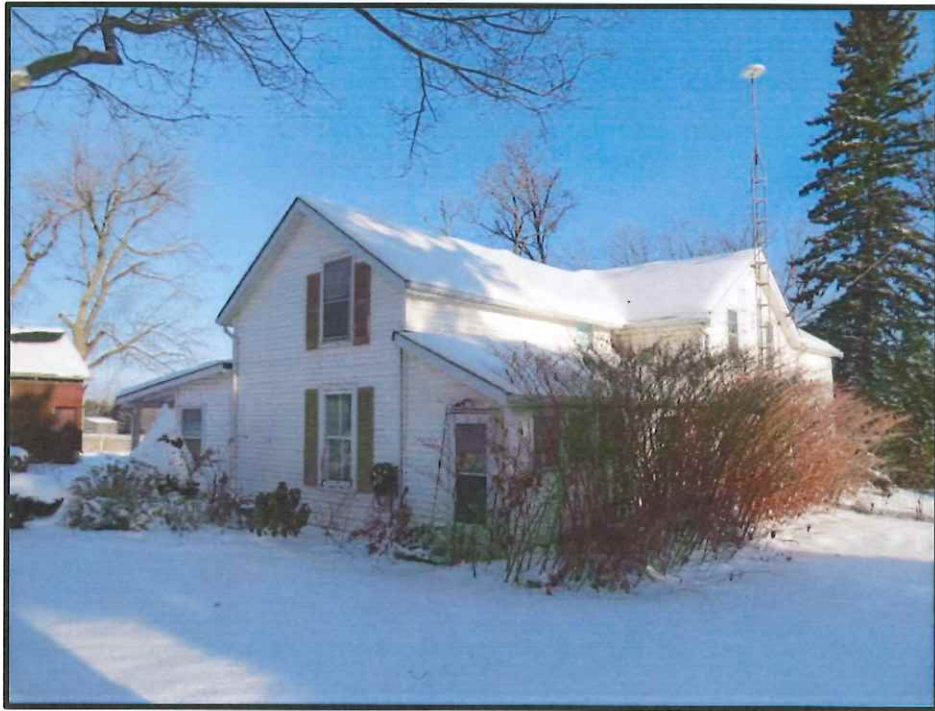
Image 7: Southeast Corner of the Farmhouse
(Photo taken on November 13, 2019; Facing Northwest)

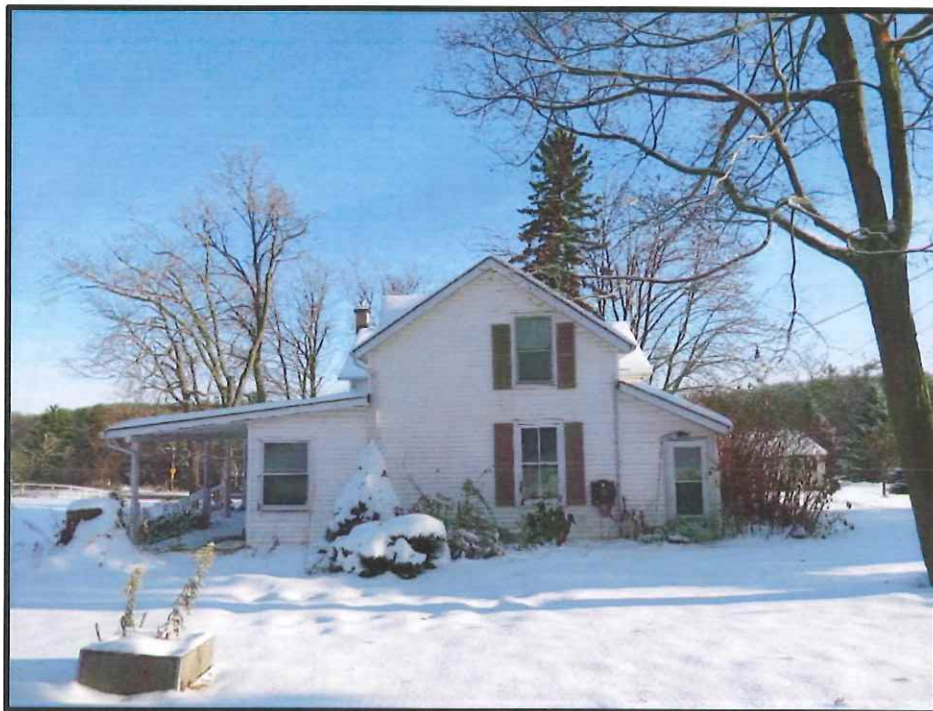
Image 8: South Elevation of the Farmhouse
(Photo taken on November 13, 2019; Facing North)

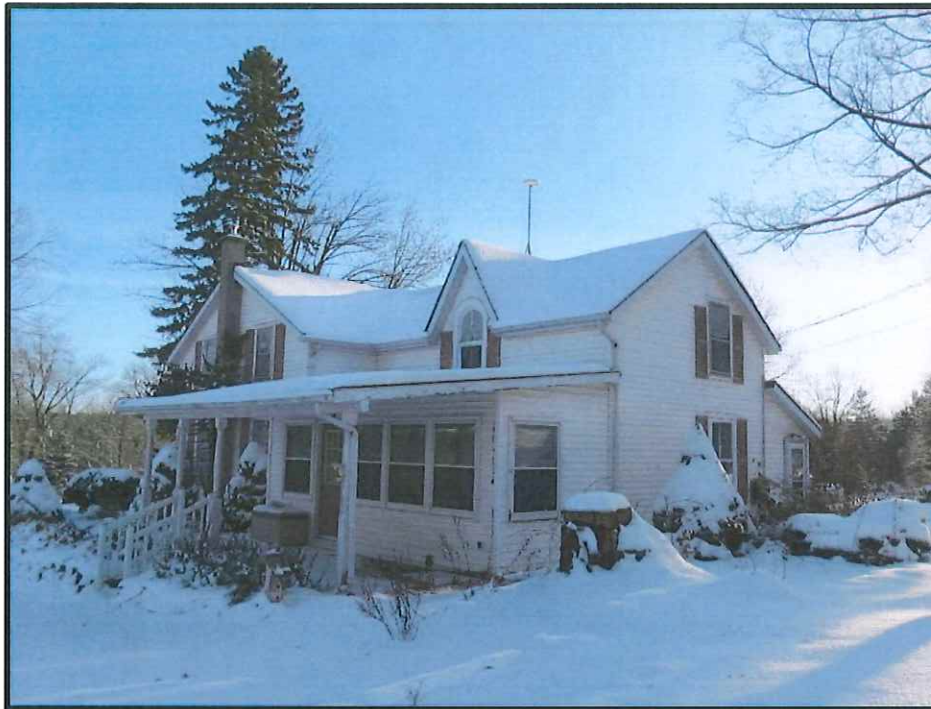
Image 9: Southwest Corner of the Farmhouse
(Photo taken on November 13, 2019; Facing Northeast)

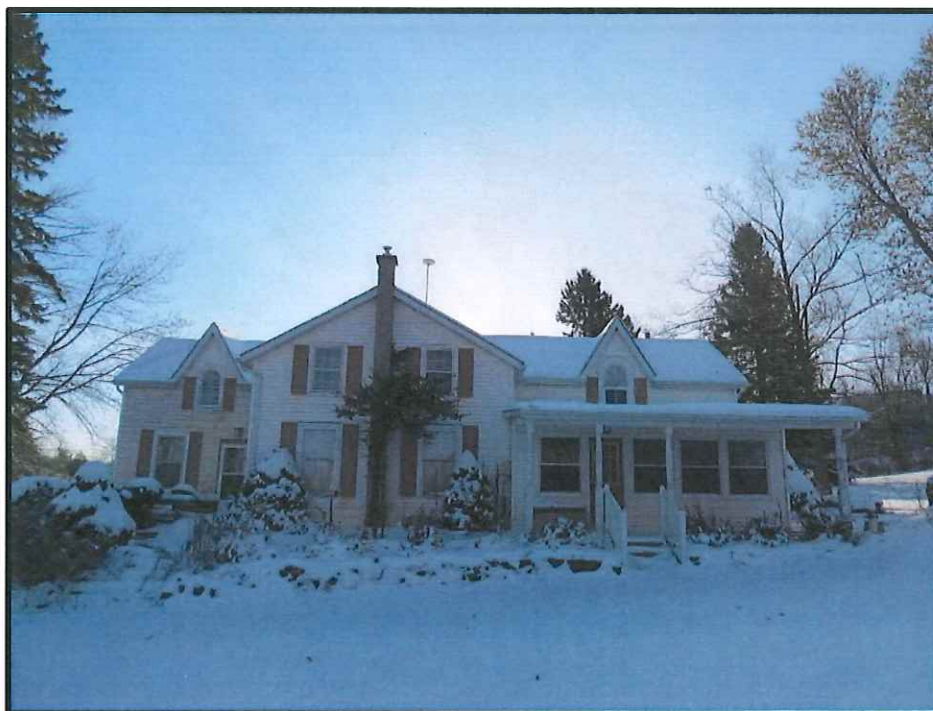
Image 10: West Elevation of the Farmhouse
(Photo taken on November 13, 2019; Facing East)

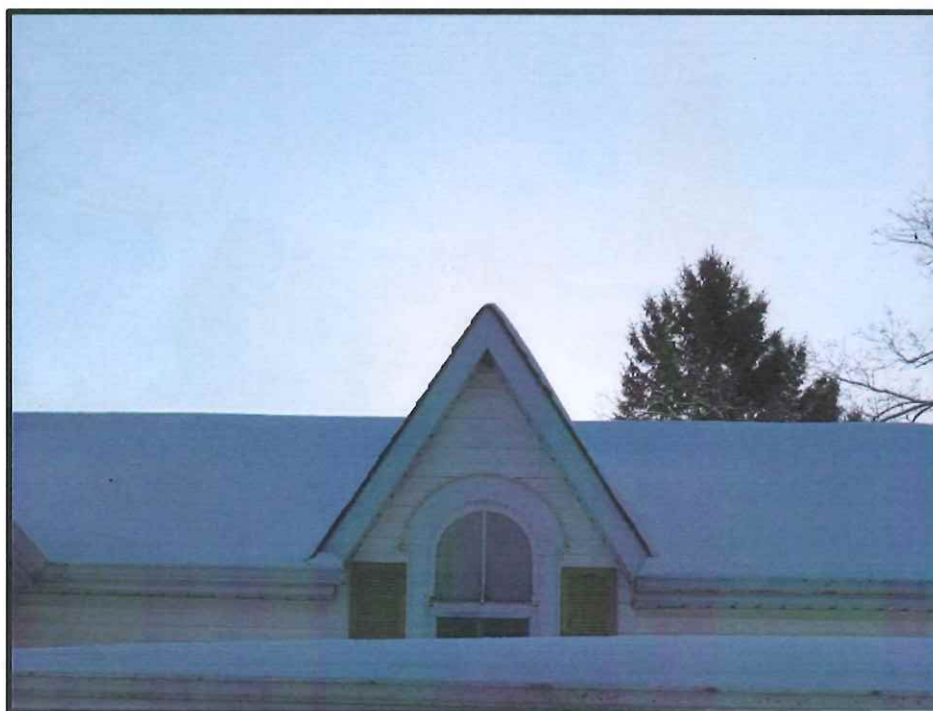
Image 11: Detail of Gable Peak in West Elevation of Farmhouse
(Photo taken on November 13, 2019; Facing East)

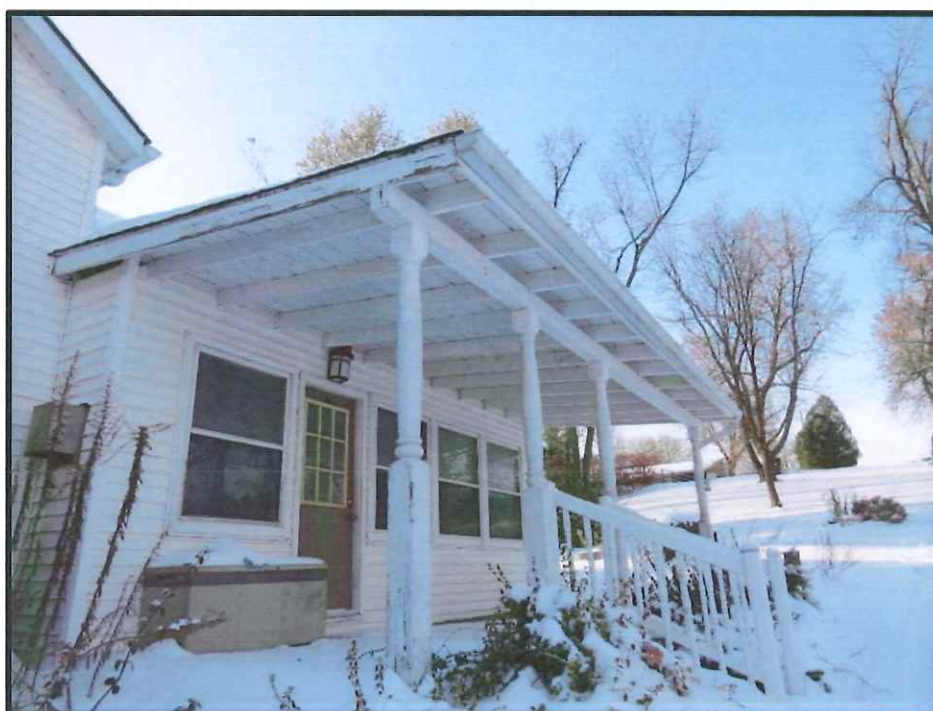
Image 12: Detail of Porch leading to South Addition to Farmhouse
(Photo taken on November 13, 2019; Facing West)
