Hager-Rambo Flood Control Facilities Study Report

Downtown and Burlington GO Mobility Hub
Burlington, Ontario
Project TPB198130

Wood Environment & Infrastructure Solutions

5/29/2020

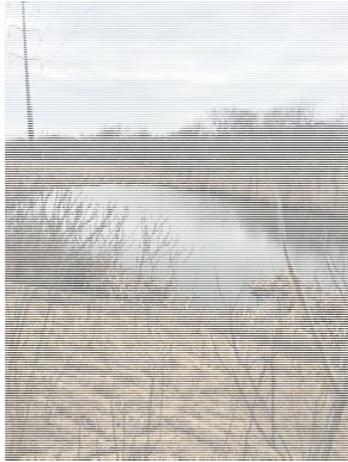
All of the facility side slopes are densely vegetated with grass and woody vegetation, that being mostly sumac (ref. Photos ER.1, 2, 5, & 11). There is no signs of erosion on the side slopes. There is only one (1) observed sign of small mammal burrowing in the side slope. There are deer trails along a number of the side slopes. The woody vegetation is comprised mostly of shrubs, and there are a number of smaller trees on the north side slope (ref. Photo ER.5). There are some trees on the south side slope (road embankment). In the vicinity of the hydro towers, the vegetation is being cut/maintained by Hydro, and all of the woody vegetation is cut.

Photo ER.1: East Rambo FCF east cell

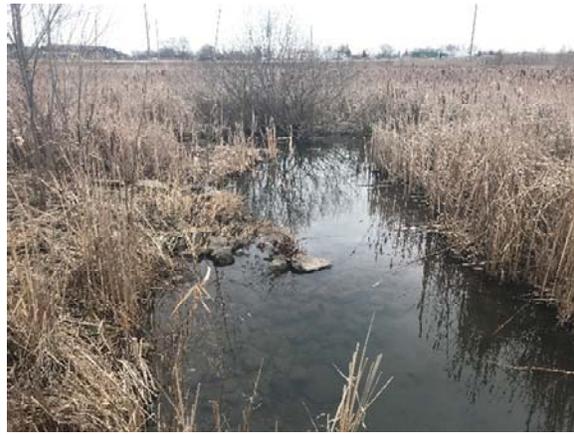
Photo ER.4: East Rambo FCF channel inlet from north – limited erosion

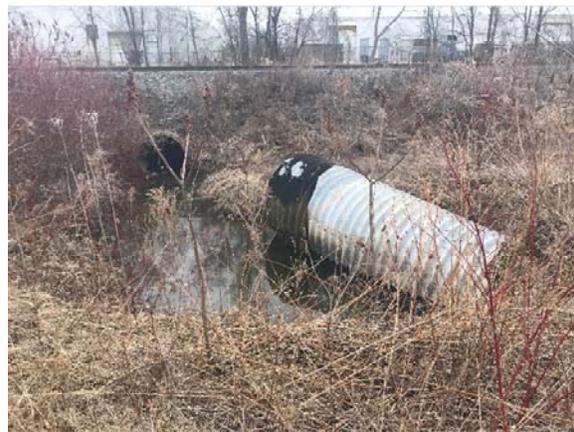
All inlets appear to be functioning as intended, with the exception of the middle inlet culvert from the north. There is erosion and scouring at the point where the subject culvert discharges into the flood control facility, which would require repair. Topographic survey is also required to determine if the upstream end of the CSP has become exposed with loss of cover, and whether it has lifted (ref. Photo ER.6).

Photo ER.6: East Rambo FCF inlet from north, note scour repair required

- East Rambo FCF
 - Erosion repair at mid-point inlet into pond, including topographic survey verification and mitigation of culvert scour and culvert perching
 - Repair to rip rap lining of inlet ditch from North Service Road
 - Removal of debris from outlet grate and structure
 - Consideration for a bathymetric survey of the pond to confirm sedimentation and vegetation accumulation and need for a potential clean-out
- West Hager FCF
 - Remove sedimentation in outlet control culvert

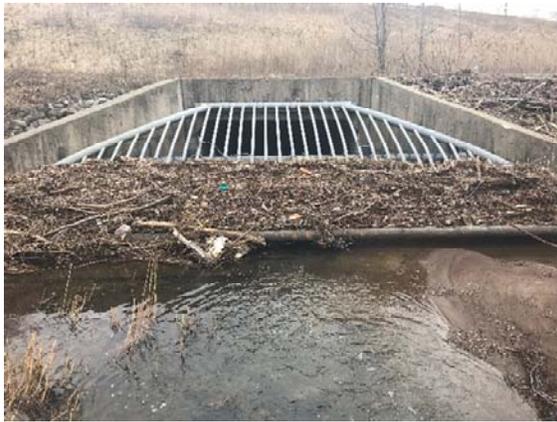
Based on discussion with City staff, this outlet is inspected regularly for debris, which is removed as required. There were no other observed locations of debris accumulation or blockage in the facility, and the other culverts were clear. The outlet grate was only partially blocked by debris (ref Photos ER.9 and ER.14). Further as cited earlier, based on anecdotal evidence of performance over the past two decades, there have been no reports of adverse blockages or significant sediment build-up.

Photo ER.9: East Rambo Facility outlet control culvert with safety grate and debris

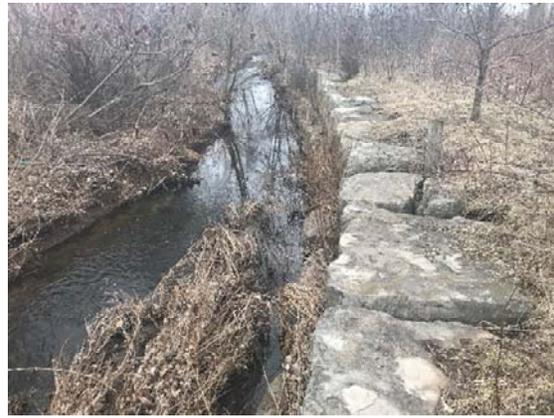
Photo ER.10: creek u/s of East Rambo FCF inlet in west corner – minimal scouring

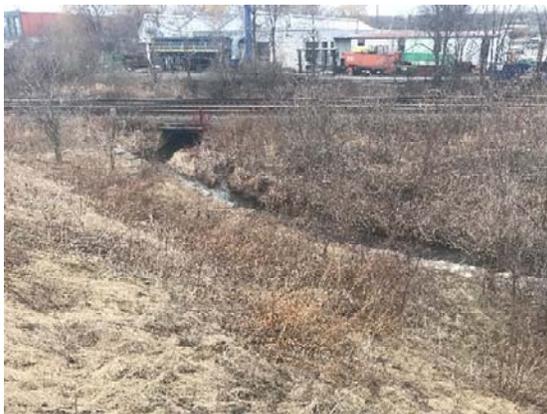
Photo ER.11: East Rambo creek d/s of CNR at west end of FCF

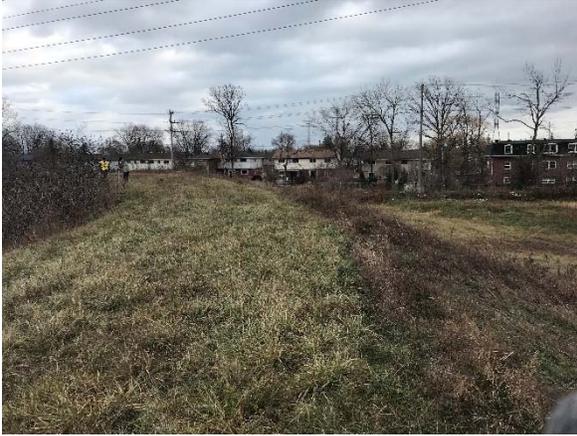
The outlet control berm is well vegetated (ref. Photo F.1) and does not have any evidence of erosion. The upstream face has woody vegetation (ref. Photos F.2 & 3). The spillway is stabilized with interlocking concrete block which is covered with topsoil and vegetation.

Photo F.1: Freeman FCF Outlet Berm

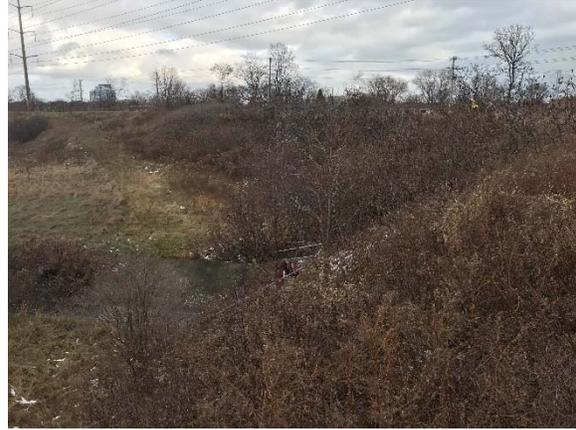
There is a single concrete box culvert outlet and embankment which is discussed/assessed further in Section 2.3 (ref. Photo F.2), which appears to be performing as per design, and there is no evidence of any erosion or debris blockage. There were no other observed locations of debris accumulation in the facility, and the inlet culvert was also clear of any debris. Based on discussion with City staff, there have not been any historic incidents of debris accumulation in this facility over the past two decades.

Photo F.2: Upstream end of Freeman FCF Outlet Control Culvert

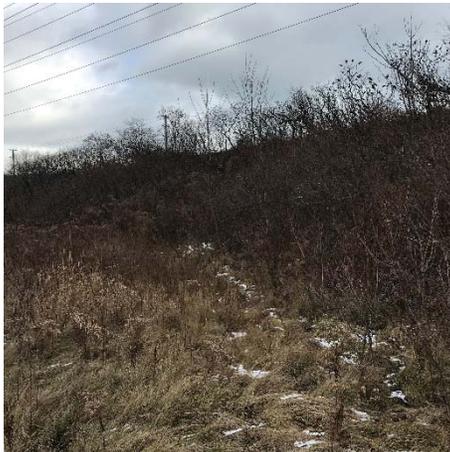
Photo F.3: Upstream face of Freeman FCF Outlet Berm

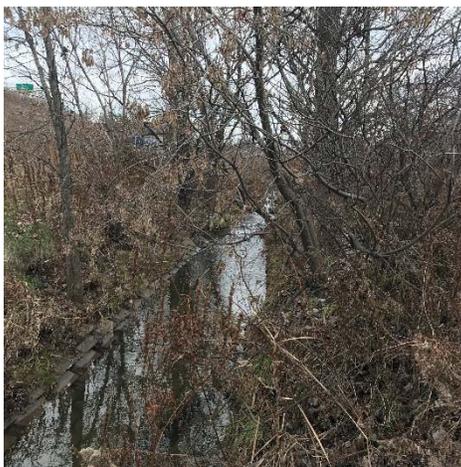
There are two connecting channels in the facility: one from the main inlet to the outlet, and a second channel from the east storm inlet and wetland westerly to the main channel. These both appear to be functioning as intended. There are no signs of any significant erosion in the channels (ref. Photos F.4, 5, & 6). There is concrete block lining in most of the channel, and there is no evidence of any notable damage to the concrete block lining. There are shrubs and trees growing along the channel (ref. Photos F.4 & 5) which should be monitored to ensure that the roots do not negatively impact the channel. The roots may be providing some degree of stabilization.

Photo F.5: Lined channel in lower section, near inlet, note woody vegetation

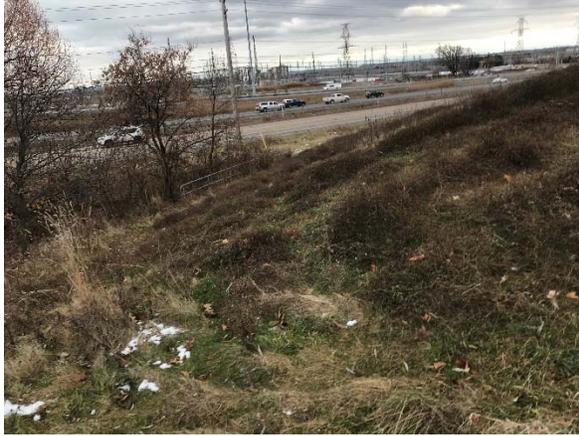
The outlet control berm is well vegetated (ref. Photos WH.1, 2 & 3) and does not have any evidence of erosion on either the upstream or downstream face. Both the upstream and downstream sides of the berm have some woody vegetation. The spillway is formed by the earthen berm, and spans the width of the valley, with an increased grade at the tie-ins at the sides. There is no evidence of erosion of the berm/spillway and stabilization measures appear to be in good condition.

Photo WH.1: West Hager FCF downstream face of outlet control berm

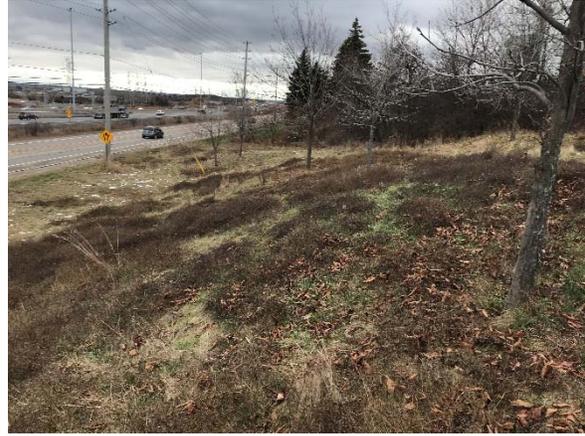
Photo WH.2: West Hager FCF downstream face of outlet control berm

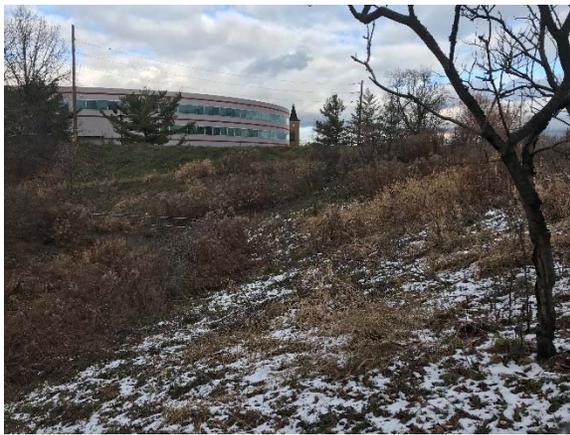
Photo WH.3: West Hager FCF upstream face of outlet control berm

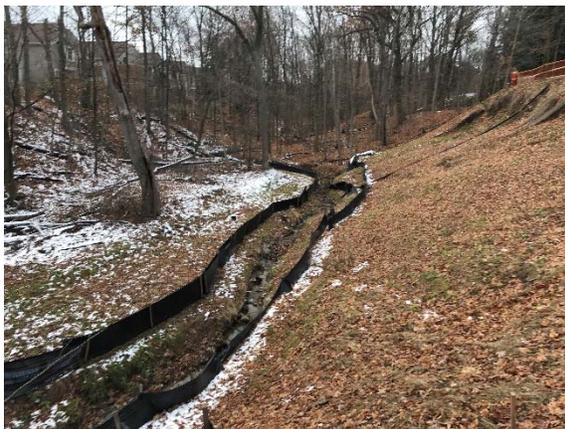
The main channel and tributaries within the most downstream portion of the facility all appear to be functioning hydraulically as intended. The upper west tributary appears to have been recently realigned by the City, to mitigate local valley slope erosion and to repair a recent slope failure on the east valley slope (ref. Photo WH.5). This work appears to have been completed within the past year and would therefore likely still be under warranty and observation by the City.

Photo WH.5: Upper west tributary to West Hager FCF – note recent City valley erosion repairs

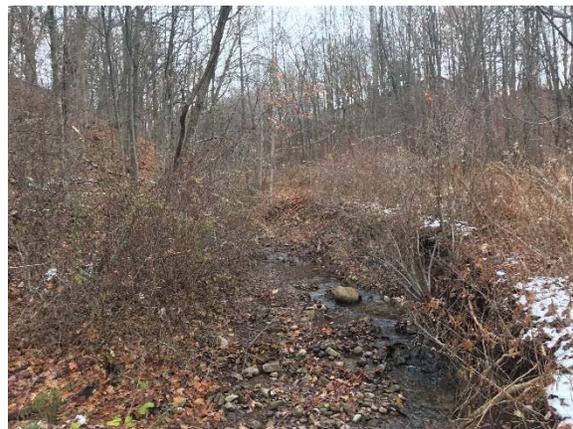
Photo WH.6: Upper east tributary to West Hager FCF – typical bank erosion scar

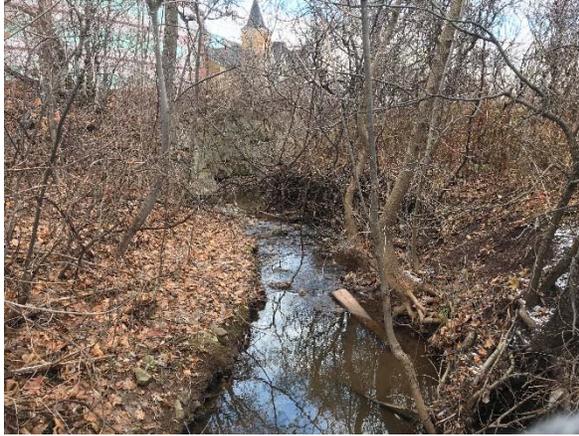
Photo WH.7: West Hager FCF downstream of facility outlet – note erosion

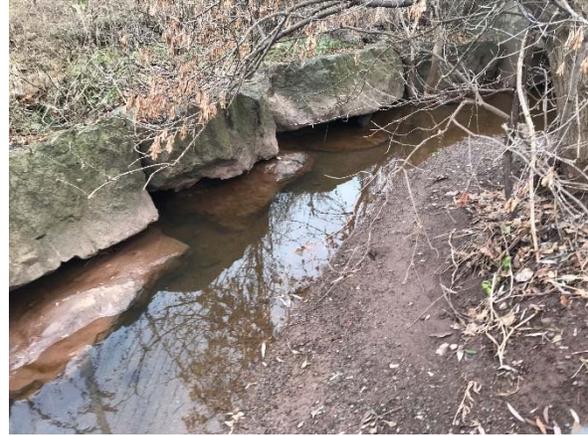
Photo WH.8: Immediately downstream of outlet culvert – armour stones potentially undermining

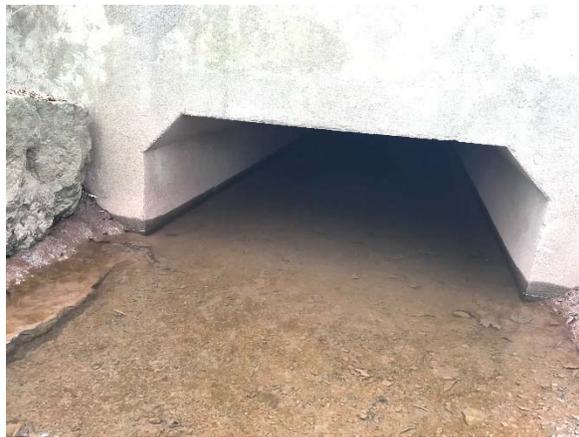
Notwithstanding, bedload and sediment filling of the box appears to have occurred over time, such that the effective opening height ranges between 0.8 and 0.9 m (1.1 m reported height in the City's GIS database). Of note, the available record drawings (refer to Appendix A) indicate a 1.44 m x 1.44 m box culvert which suggests the dimensions may have been altered a later date (given the field measured 1.8 m width). The sedimentation should be removed such that the full capacity of the outlet culvert is restored. There were no other observed locations of debris accumulation elsewhere in the facility. Based on discussion with City staff, there have not been any historic incidents of debris accumulation in this facility over the past two decades.

Photo WH.9: Downstream face of outlet control culvert, note sediment deposition mid-depth

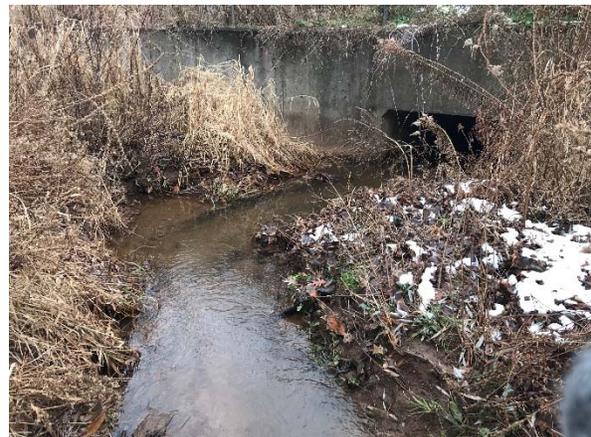
Photo WH.10: Channel immediately upstream of outlet control culvert, minor erosion, deposition in culvert

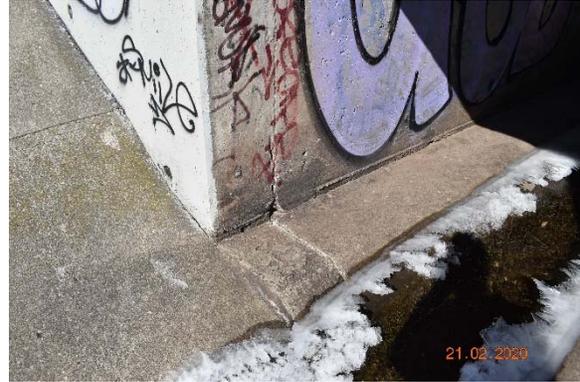
Photo F.16: Medium to Wide Cracking at Culvert Outlet

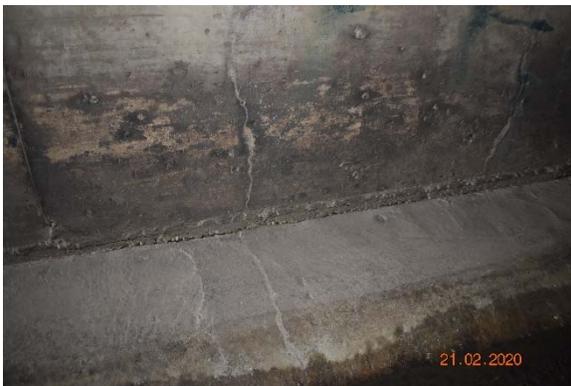
Photo F.17: Segregation of Concrete Below High-Water Level

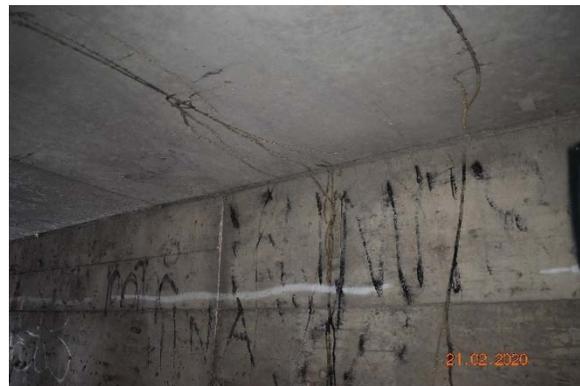
Photo F.18: Stalactites Along Barrel Soffit and Culvert Walls

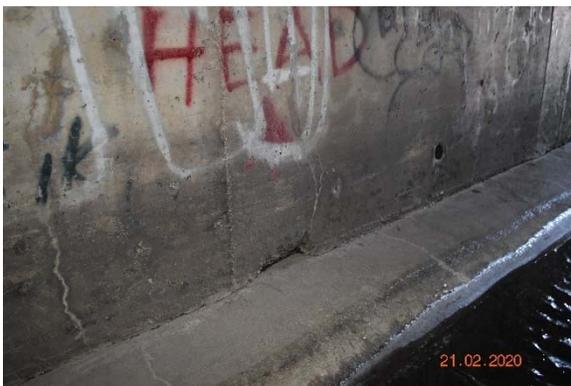
Photo F.19: Localized Spalling with Exposed Rebar at Culvert Wall

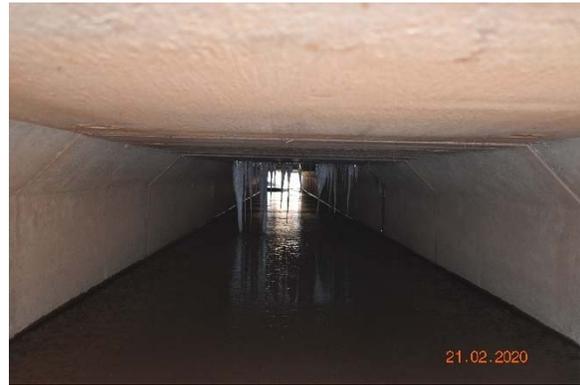
Upon site investigation, the existing precast concrete culvert structure appeared to be in overall good condition with light cracking and scaling seen throughout with minimal differential settlement observed between the precast concrete units near the inlet and outlet ends. Gaps between the precast units, with frozen water draining between the gaps, was observed. Drainage through the precast units can be caused by defects in the waterproofing, or a lack of waterproofing above the precast units. Drainage between the precast units can over time drain away earth from above the precast units causing the earth above the culvert to settle, however the level of drainage observed between the units did not appear to be of concern at this time.

Photo WH.14: Barrel View Looking North Towards
Culvert Inlet, Note Drainage Through Joints

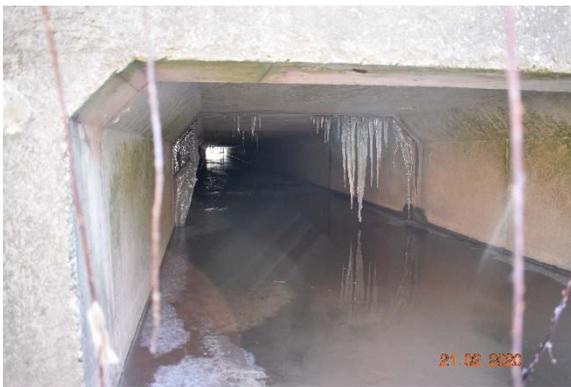
Photo WH.15: Barrel View Looking South Towards
Outlet, Note Drainage Through Joints
