# Appendix A Background Information

# HAGER-RAMBO FLOOD CONTROL WORKS OPERATIONS AND MAINTENANCE MANUAL

# CITY OF BURLINGTON HALTON REGION CONSERVATION AUTHORITY

December 1997

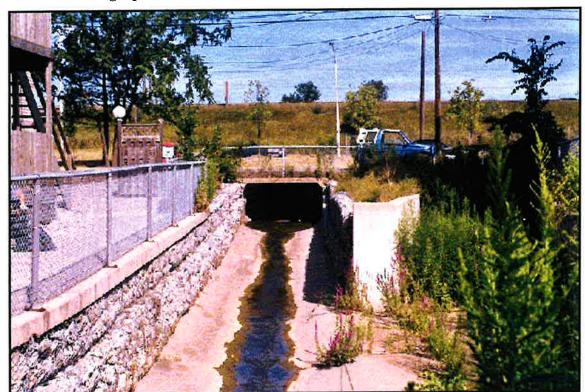
**Photo 2.1** - Downstream view of the Queensway Drive culvert, at the upstream limits of the study area. Note the heavy vegetation blocking the access ramp on the right, and growth through the cracks in the channel.

Vegetation that may be obstructing the culverts, drainage or outlet pipes, or growing through the channel should be removed. The low flow channel should be monitored for sediment accumulation, and cleaned every five years (HRCA recommendation from Halton Channel Study). However, with the present state of the Hager-Rambo system this component does not seem to be a factor with the operation or function of the channels. Therefore, due to the channel design features and minimal sediment being transported into the system, this procedure is not recommended unless a serious blockage of the channel or culvert structures is imminent. Locations for access to the channel should remain clear of any obstructions (tall/thick vegetation). The locks and gates should be checked twice a year to ensure easy access under normal or emergency conditions.

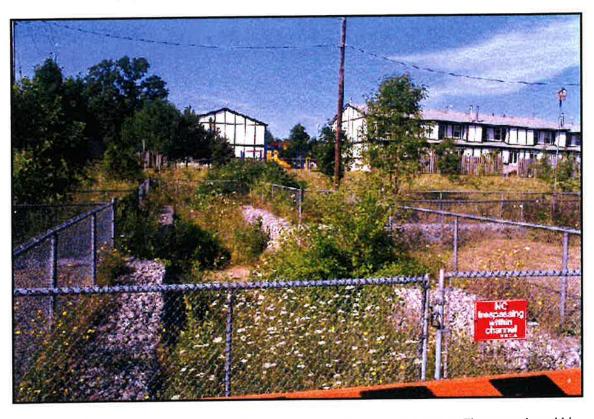
**Photo 2.6** – View of the maintenance access gates and ramps from Fassel Avenue. The vegetation within this area should be kept clear at all times to provide unconstrained access.

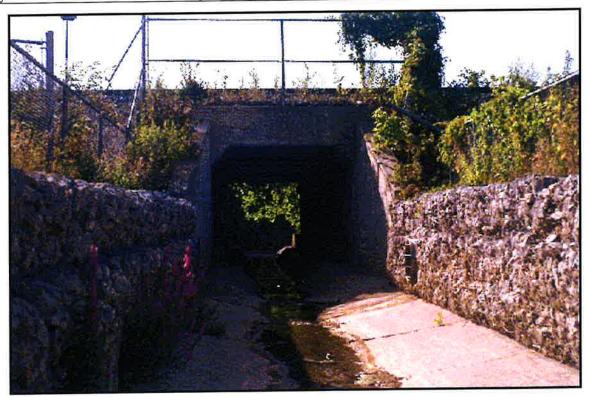
**Photo 2.7** - Looking downstream at the CNR crossing from station 0+510. Note the damage to the chainlink fencing, and the vegetation growth through the channel base and gabions

The channelization of the East Rambo at this location is unique from the other sites of the Hager-Rambo Flood Control Works, since the entire channel is lined with a two-stage gabion basket retaining wall system. This element should be inspected for any settlement or displacement of the baskets, the degradation of the wire or stone, and large vegetation (tree roots) that may cause damage to the walls. Typically, the most damaging impact is from vandalism, particularly in residential areas.

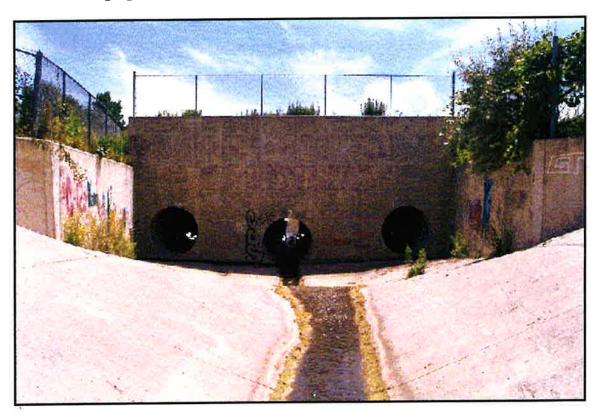
Photo 5.1 - View of the upstream side of the CNR crossing with the triple 2100 mm concrete pipe culverts. Note the vegetation growth out of the concrete.

The concrete culverts, headwalls, and wingwalls should be inspected annually. The concrete should be checked for any cracking or spalling, which may be repaired by sealing or grouting. Any major areas of cracking (> 3mm), displacement, or heaving (> 5 mm), along with the separation of slab or wall joints (expansion / control) and movement of backfill material, requires a thorough investigation by a qualified Structural Engineer, to determine the cause and recommend remedial works.

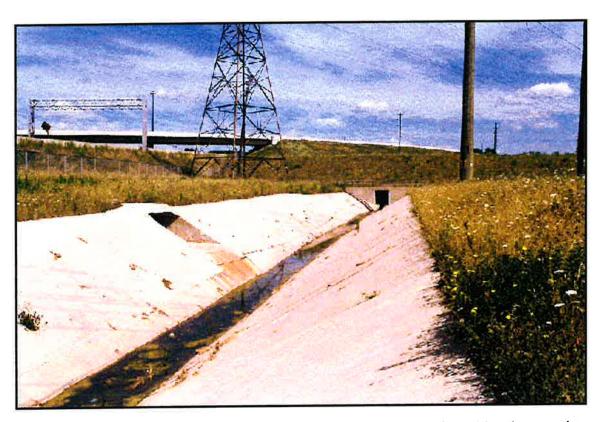
**Photo 6.3** - Looking upstream at the concrete channel section and outlet culvert. Note the vegetation growing out of the drainage pipes.

Vegetation or debris that may be obstructing the concrete channel invert, drainage or outlet pipes, or growing through the channel invert should be removed. Invasive species such as Purple Loosestrife that are present in the channel should be removed prior to pollination by manually digging or pulling the plants and roots, or by biological or chemical control. Locations for access to the channel should remain clear of any obstructions (tall/thick vegetation). The locks and gates should be checked twice a year to ensure easy access under normal or emergency conditions.

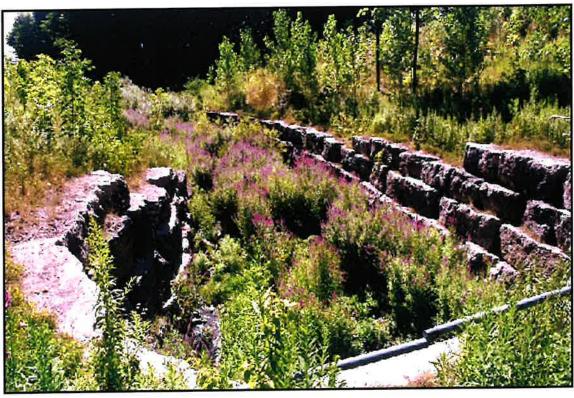
**Photo 9.4 -** Looking downstream from atop the culvert 4.5 x 3.5 metre culvert. Note the broken handrail and high concentration of Purple Loosestrife.

The channelization of East Hager Creek at this location utilizes the function of a "natural" channel system. As in the downstream sites, Purple Loosestrife is the dominant invasive species within the channel and should be removed in order to ensure maximum efficiency of the ecosystem. Larger debris (fallen trees, etc.) that may be obstructing the culverts or channel should be removed.
