Hager-Rambo Flood Control Facilities Study Report

Downtown and Burlington GO Mobility Hub
Burlington, Ontario
Project TPB198130

City of Burlington

9/22/2020

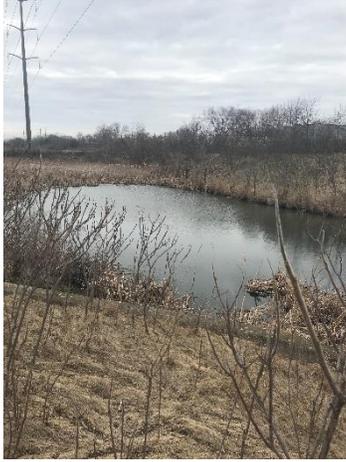
All of the facility side slopes are densely vegetated with grass and woody vegetation, that being mostly sumac (ref. Photos ER.1, 2, 5, & 11). There is no signs of erosion on the side slopes. There is only one (1) observed sign of small mammal burrowing in the side slope. There are deer trails along a number of the side slopes. The woody vegetation is comprised mostly of shrubs, and there are a number of smaller trees on the north side slope (ref. Photo ER.5). There are some trees on the south side slope (road embankment). In the vicinity of the hydro towers, the vegetation is being cut/maintained by Hydro, and all of the woody vegetation is cut.

Photo ER.1: East Rambo FCF east cell

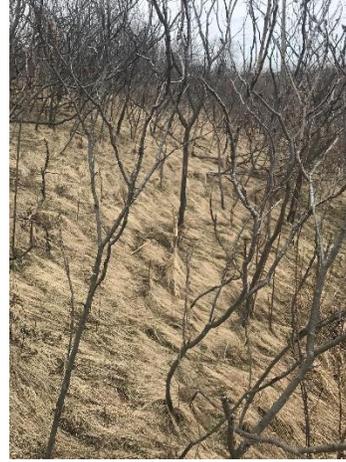
Photo ER.2: East Rambo FCF typical slope vegetation

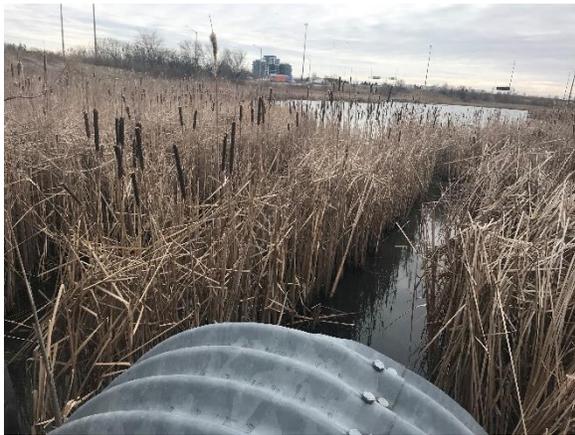
Photo ER.3: East Rambo FCF driveway culvert between east and main facility

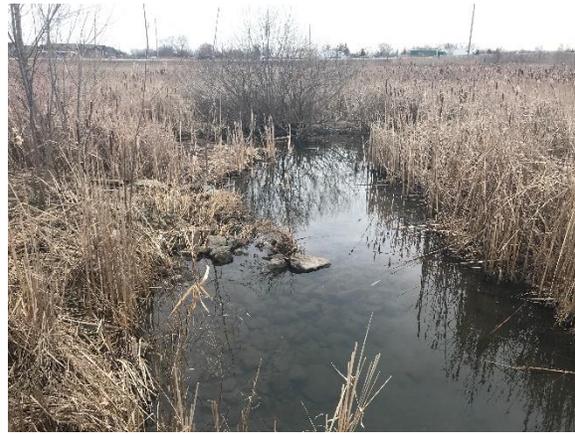
Photo ER.4: East Rambo FCF channel inlet from north – limited erosion

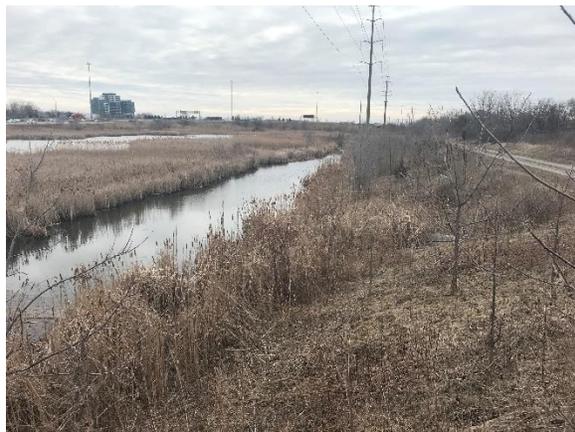
Photo ER.5: East Rambo FCF looking west

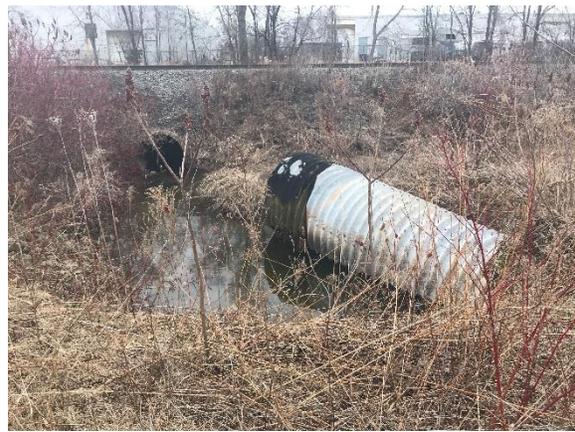
All inlets appear to be functioning as intended, with the exception of the middle inlet culvert from the north. There is erosion and scouring at the point where the subject culvert discharges into the flood control facility, which would require repair. Topographic survey is also required to determine if the upstream end of the CSP has become exposed with loss of cover, and whether it has lifted (ref. Photo ER.6).

Photo ER.6: East Rambo FCF inlet from north, note scour repair required

- East Rambo FCF
 - Erosion repair at mid-point inlet into pond, including topographic survey verification and mitigation of culvert scour and culvert perching
 - Repair to rip rap lining of inlet ditch from North Service Road
 - Removal of debris from outlet grate and structure
 - Consideration for a bathymetric survey of the pond to confirm sedimentation and vegetation accumulation and need for a potential clean-out
- West Hager FCF
 - Remove sedimentation in outlet control culvert

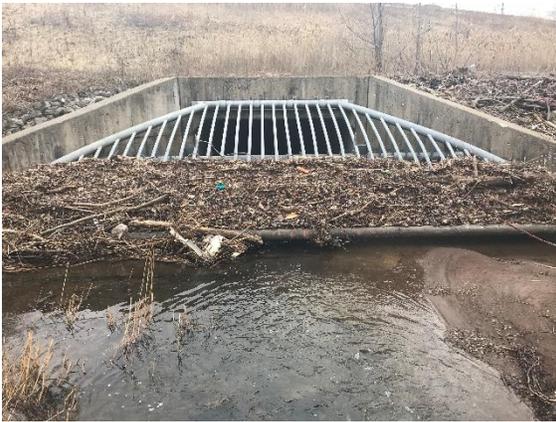
Based on discussion with City staff, this outlet is inspected regularly for debris, which is removed as required. There were no other observed locations of debris accumulation or blockage in the facility, and the other culverts were clear. The outlet grate was only partially blocked by debris (ref Photos ER.9 and ER.14). Further as cited earlier, based on anecdotal evidence of performance over the past two decades, there have been no reports of adverse blockages or significant sediment build-up.

Photo ER.9: East Rambo Facility outlet control culvert with safety grate and debris

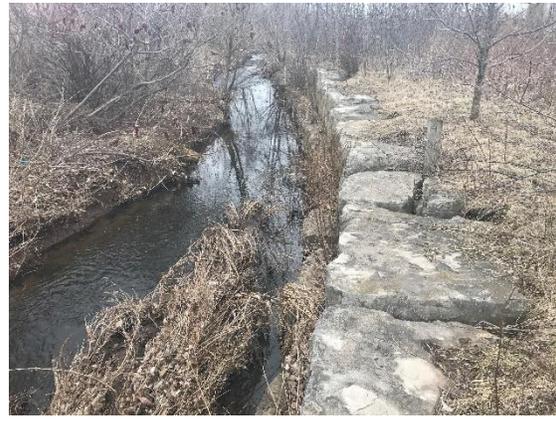
Photo ER.10: creek u/s of East Rambo FCF inlet in west corner – minimal scouring

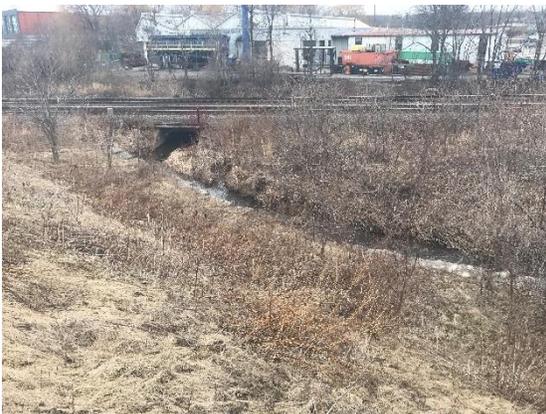
Photo ER.11: East Rambo creek d/s of CNR at west end of FCF

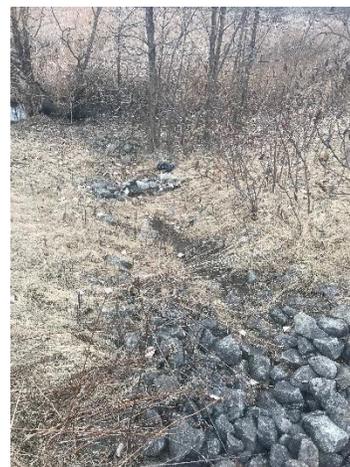
There is one (1) inlet ditch from the North Service Road which has had the rip-rap lining become eroded and moved to the creek invert, which should also be repaired (ref. Photo ER, 12).

Photo ER.12: East Rambo FCF rip rap spillway eroded at North Service Road ditch near entrance

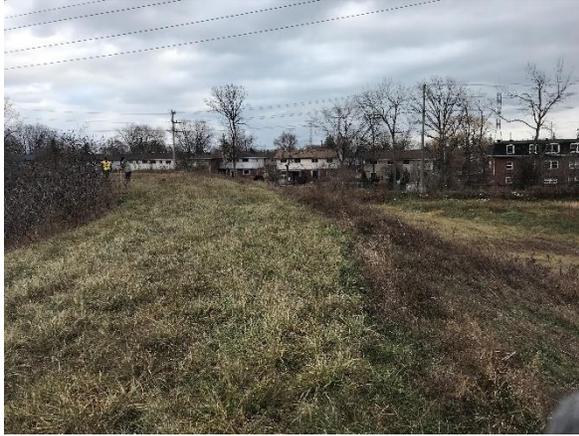
The outlet control berm is well vegetated (ref. Photo F.1) and does not have any evidence of erosion. The upstream face has woody vegetation (ref. Photos F.2 & 3). The spillway is stabilized with interlocking concrete block which is covered with topsoil and vegetation.

Photo F.1: Freeman FCF Outlet Berm

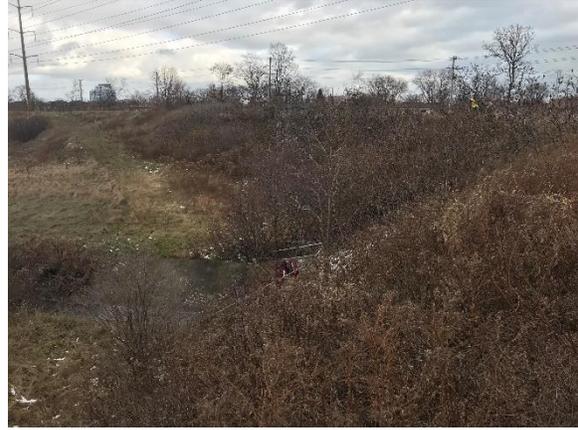
There is a single concrete box culvert outlet and embankment which is discussed/assessed further in Section 2.3 (ref. Photo F.2), which appears to be performing as per design, and there is no evidence of any erosion or debris blockage. There were no other observed locations of debris accumulation in the facility, and the inlet culvert was also clear of any debris. Based on discussion with City staff, there have not been any historic incidents of debris accumulation in this facility over the past two decades.

Photo F.2: Upstream end of Freeman FCF Outlet Control Culvert

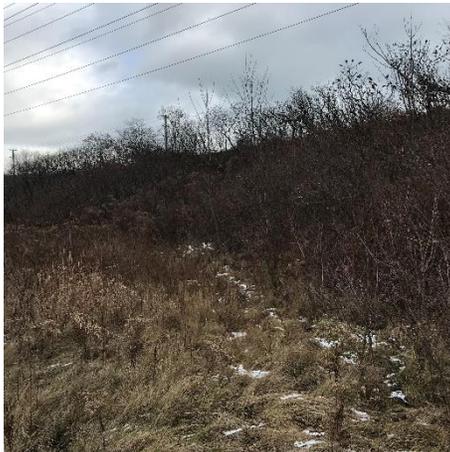
Photo F.3: Upstream face of Freeman FCF Outlet Berm

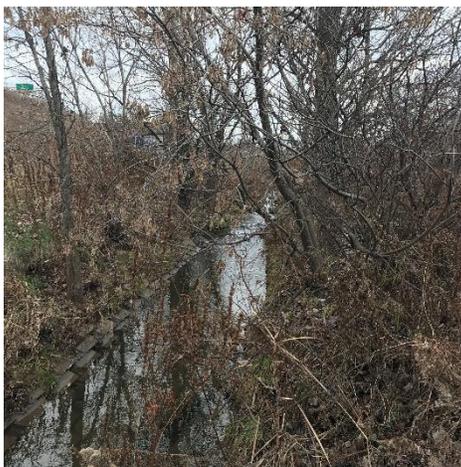
Photo F.5: Lined channel in lower section, near inlet, note woody vegetation

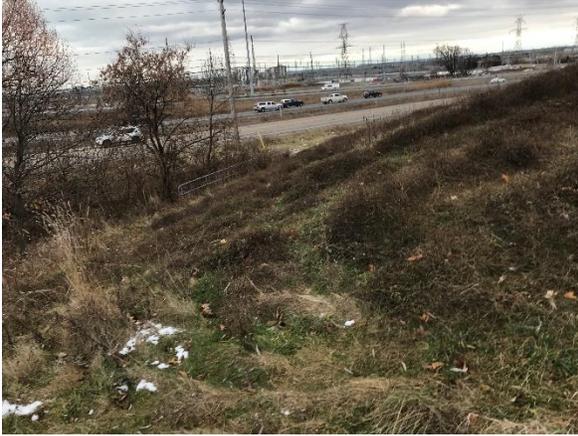
The outlet control berm is well vegetated (ref. Photos WH.1, 2 & 3) and does not have any evidence of erosion on either the upstream or downstream face. Both the upstream and downstream sides of the berm have some woody vegetation. The spillway is formed by the earthen berm, and spans the width of the valley, with an increased grade at the tie-ins at the sides. There is no evidence of erosion of the berm/spillway and stabilization measures appear to be in good condition.

Photo WH.1: West Hager FCF downstream face of outlet control berm

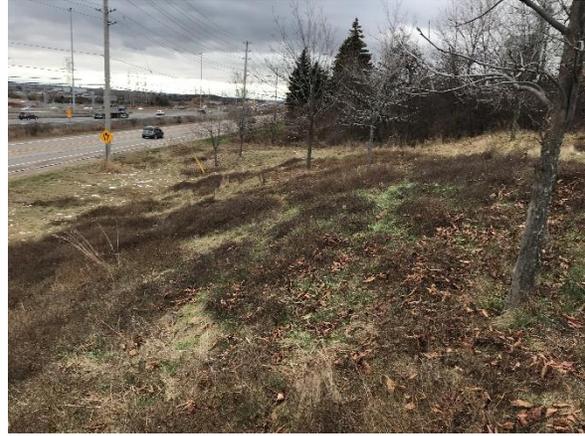
Photo WH.2: West Hager FCF downstream face of outlet control berm

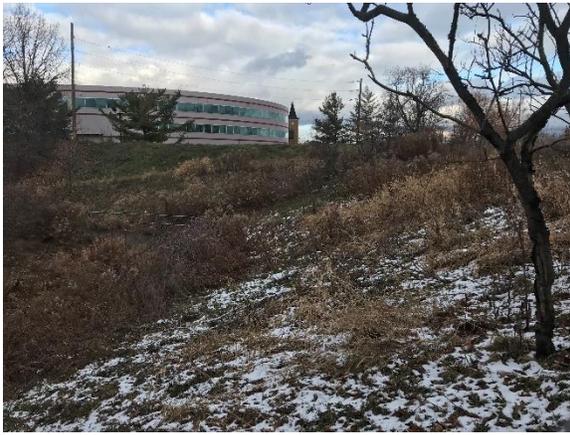
Photo WH.3: West Hager FCF upstream face of outlet control berm

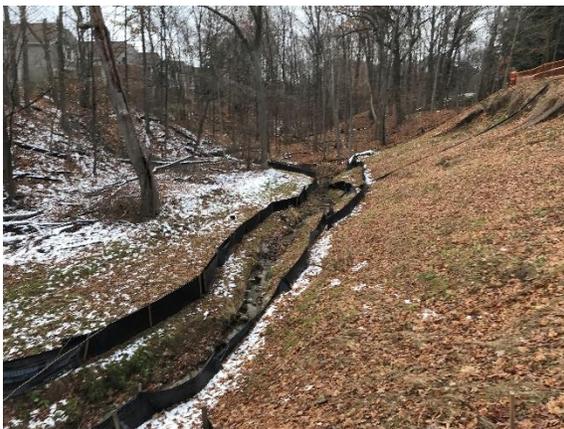
The main channel and tributaries within the most downstream portion of the facility all appear to be functioning hydraulically as intended. The upper west tributary appears to have been recently realigned by the City, to mitigate local valley slope erosion and to repair a recent slope failure on the east valley slope (ref. Photo WH.5). This work appears to have been completed within the past year and would therefore likely still be under warranty and observation by the City.

Photo WH.5: Upper west tributary to West Hager FCF – note recent City valley erosion repairs

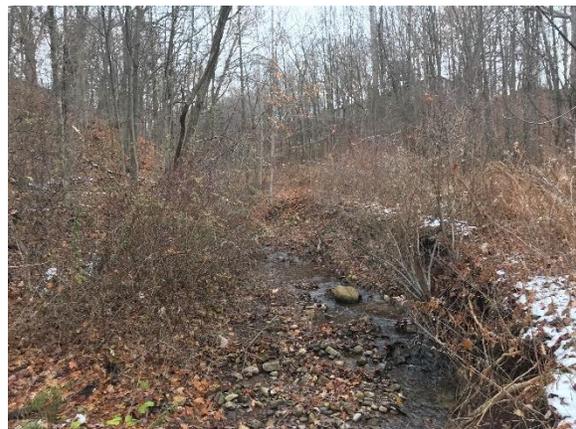
Photo WH.6: Upper east tributary to West Hager FCF – typical bank erosion scar

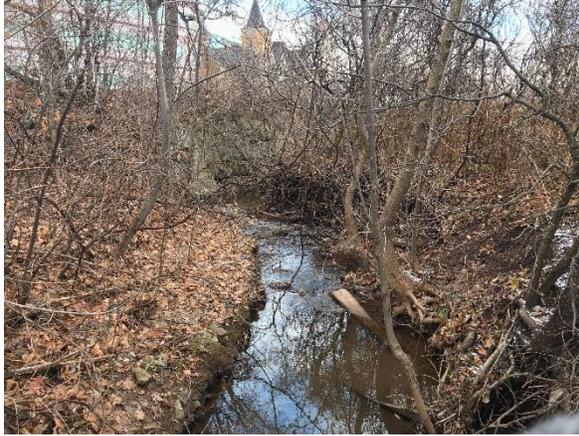
Photo WH.7: West Hager FCF downstream of facility outlet – note erosion

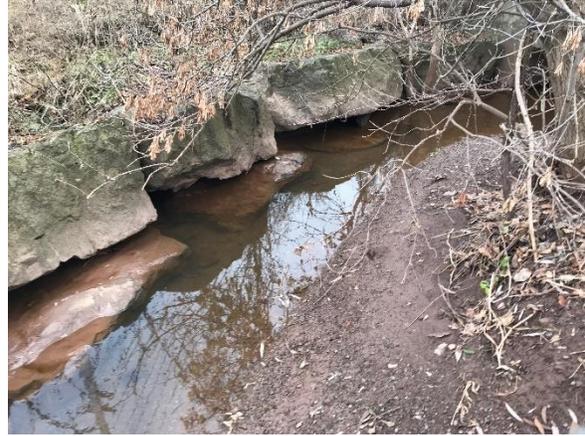
Photo WH.8: Immediately downstream of outlet culvert – armour stones potentially undermining

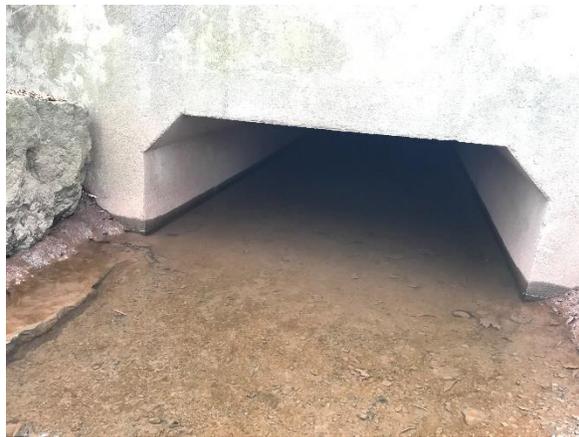
Notwithstanding, bedload and sediment filling of the box appears to have occurred over time, such that the effective opening height ranges between 0.8 and 0.9 m (1.1 m reported height in the City's GIS database). Of note, the available record drawings (refer to Appendix A) indicate a 1.44 m x 1.44 m box culvert which suggests the dimensions may have been altered a later date (given the field measured 1.8 m width). The sedimentation should be removed such that the full capacity of the outlet culvert is restored. There were no other observed locations of debris accumulation elsewhere in the facility. Based on discussion with City staff, there have not been any historic incidents of debris accumulation in this facility over the past two decades.

Photo WH.9: Downstream face of outlet control culvert, note sediment deposition mid-depth

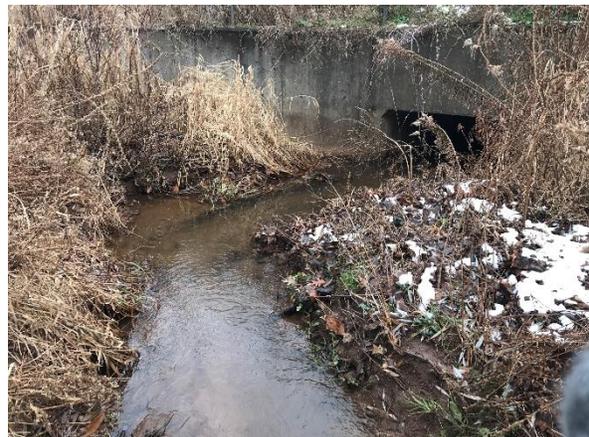
Photo WH.10: Channel immediately upstream of outlet control culvert, minor erosion, deposition in culvert

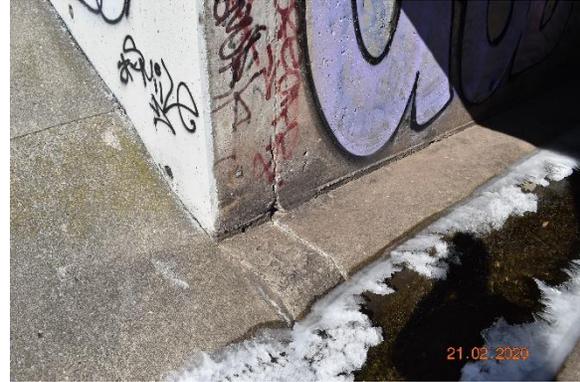
Photo F.16: Medium to Wide Cracking at Culvert Outlet

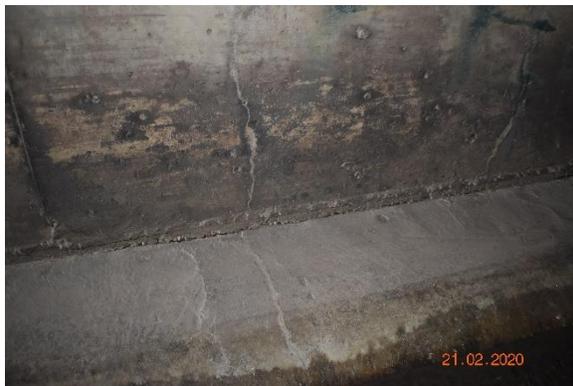
Photo F.17: Segregation of Concrete Below High-Water Level

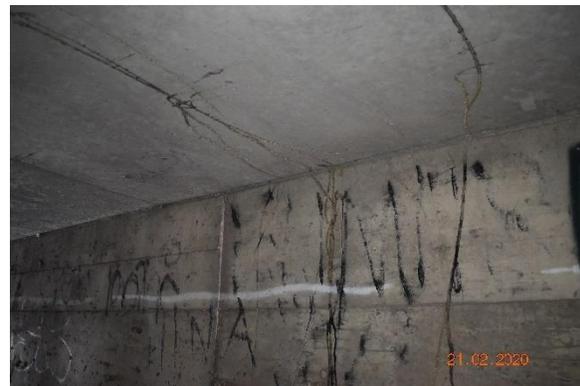
Photo F.18: Stalactites Along Barrel Soffit and Culvert Walls

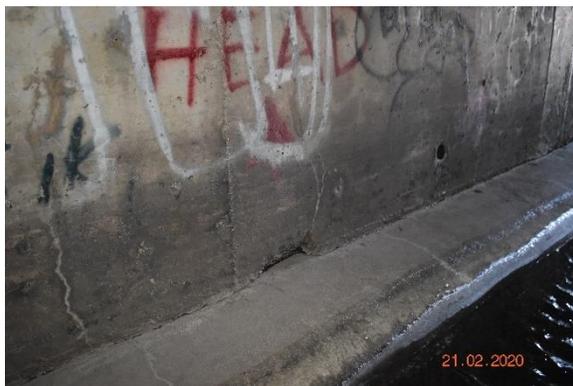
Photo F.19: Localized Spalling with Exposed Rebar at Culvert Wall

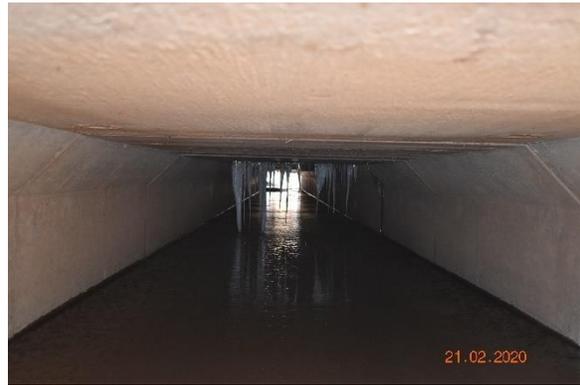
Upon site investigation, the existing precast concrete culvert structure appeared to be in overall good condition with light cracking and scaling seen throughout with minimal differential settlement observed between the precast concrete units near the inlet and outlet ends. Gaps between the precast units, with frozen water draining between the gaps, was observed. Drainage through the precast units can be caused by defects in the waterproofing, or a lack of waterproofing above the precast units. Drainage between the precast units can over time drain away earth from above the precast units causing the earth above the culvert to settle, however the level of drainage observed between the units did not appear to be of concern at this time.

Photo WH.14: Barrel View Looking North Towards
Culvert Inlet, Note Drainage Through Joints

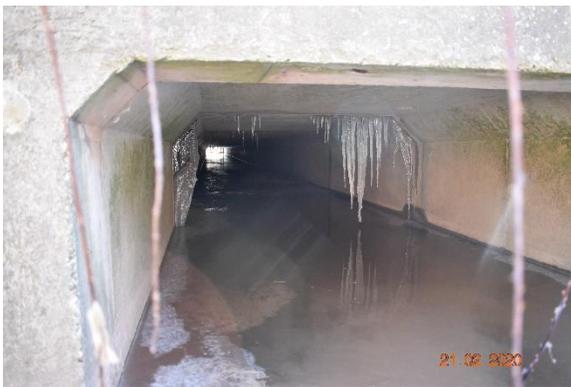
Photo WH.15: Barrel View Looking South Towards
Outlet, Note Drainage Through Joints
