## HAGER-RAMBO FLOOD CONTROL WORKS OPERATIONS AND MAINTENANCE MANUAL

## CITY OF BURLINGTON HALTON REGION CONSERVATION AUTHORITY

December 1997

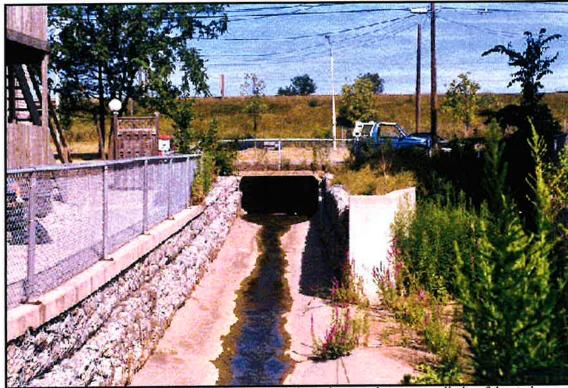
**Photo 2.1** - Downstream view of the Queensway Drive culvert, at the upstream limits of the study area. Note the heavy vegetation blocking the access ramp on the right, and growth through the cracks in the channel.

Vegetation that may be obstructing the culverts, drainage or outlet pipes, or growing through the channel should be removed. The low flow channel should be monitored for sediment accumulation, and cleaned every five years (HRCA recommendation from Halton Channel Study). However, with the present state of the Hager-Rambo system this component does not seem to be a factor with the operation or function of the channels. Therefore, due to the channel design features and minimal sediment being transported into the system, this procedure is not recommended unless a serious blockage of the channel or culvert structures is imminent. Locations for access to the channel should remain clear of any obstructions (tall/thick vegetation). The locks and gates should be checked twice a year to ensure easy access under normal or emergency conditions.

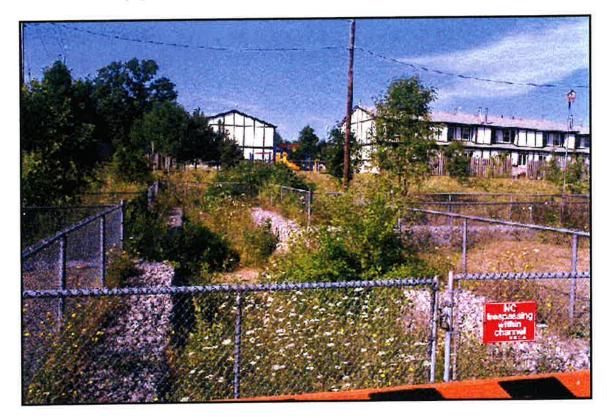
**Photo 2.6** – View of the maintenance access gates and ramps from Fassel Avenue. The vegetation within this area should be kept clear at all times to provide unconstrained access.

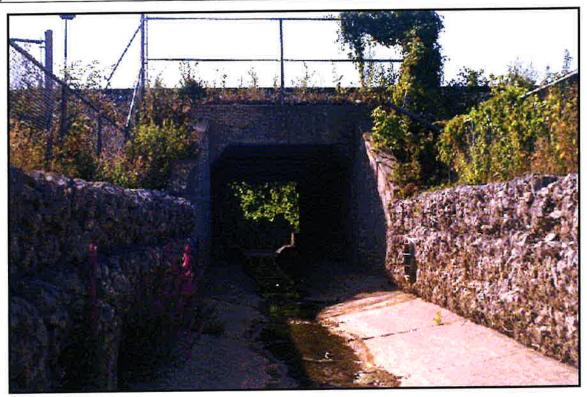
**Photo 2.7** - Looking downstream at the CNR crossing from station 0+510. Note the damage to the chainlink fencing, and the vegetation growth through the channel base and gabions

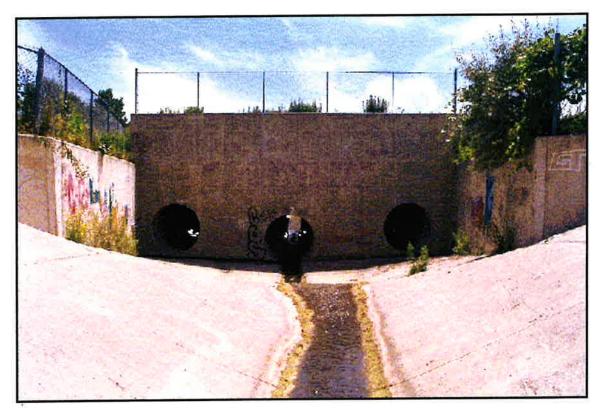
Photo 5.1 - View of the upstream side of the CNR crossing with the triple 2100 mm concrete pipe culverts. Note the vegetation growth out of the concrete.

The concrete culverts, headwalls, and wingwalls should be inspected annually. The concrete should be checked for any cracking or spalling, which may be repaired by sealing or grouting. Any major areas of cracking (> 3mm), displacement, or heaving (> 5 mm), along with the separation of slab or wall joints (expansion / control) and movement of backfill material, requires a thorough investigation by a qualified Structural Engineer, to determine the cause and recommend remedial works. The culverts should also be checked for sediment accumulation and cleaned as necessary (Reference Section 2.6.4). Throughout these works the walls are covered with graffiti and which may be removed by sandblasting or painted over for aesthetic reasons.

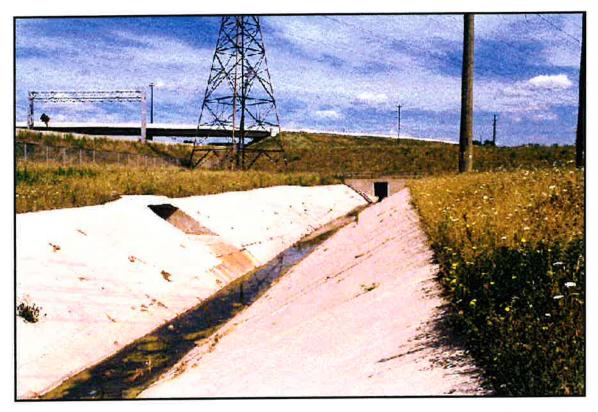
Photo 6.3 - Looking upstream at the concrete channel section and outlet culvert. Note the vegetation growing out of the drainage pipes.

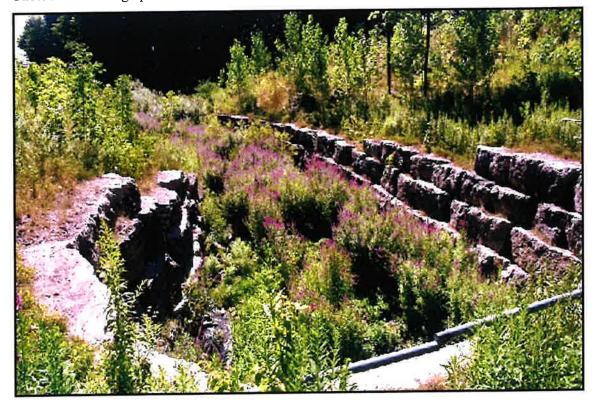
Photo 9.4 - Looking downstream from atop the culvert 4.5 x 3.5 metre culvert. Note the broken handrail and high concentration of Purple Loosestrife.
