PRE-CONSTRUCTION ARBORIST REPORT

May 5th, 2020

2477 Queensway Drive
Burlington, ON

Chris Tiseo
Ontario Arborist #400949814
Glenwood Tree Service Inc.
info@glenwoodtree.ca

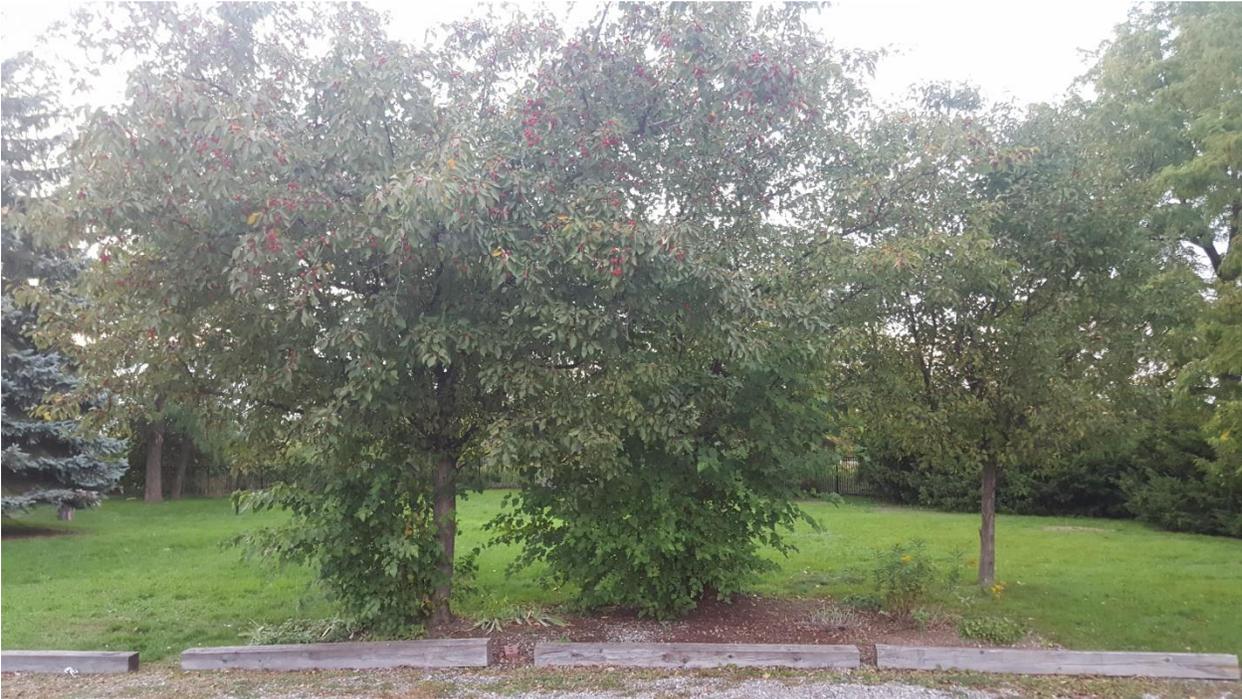
Below: Trees #1-#3

No.	Botanical Name	Common Name	DBH (cm)	Dripline (m)	Category	Condition	Comments	Risk	Recommendation	TPZ (distance in metres)
1	<i>Malus sp.</i>	Crabapple	21	3	Private	Fair	Watershoots. In conflict with proposed construction.	H	R	N/A
2	<i>Malus sp.</i>	Crabapple	17	2.2	Private	Fair	Watershoots. In conflict with proposed construction.	H	R	N/A
3	<i>Malus sp.</i>	Crabapple	14	1.5	Private	Poor	In decline. In conflict with proposed construction.	H	R	N/A
4	<i>Picea abies</i>	Norway Spruce	15	1.7	Private	Fair	Deadwood. Damaged bark. In conflict with proposed construction.	H	R	N/A
5	<i>Betula pendula</i>	Silver Birch	19.5	2	Private	Poor	Significant dead portions. In conflict with proposed construction.	H	R	N/A
6	<i>Juglans nigra</i>	Black Walnut	14	2.1	Private	Poor	Deadwood. Infected with Walnut anthracnose. In conflict with proposed construction.	H	R	N/A
7	<i>Euonymus alatus</i>	Burning Bush	N/A	1	Private	Poor	Mostly dead. In conflict with proposed construction.	H	R	N/A

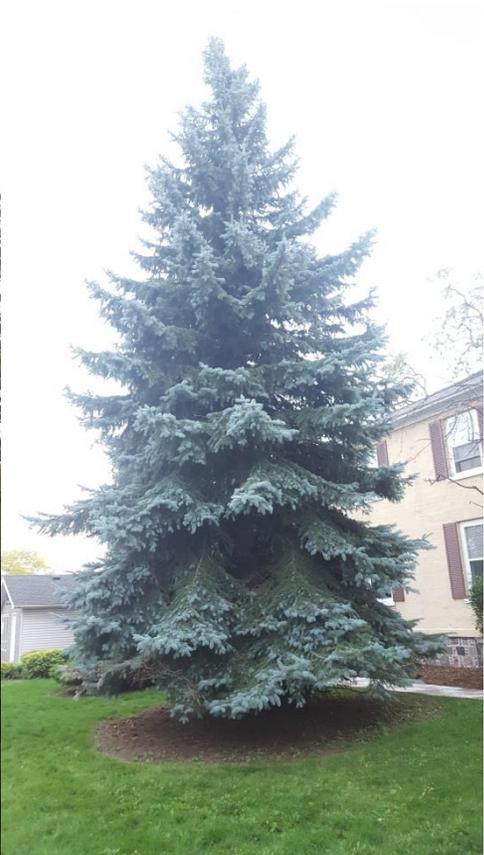
Below: Tree #8

8	<i>Picea pungens</i>	Colorado Blue Spruce	30	2	Private	Fair	Lower deadwood. In conflict with proposed construction.	H	R	N/A
9	<i>Malus sp.</i>	Crabapple	45	2	Private	Dead	100% dead. In conflict with proposed construction.	H	R	N/A
10	<i>Robinia</i>	Black Locust	47	4	Private	Fair	Significant deadwood. In	H	R	N/A

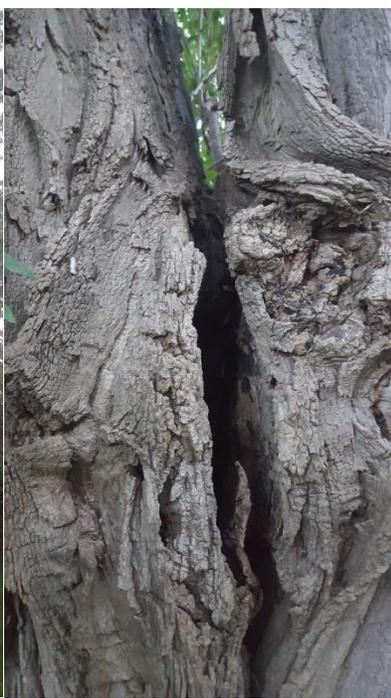
Below: Tree #17

<i>pseudoacacia</i>						conflict with proposed construction.			
11	<i>Robinia pseudoacacia</i>	Black Locust	30	3	Private	Fair	Significant deadwood. In conflict with proposed construction.	H	R	N/A
12	<i>Robinia pseudoacacia</i>	Black Locust	34	3.8	Private	Fair	Significant deadwood. In conflict with proposed construction.	H	R	N/A
13	<i>Morus alba</i>	White Mulberry	14.5	1.6	Private	Poor	Deadwood. Poor structure. In conflict with proposed construction.	H	R	N/A
14	<i>Robinia pseudoacacia</i>	Norway Spruce	34	4	Private	Fair	Considerable dead due to proximity to tree #10	H	R	N/A
15	<i>Robinia pseudoacacia</i>	Black Locust	71	3.5	Private	Poor	Broken top. Deadwood. In conflict with proposed construction.	H	R	N/A
16	<i>Robinia pseudoacacia</i>	Black Locust	30	2.1	Private	Poor	Broken stem. Deadwood. In conflict with proposed construction.	H	R	N/A
17	<i>Robinia pseudoacacia</i>	Black Locust	101	6	Private	Poor	Split at main union. Large cavity. Major deadwood. In conflict with proposed construction.	H	R	N/A

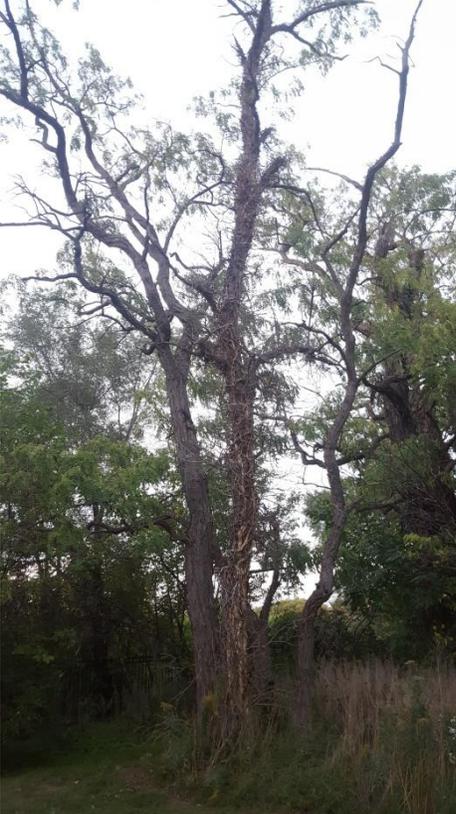
Below: Trees #18, #19, #20, #21

18	<i>Robinia pseudoacacia</i>	Black Locust	25	3	Private	Poor	Significant deadwood. Broken limbs. In conflict with proposed construction.	H	R	N/A
19	<i>Robinia pseudoacacia</i>	Black Locust	19	2	Private	Dead	100% dead. In conflict with proposed construction.	H	R	N/A
20	<i>Robinia pseudoacacia</i>	Black Locust	41	3	Private	Poor	Significant deadwood. Broken top. In conflict with proposed construction.	H	R	N/A

21	<i>Robinia pseudoacacia</i>	Black Locust	36	3	Private	Poor	Significant deadwood. In conflict with proposed construction.	H	R	N/A
22	<i>Robinia pseudoacacia</i>	Black Locust	17	2.3	Private	Fair	Deadwood. Broken branches. In conflict with proposed construction.	H	R	N/A
23	<i>Gleditsia triacanthos 'inermis'</i>	Thornless Honeylocust	30	3	Private	Fair	Suckers and watershoots. Deadwood. Poor structure. In conflict with proposed construction.	H	R	N/A
24	<i>Robinia pseudoacacia</i>	Black Locust	82	5.5	Private	Poor	Cavity. Broken limbs. Deadwood. Not viable to maintain	L	R	N/A
25	<i>Robinia pseudoacacia</i>	Black Locust	25	2	Private	Poor	Broken stem. Broken top. Not viable to maintain.	L	R	N/A
26	<i>Robinia pseudoacacia</i>	Black Locust	38	3	Private	Poor	Dead top. Significant deadwood. Not viable to maintain.	L	R	N/A
27	<i>Malus sp.</i>	Crabapple	13	1.5	Private	Fair	Poor location close to wall. Undesirable species.	M	R	N/A

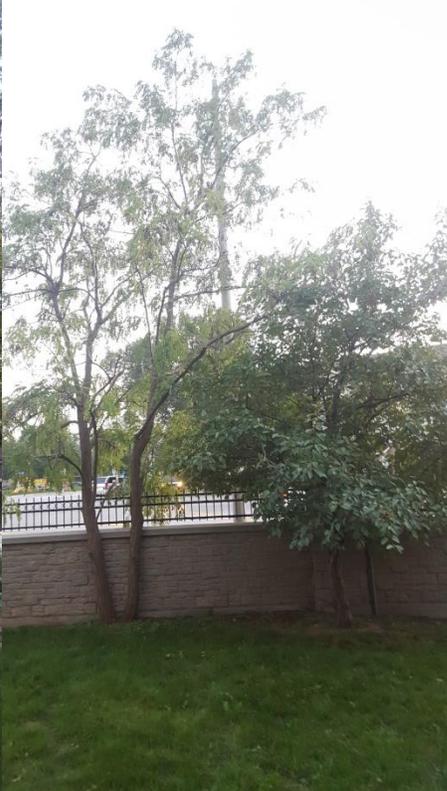
Below: Trees #27, #28

28	<i>Robinia pseudoacacia</i>	Black Locust	34	2	Private	Fair	Deadwood. Poor location against wall.	M	R	N/A
29	<i>Robinia pseudoacacia</i>	Black Locust	132	5	Private	Fair	Significant deadwood. Unsuitable species for children's play area	L	R	N/A
30	<i>Thuja occidentalis</i>	Eastern White Cedar	15	1	Private	Good	In conflict with proposed construction.	H	R	N/A
31	<i>Picea mariana</i>	Black Spruce	37	2.5	Private	Poor	Significant dead. In conflict with proposed construction.	H	R	N/A
32	<i>Robinia pseudoacacia</i>	Black Locust	30	3	Private	Fair	Deadwood. In conflict with proposed construction.	H	R	N/A
33	<i>Picea abies</i>	Norway	50	3.5	Private	Good	Recommend elevation	M	R	N/A

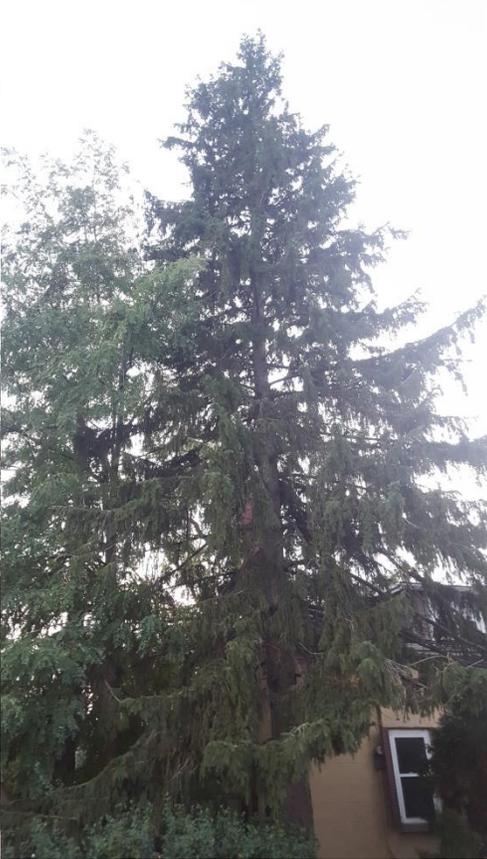
Below: Trees #32, #33

Spruce					and trimming away from house.			
34	<i>Thuja occidentalis</i>	Eastern White Cedar	7.5	0.5	Private	Fair	Deadwood	L	R	N/A
35	<i>Thuja occidentalis</i>	Eastern White Cedar	8	1	Private	Fair	Deadwood	L	R	N/A
36	<i>Syringa vulgaris</i>	Common Lilac	32	1.5	Private	Good		L	P	4
37	<i>Acer palmatum</i>	Japanese Maple	28	1.4	Private	Fair	In conflict with proposed construction.	H	R	N/A
38	<i>Juglans nigra</i>	Black walnut	33	3	City	Fair	Will need to be elevated for new building	L	P	2.4
39	<i>Ulmus pumila</i>	Siberian elm	59	4	City	Fair	Will need to be elevated for new building	L	P	3.6
40	<i>Morus alba</i>	White mulberry	12	3	City	Fair	Will need to be elevated for new building	L	P	2.4
41	<i>Juglans nigra</i>	Black walnut	29	3	City	Fair	Will need to be elevated for new building	L	P	2.4
42	<i>Robinia pseudoacacia</i>	Black locust	56	2.5	City	Poor	Deadwood; Decay	L	P	3.6
43	<i>Acer negundo</i>	Manitoba maple	35	4	City	Fair	Stem going over fence will need to be removed	L	P	2.4

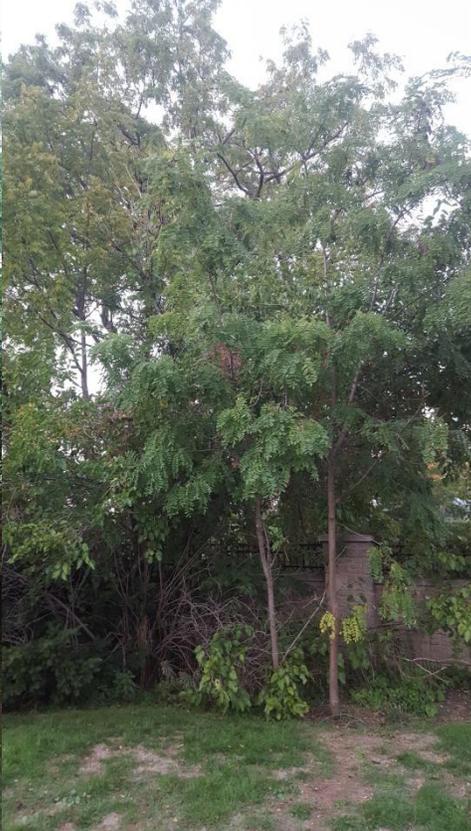
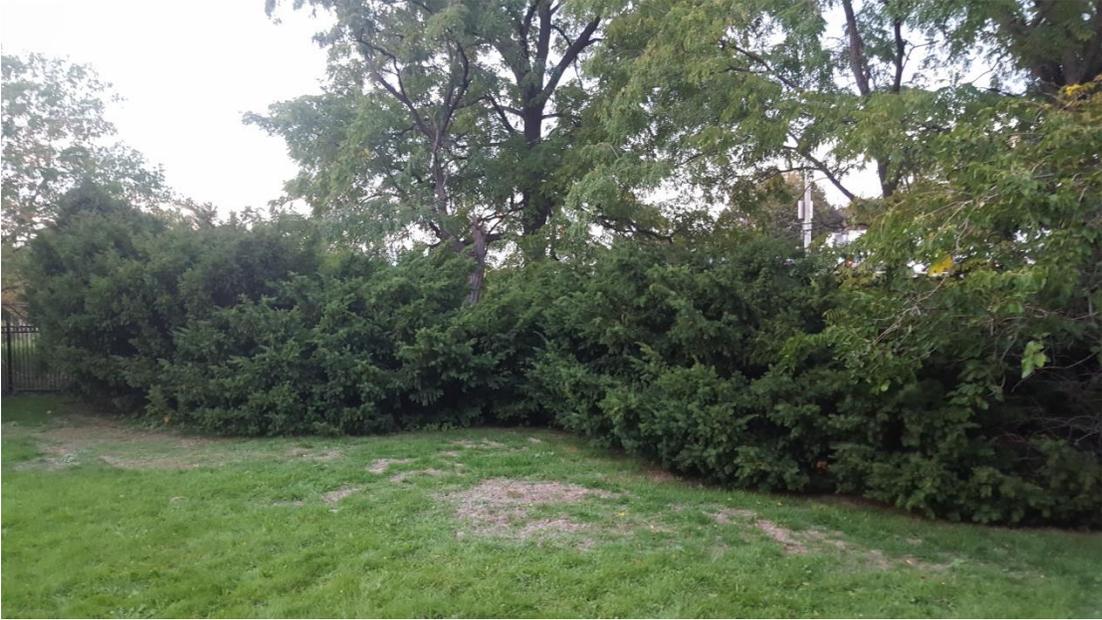
Below: Tree Grouping A

Tree Grouping	Dominant Species	DBH Range	Category	Condition	Comments	Risk	Recommendation
A	<i>Robinia pseudoacacia</i> ; <i>Morus alba</i> ; <i>Taxus sp.</i> ; <i>Fraxinus pennsylvanica</i>	5-21	Private	Fair	Ash infected with EAB. Dead stem on Mulberry. Overall grouping overcrowded. In conflict with proposed development	H	R
B	<i>Robinia pseudoacacia</i> ; <i>Picea pungens</i> ; <i>Juniperus virginiana</i>	3-19	Private	Fair	Junipers overgrown and in decline; overall grouping overcrowded. In conflict with proposed construction	H	R
C	<i>Robinia pseudoacacia</i> ; <i>Morus alba</i> ; <i>Acer ginnala</i>	3-18	Private	Poor	Considerable dead in all trees and shrubs. Grouping extremely crowded and overgrown. In conflict with	H	R

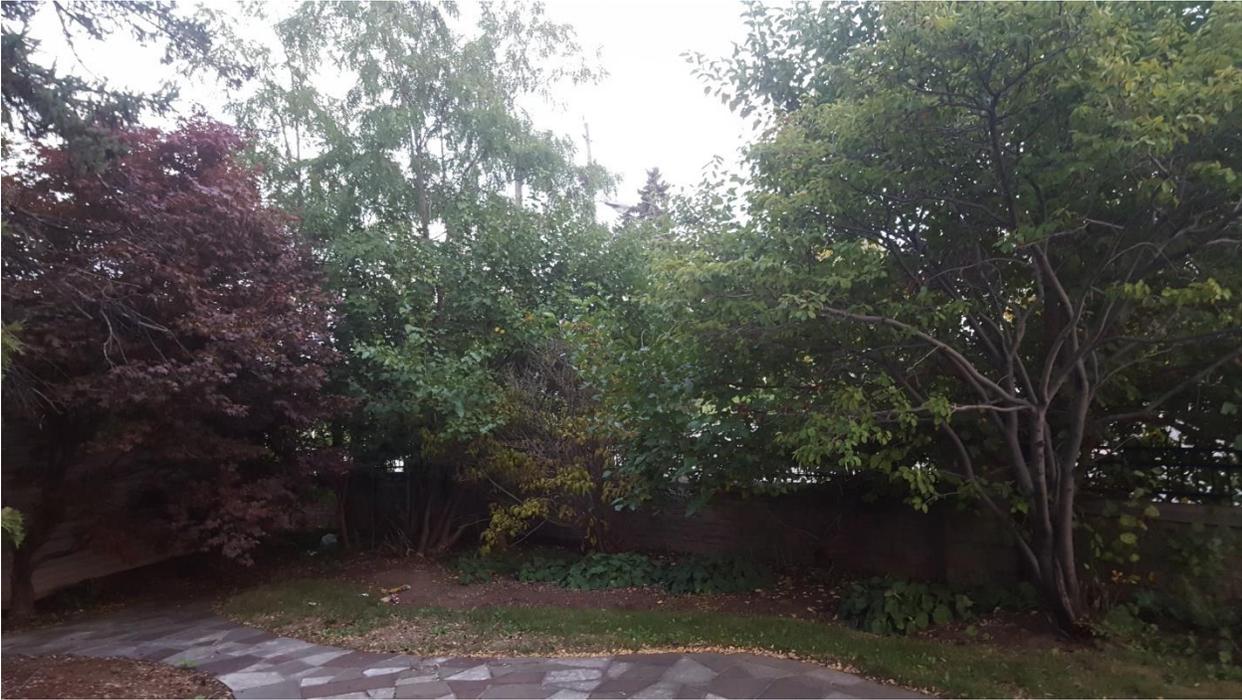
Below: Tree Grouping D, Tree #37, Tree #38

proposed development		
D	<i>Robinia pseudoacacia;</i> <i>Morus alba</i>	4-16	Private	Poor	Deadwood. Overcrowded. Invasive species encroaching on more desirable species in area	L	R
