Arborist Report and Tree Preservation Plan

338 Johnston Drive, Burlington ON.

GLN Farm and Forest Research Co Ltd.
17 November 2020
Revised: 7 December 2020

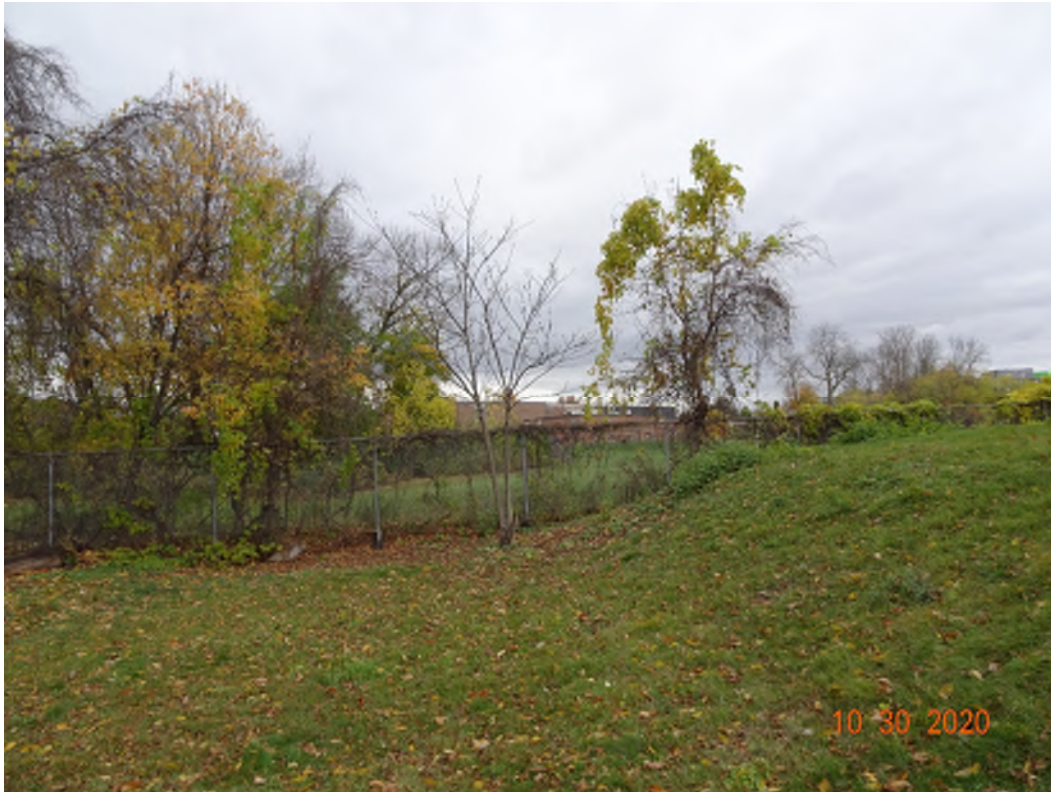
Picture 1. From

South overview of tree in relation to slope. Parking lot on right just out of picture.

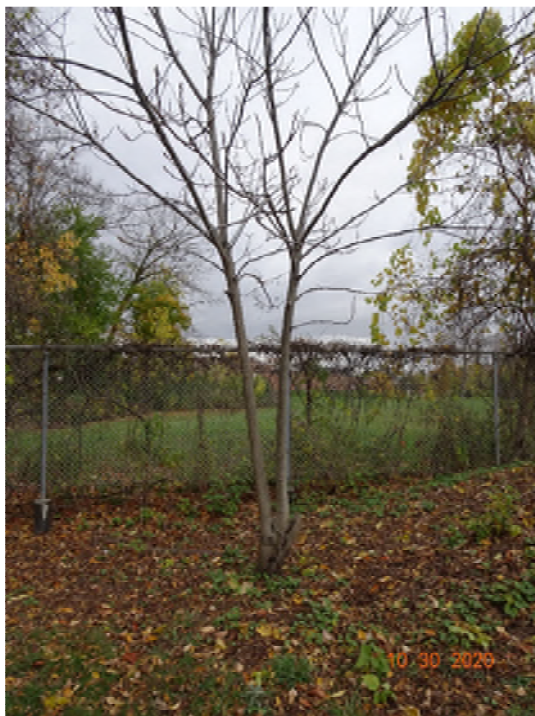
Picture 2. From South, tree in proximity to fence. Stubs visible.

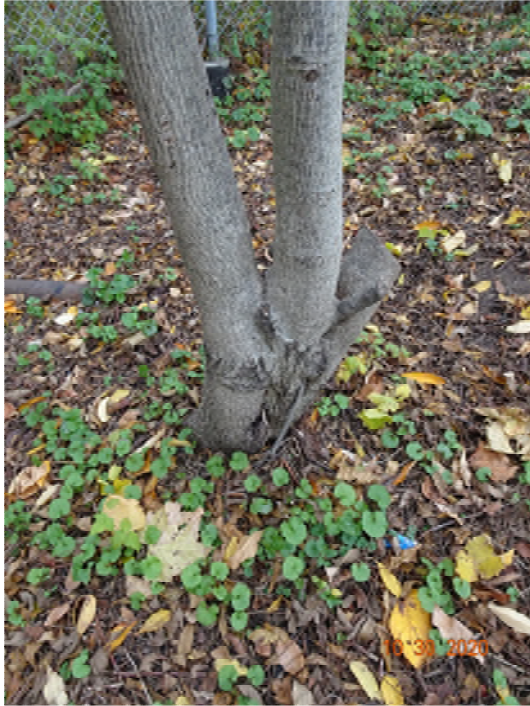
Picture 3. From South, what appears to be a graft line of the two remaining leaders, weak crotch and stub of 3rd leader.

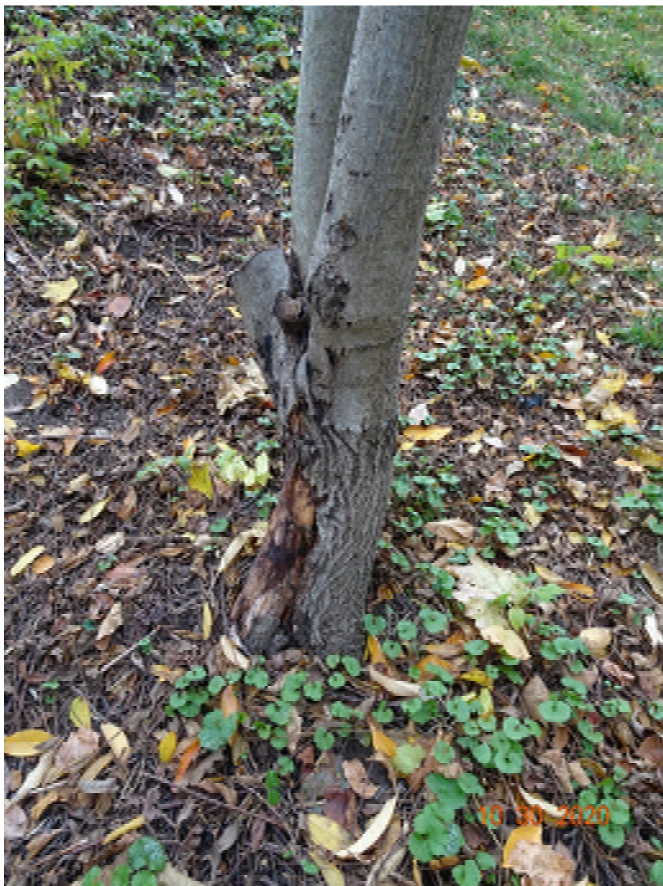
Picture 4. From North West showing bark missing at base and sooty areas.

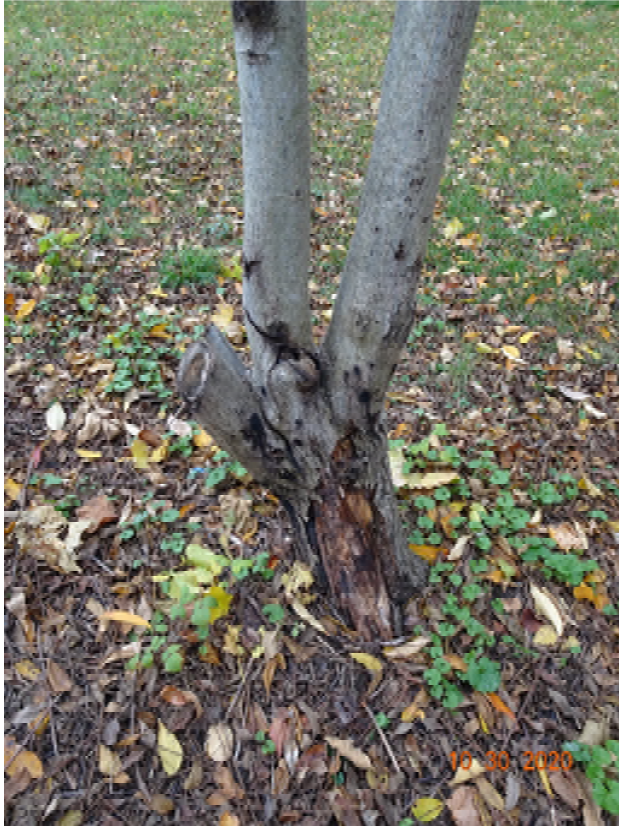
Picture 5. From North East showing extent of missing bark and poor leader connection structure.

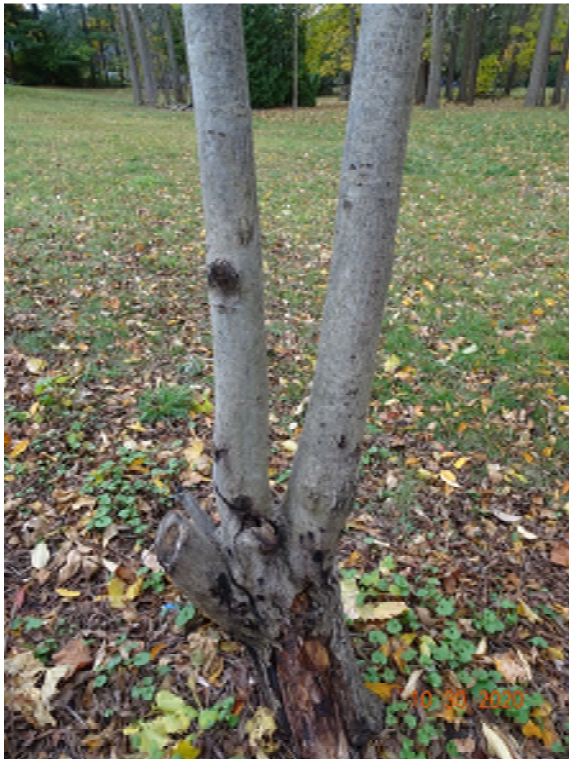
Picture 6. From north East showing lower sooty areas

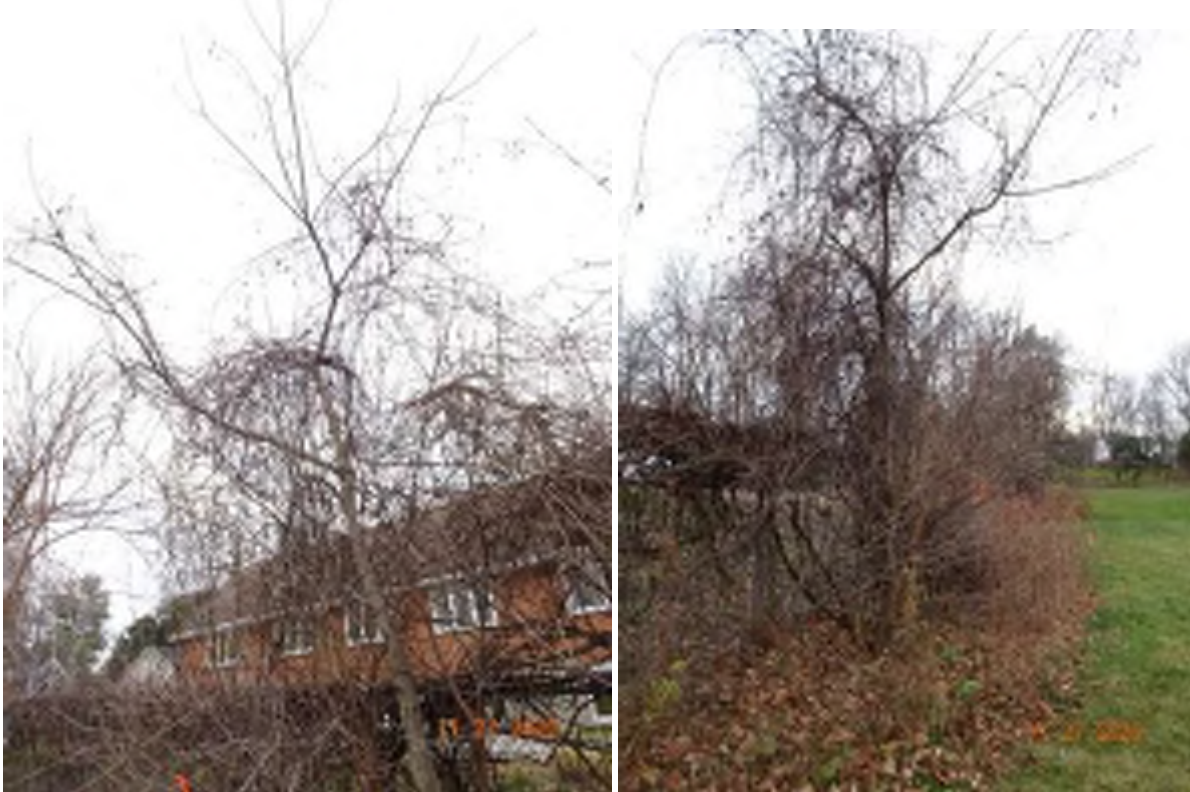
Picture 1. A. From North overview of tree in relation to fence and church. B. From East showing tree in proximity to significant vine on fence and in canopy. Parking lot over fence at #338 Johnston Drive.

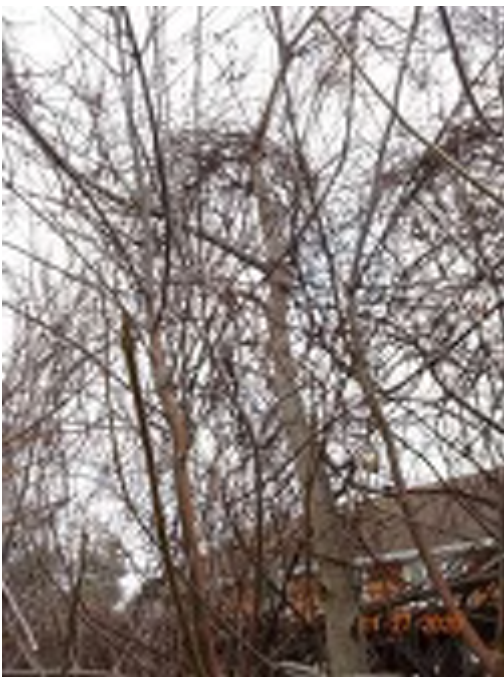
Picture 2. From North looking up into canopy showing competing growth.

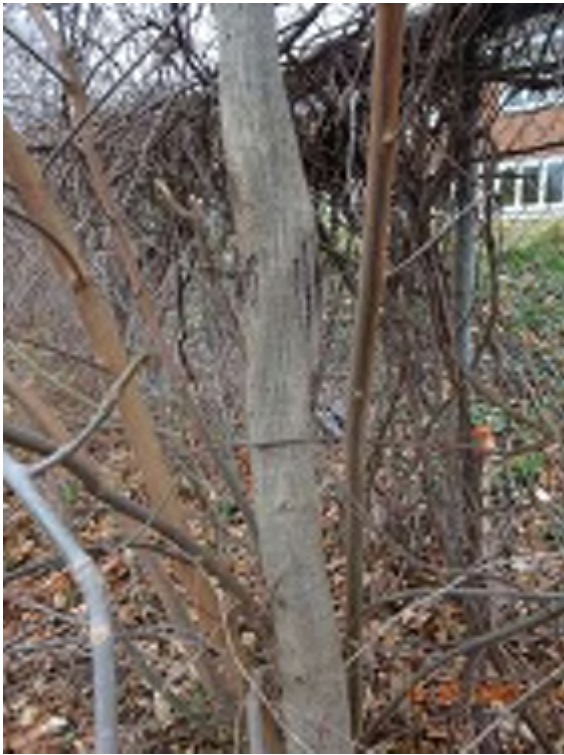
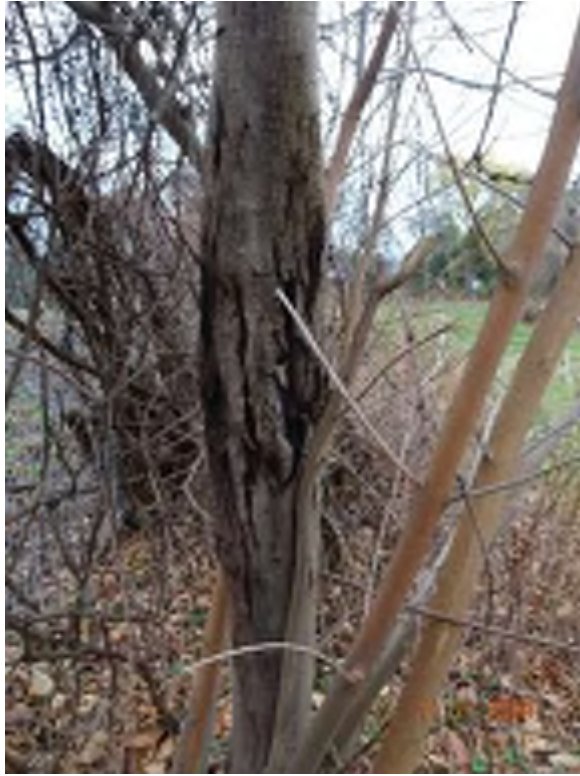
Picture

3. A. From North West showing lower trunk with canker bulge, and competing Ash growth. B. From East showing extent of trunk canker and decay and Ash conflict.

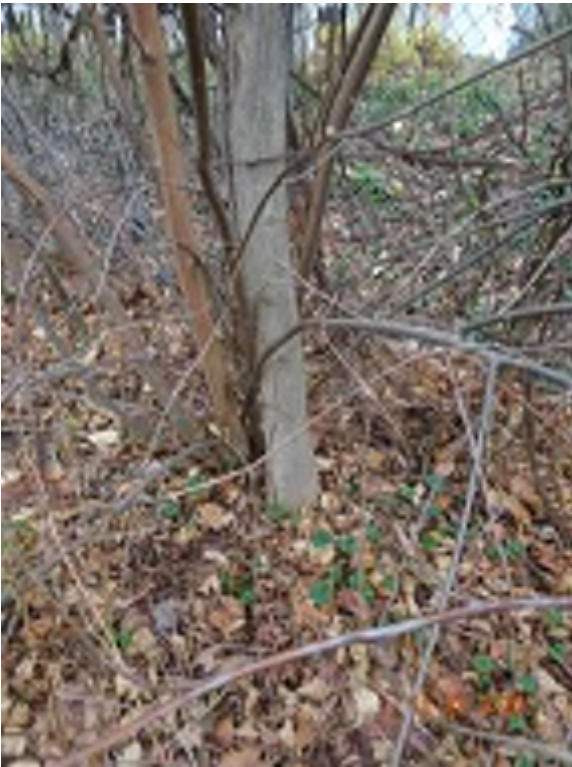
Picture 5. From North showing base of tree with competing Ash in conflict with the Butternut.
