# Arborist Report

4029 Spruce Avenue  
Burlington, Ontario  
L7L 1K1  
January 4<sup>th</sup>, 2021

RE: Arborist Report and Tree Protection Plan

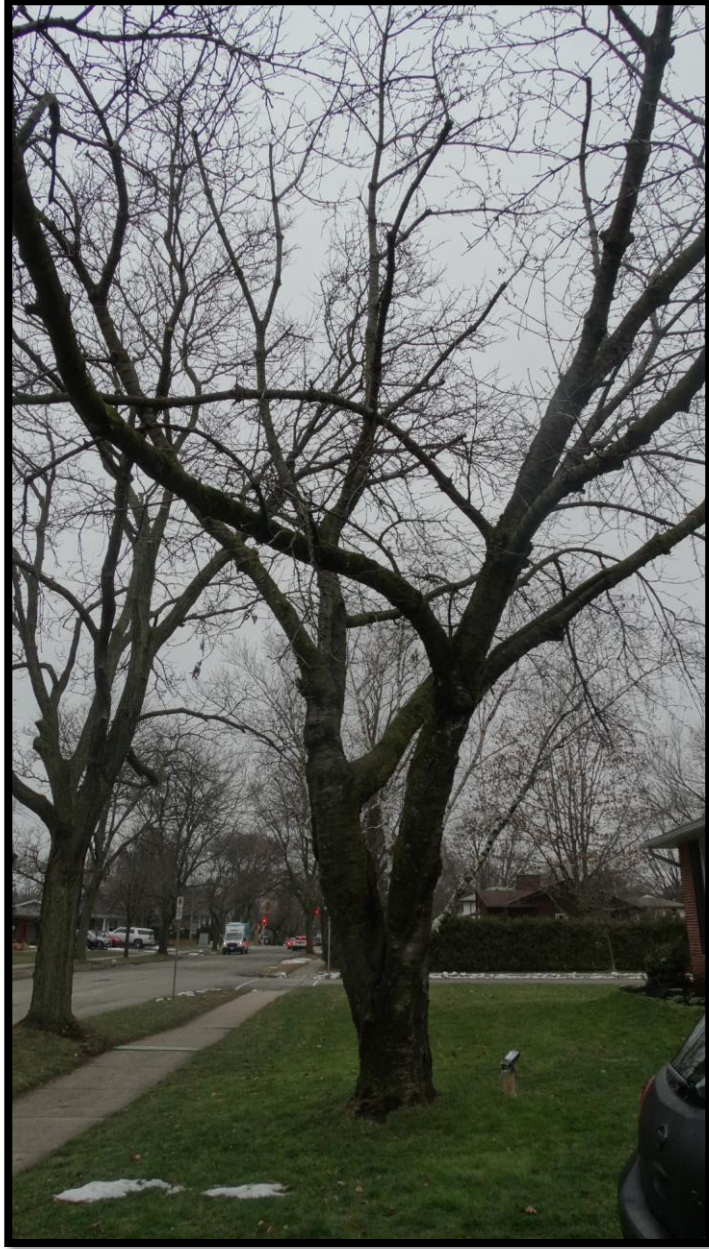
Tree 1 is a double-stemmed Kwanzan cherry located in the front yard adjacent to the existing driveway. Several surface roots have been damaged, most likely due to lawn maintenance equipment. Closer to the base of the tree, four primary roots are being constricted by surface roots.

Image 1: Tree 1 in situ

The proposed driveway expansion would be within the TPZ of this tree and would cause the tree to experience stress. The combination of the structurally compromised union, the need to prune a significant portion of the tree for clearance, and the expected damage to the roots are reasons to suggest this tree be removed. It is likely to struggle or become hazardous after the work is completed. Being that this tree is city-owned, it will require written permission from the manager of urban forestry. Any compensation for the removal of this tree is at the discretion of the department of urban forestry.

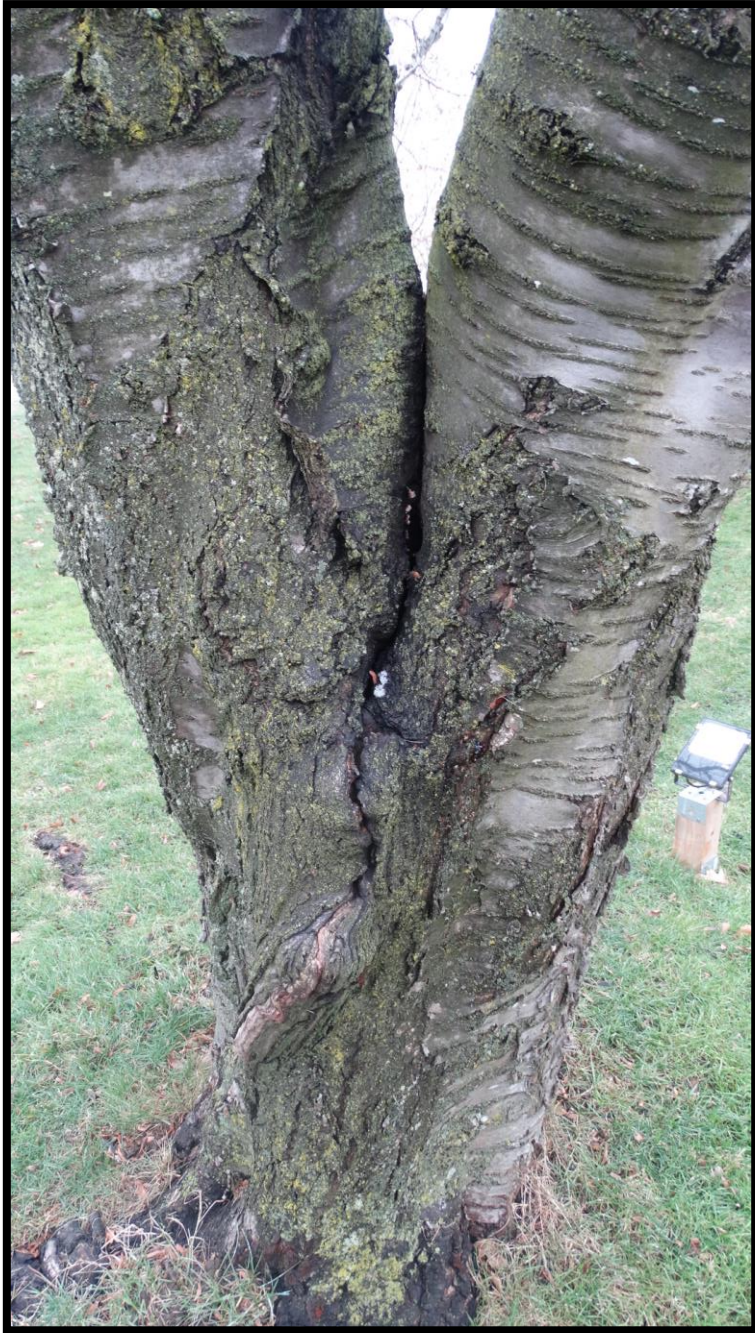
The main union of the two stems forms a narrow-angle, causing the development of included bark. At this main union there is dead tissue present, as well as a seam that extends to the base of the tree. This would suggest that the two stems have not formed a strong union, and is a potential failure point. There is likely decay present between the two stems.

Image 2: Compromised union of tree 1

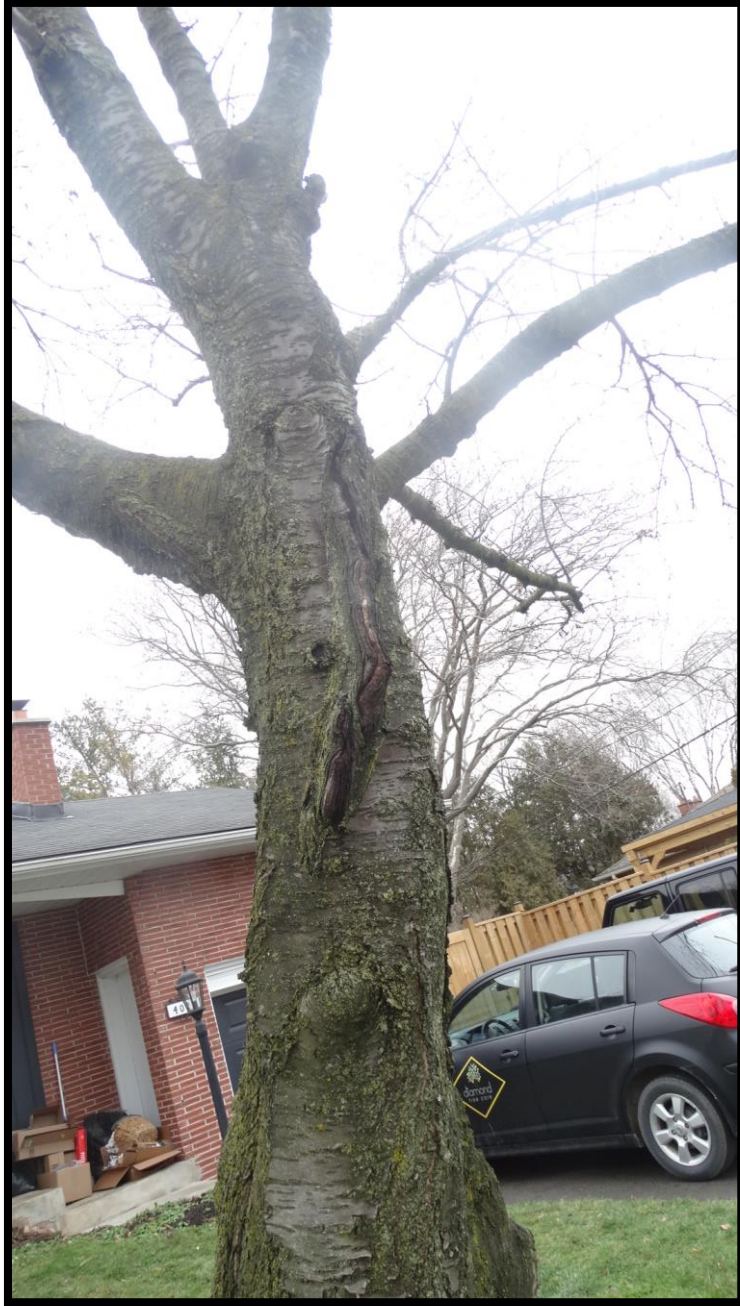
According to the homeowner, the canopy was pruned approximately six months ago. It appears that the canopy was reduced to appropriately sized laterals in the style of reduction pruning. Several stubs remain in the canopy. Further pruning will be required to accommodate the proposed development and equipment access. The stem furthest from the house has a seam facing the road, suggesting internal decay.

Image 3: Seam on the stem closest to the road of tree 1

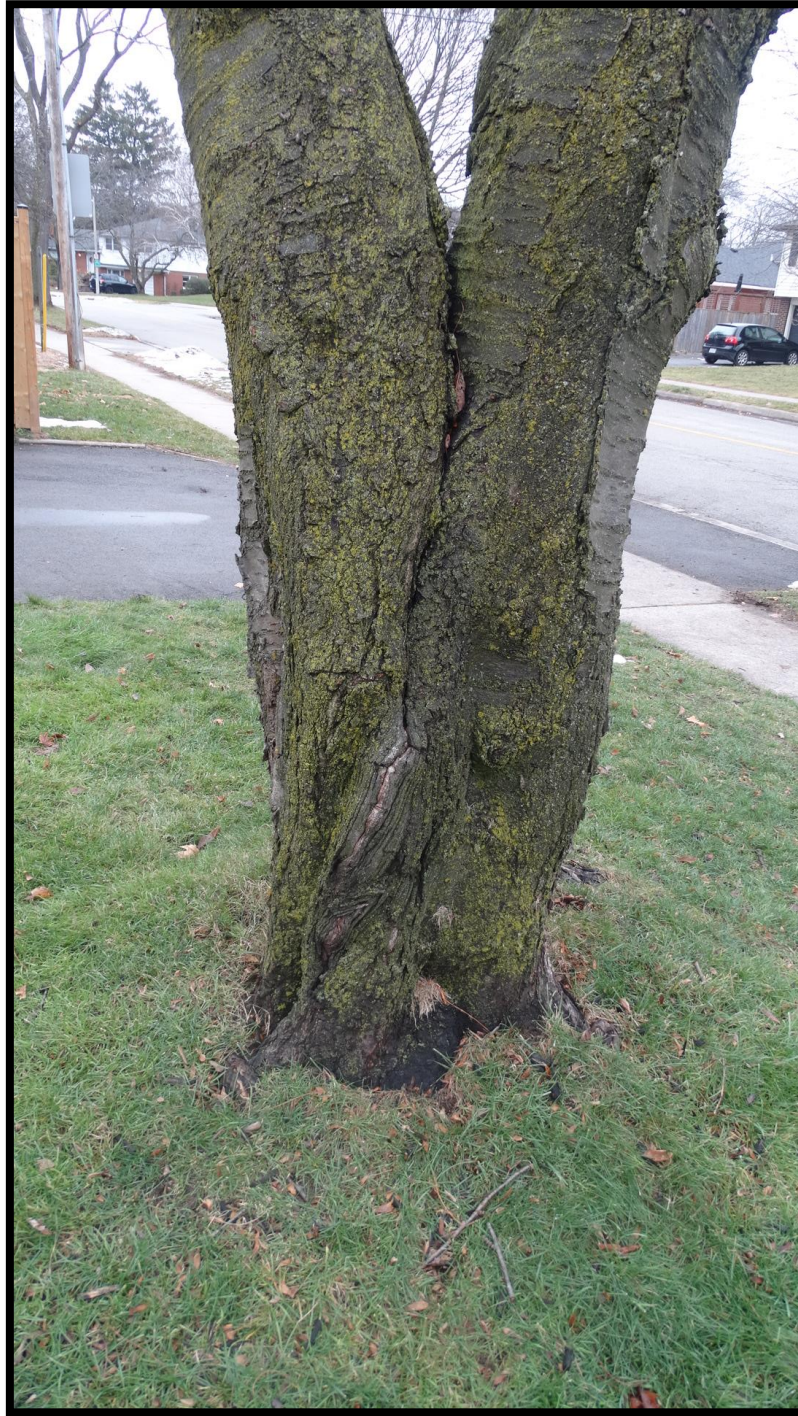
Image 4: View of the compromised union of tree 1 from the other side of the tree

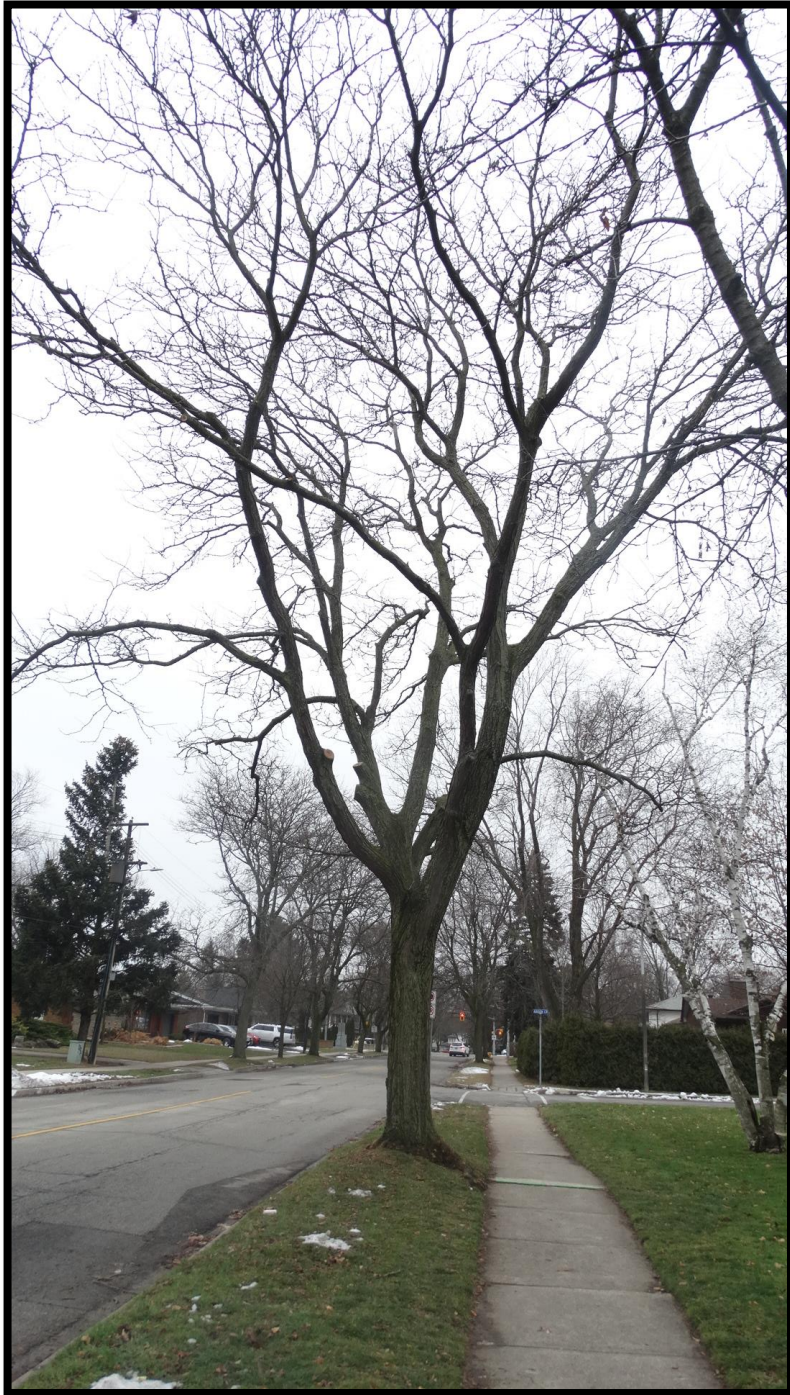
Tree 2 is a city-owned honey locust located on the boulevard along Spruce avenue. The roots from this tree are raising the sidewalk. Some of the roots are exposed on the roadside of the tree, as the tree sits higher than the grade. This tree appears to be in good health with no visible diseases or decay.

This tree was recently pruned, and the centre appears “cleaned out” with little internal canopy. There are multiple stems originating at approximately 3m above ground. All of the unions appear u-shaped which indicates a stronger point of attachment than v-shaped unions.

Image 5: Tree 2 in situ. The limited space for tree protection hoarding can be seen.

To protect this tree during construction, tree hoarding will be limited to the distance of the sidewalk. The hoarding can be placed to the full extent of the TPZ along the open space in the boulevard. The driveway expansion will be outside of the critical root zone. If it is expanded

further, the distance from the tree will need to be measured and re-assessed.

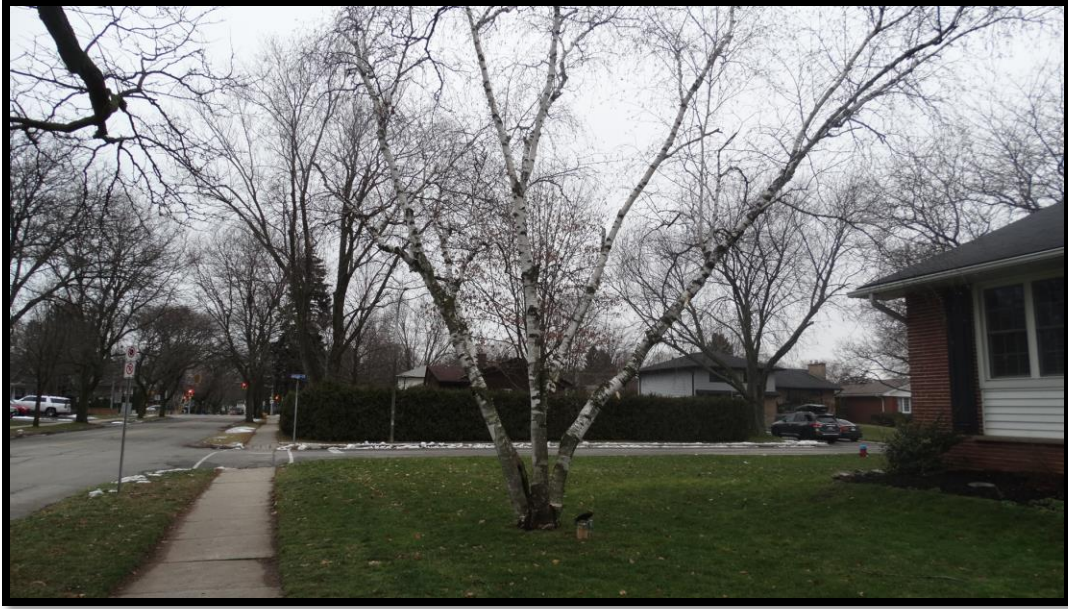
Tree 3 is a multi-stem white birch in the front yard of the house. It is located on city property. There are currently 4 stems originating from the base that all form narrow-angled unions. These are potential failure points as included bark forms, or as the trunks continue to compete for space. One stem has been removed in the past, creating a potential entry point for decay.

Image 6: Tree 3 in situ. The stem to the right will need to be pruned or removed to accommodate the proposed construction.

This tree is in fair health overall and can be retained during construction. The tree hoarding will form a square around the tree. There is to be no excavation as part of this project that would impact the critical root zone.

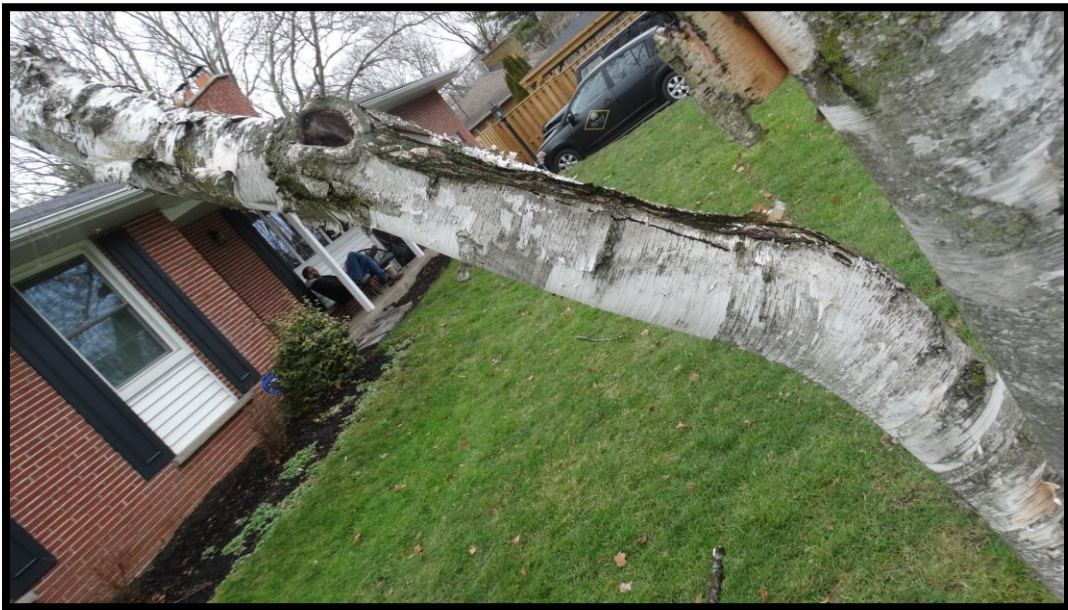
There is decay present in the stem growing closest to the house. The site of the decay is at an old pruning wound. On the top side of the stem there is a seam, suggesting further spread of internal decay. This stem will need to be pruned to accommodate the proposed construction. It will require written permission to be pruned by the manager of urban forestry, or be pruned by city staff.

Image 7: Old pruning wound and seam on the topside of the limb to be pruned, on tree 3.

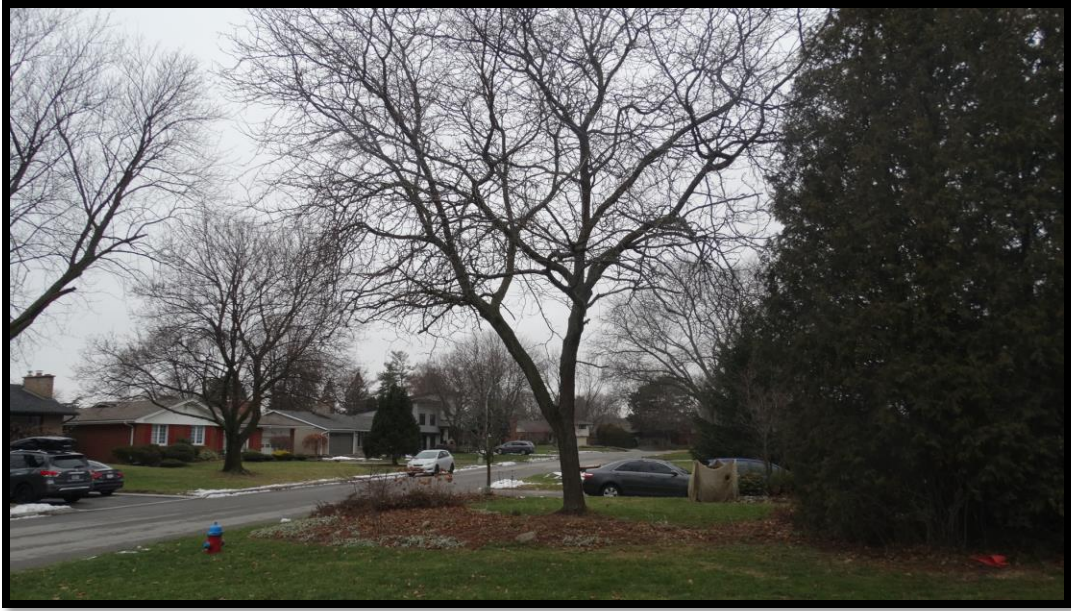
Tree 4 is a honey locust located on the neighbouring property of 321 Arden crescent. This tree is in good overall condition with deadwood typical of the species. It has been pruned in the past for property clearance, and appears to have been “cleaned out” with minimal remaining interior canopy.

Image 8: Tree 4 in situ

The TPZ of this tree would be on the property at 321 Arden crescent, so it will be protected by restricting activity to the property boundaries of 4029 Spruce avenue. The critical root zone does extend over the property boundary, but there is to be no excavation in the area that could impact the root system of this tree.

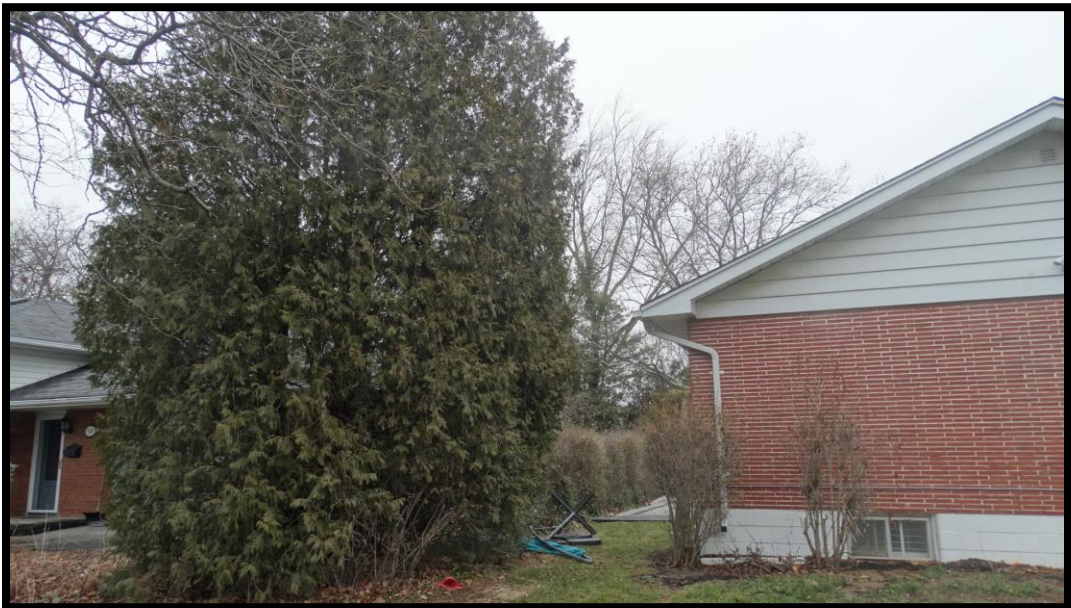
Trees 5-8 are cedars located on the neighbouring property of 321 Arden crescent. They are growing in a tight grouping. The canopy extends onto the property of 4029 Spruce avenue. These trees are in good overall condition. Any pruning required for access should be done by a certified arborist. The pruning should be done in a manner to preserve the health and aesthetics of the trees while allowing access.

Image 9: Trees 5-8 in situ.

To protect these trees, hoarding should be installed just outside the canopy, to allow movement around that side of the house as necessary. For any amount of the TPZ that is still lacking in hoarding, horizontal tree protection measures should be installed. There is no excavation to happen in this area of the property that will impact the critical root zone of the trees.

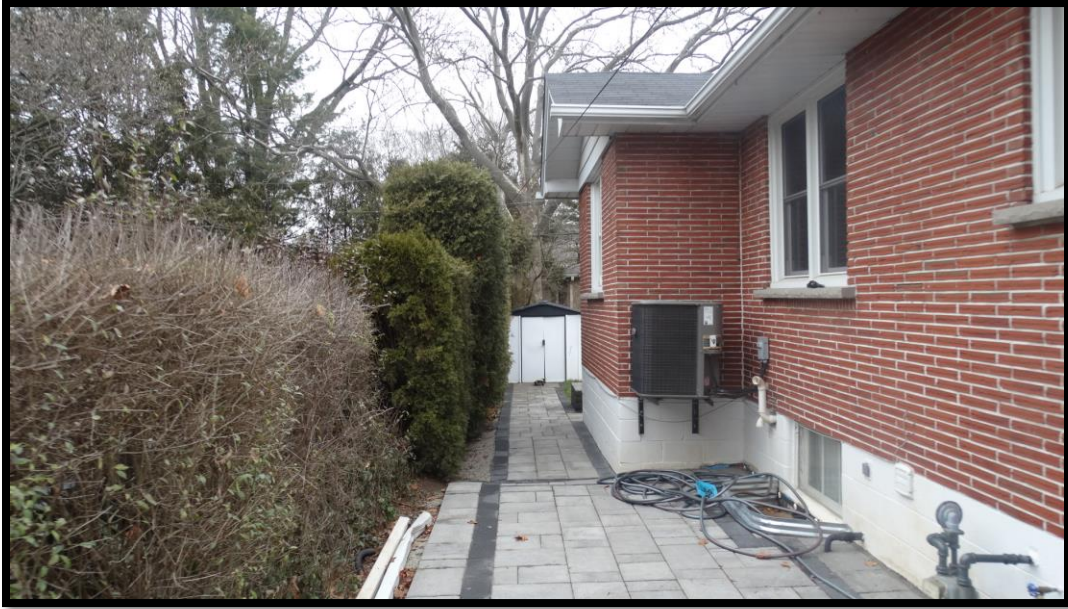
Tree 9 is a cedar hedge located at the rear of the property. The stem diameter varies from 5-20cm. The overall condition of the hedge is good. There is an existing layer of hardscape in the form of interlock stone directly adjacent to the hedge. There is no need to set up hoarding as long as the existing hardscape remains in place during construction. The canopy is directly against the hardscape, and hoarding would be limited to this edge anyways. It is possible that installing hoarding in such close proximity to the trees could result in more damage than no hoarding being installed. The only excavation to occur in the area is potentially post holes for the new porch. The digging of these post holes is likely to have little or no impact on the critical root zone of this hedge.

Image 10: Tree 9 (hedge on the left) in situ. The existing hardscape can be seen. This hardscape will need to be kept in place to act as a barrier for the hedge.

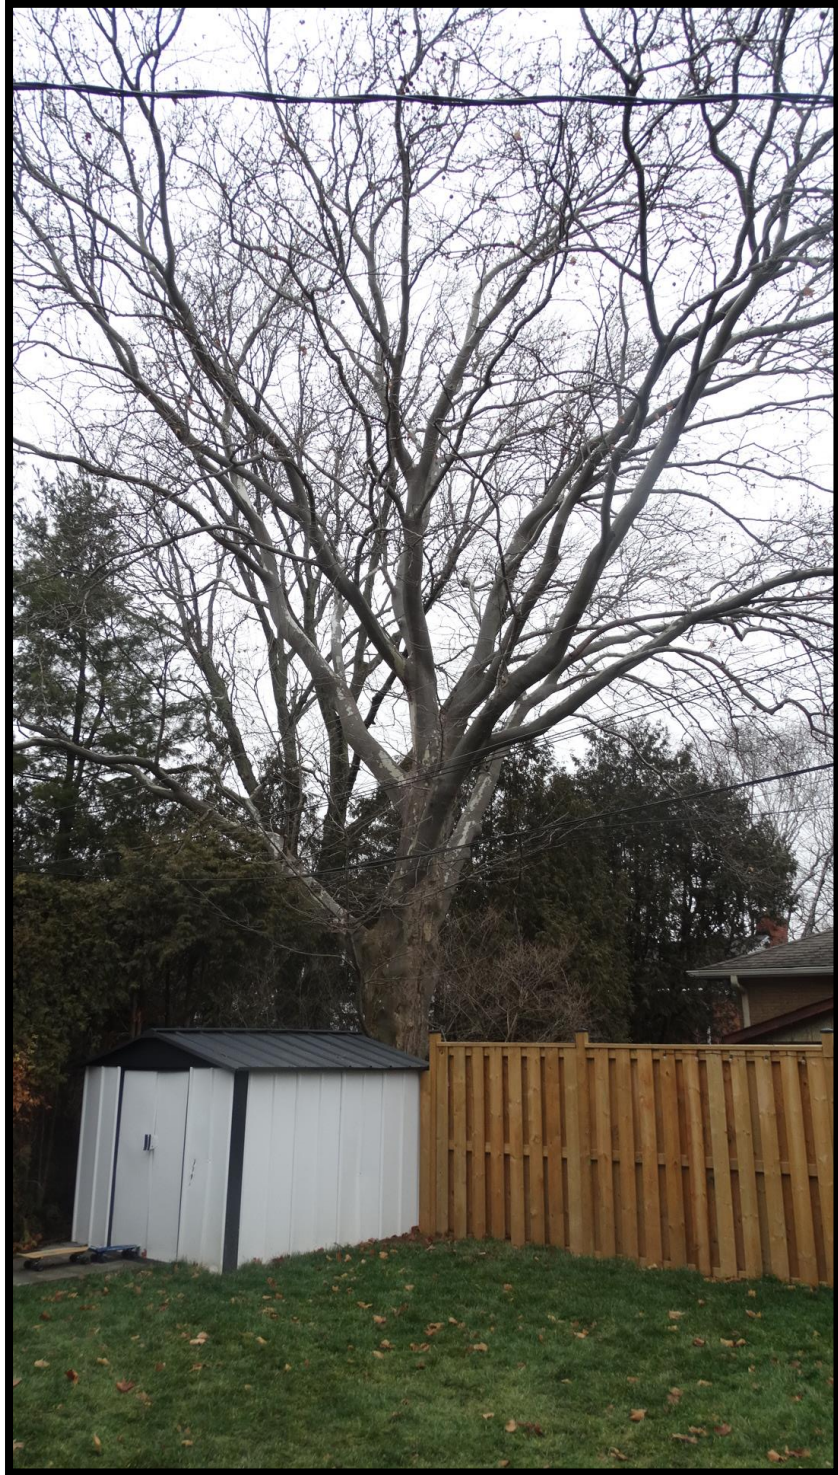
Tree 10 is a London plane tree located in the backyard of the neighbouring property of 4043 Spruce avenue. This tree is approximately 1m from the existing shed on 4039 Spruce avenue. It has been pruned in the past for clearance of the utility lines located in the backyard. Overall it appears to be in good condition.

Image 11: Tree 10 in situ. The existing shed will act as hoarding in addition to a section of hoarding to be installed. The shed will need to remain in place to act as hoarding.

This tree will require hoarding in the backyard of 4039 that can be attached to the fence and will finish at the existing shed. The existing shed will act as a physical barrier for a portion of the TPZ. This shed will need to remain in place for the duration of the project to act as the barrier. If it is to be removed, it will need to be done so by hand, without the use of machinery. A section of hoarding will need to be installed to replace the shed if it is removed. There is no excavation to happen in this area of the property that will impact the critical root zone of the trees. The digging of post holes will be done outside of the critical root zone of this tree.
