HERITAGE IMPACT ASSESSMENT

6507 JANE STREET
KILBRIDE, ON
CITY OF BURLINGTON

20 DEC 2020

Condition Assessment and Recommendations for
6507 Jane Street, Burlington

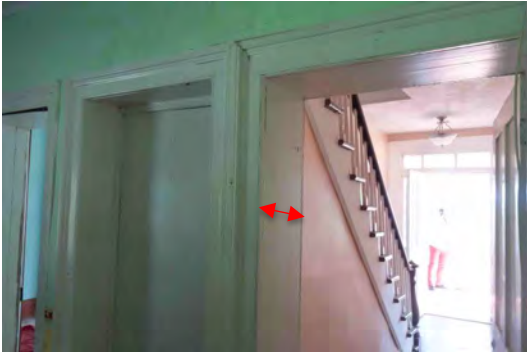
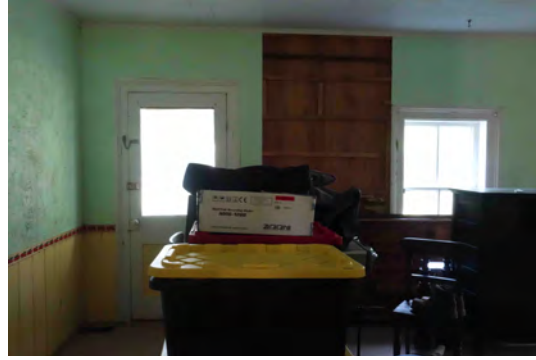
REAR ADDITION – The thick wall between the front of the house and the rear addition indicates that two separate structures were joined together (left). The exterior wall of the rear addition was opened up to confirm that it is frame construction dating from the 1840s to 1860s with lots of later alterations.

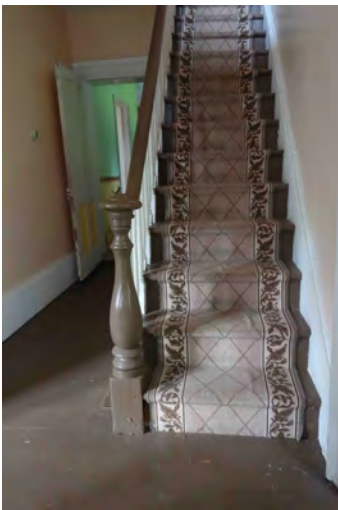
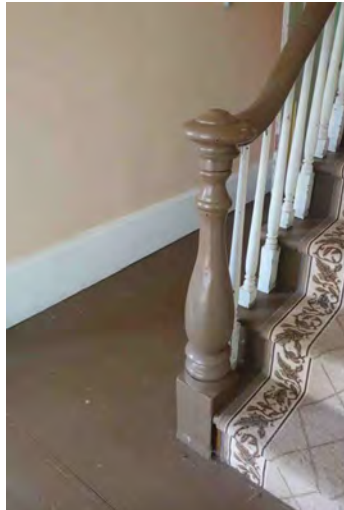
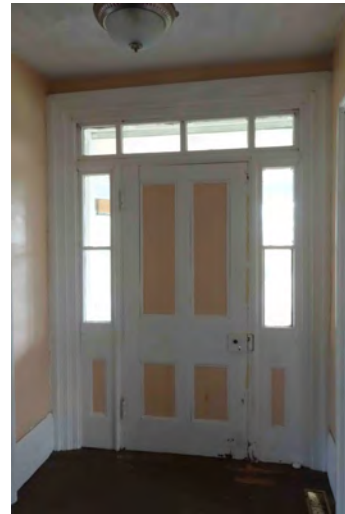
The front portion of the house has a centre-hall plan with two identical rooms on either side of the hall. The hall features a wooden staircase with a turned newel post and curved handrail. The staircase has twisted and the floors are sloped in this location, indicating structural issues with the floor framing beneath this area.

MAIN HALL – the stairs lean because of structural issues with the floor framing – the turned newel post and curved handrailing and the front door with sidelights and transom date from the mid-19th century

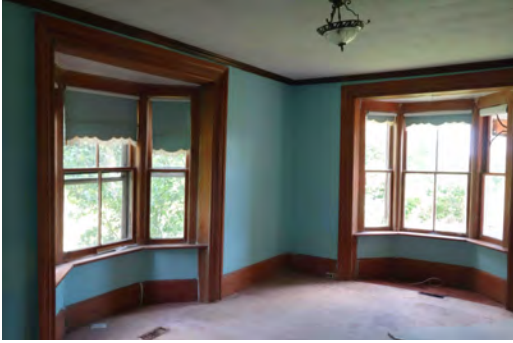
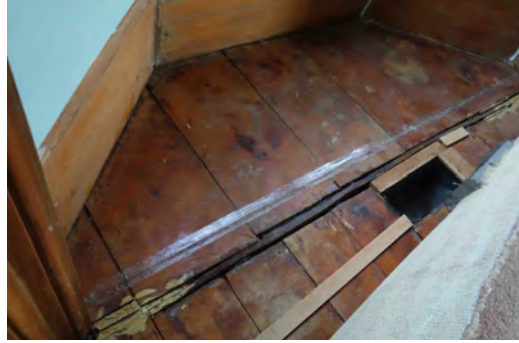
FRONT PARLOUR - there is a substantial gap in the flooring at the bay windows that is evidence of alteration and poor workmanship (right)

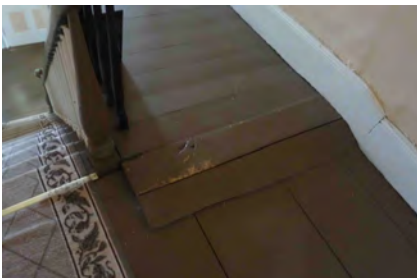
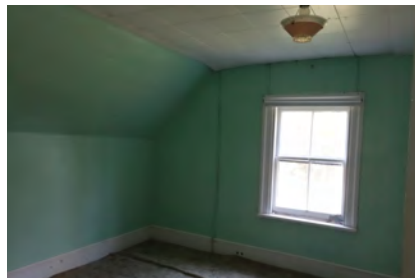
TRANSITION – there is a level change at the top of the stair landing that evidence of alteration and poor workmanship (left) – modern ceiling tiles in the bedroom is evidence of condition issues (right)

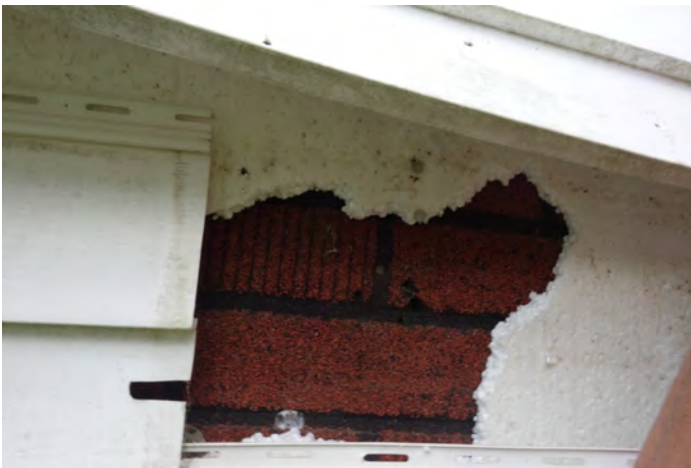
VINYL SIDING ON INSUL BRICK

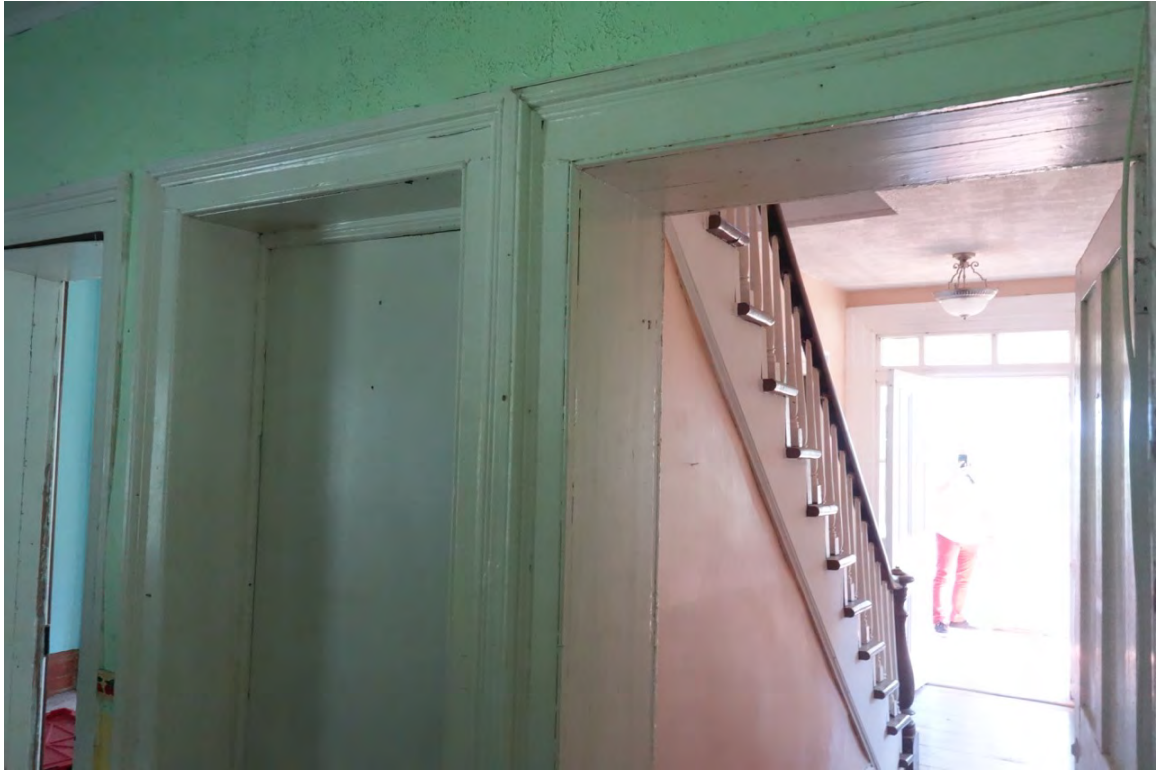
TRANSITION BETWEEN FRONT & BACK – very thick wall

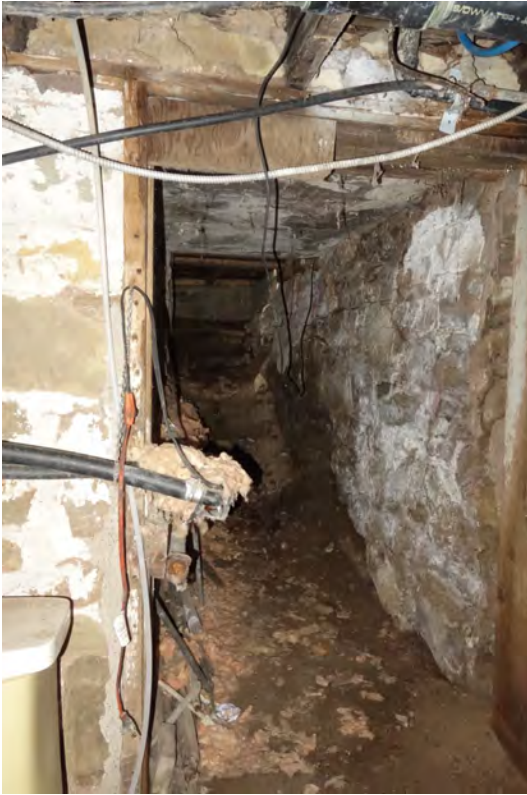
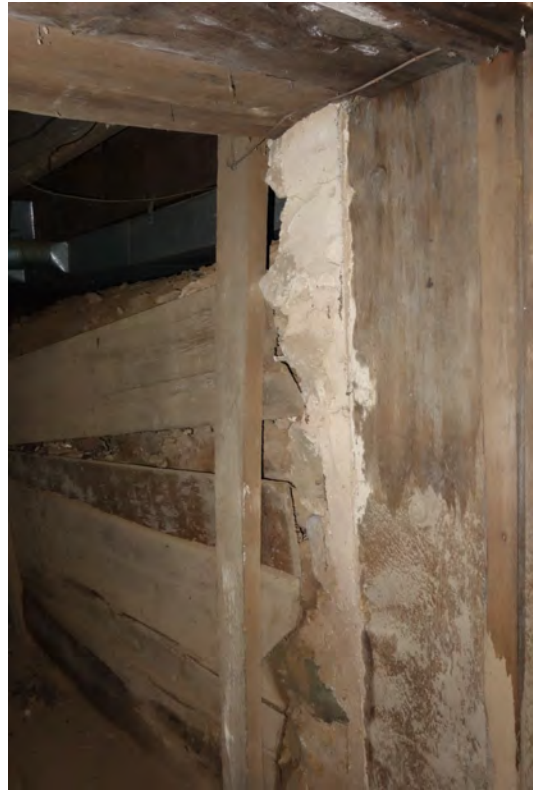
CRAWL SPACE & HALLWAY BELOW THE FRONT PART – very thick wall between front & back

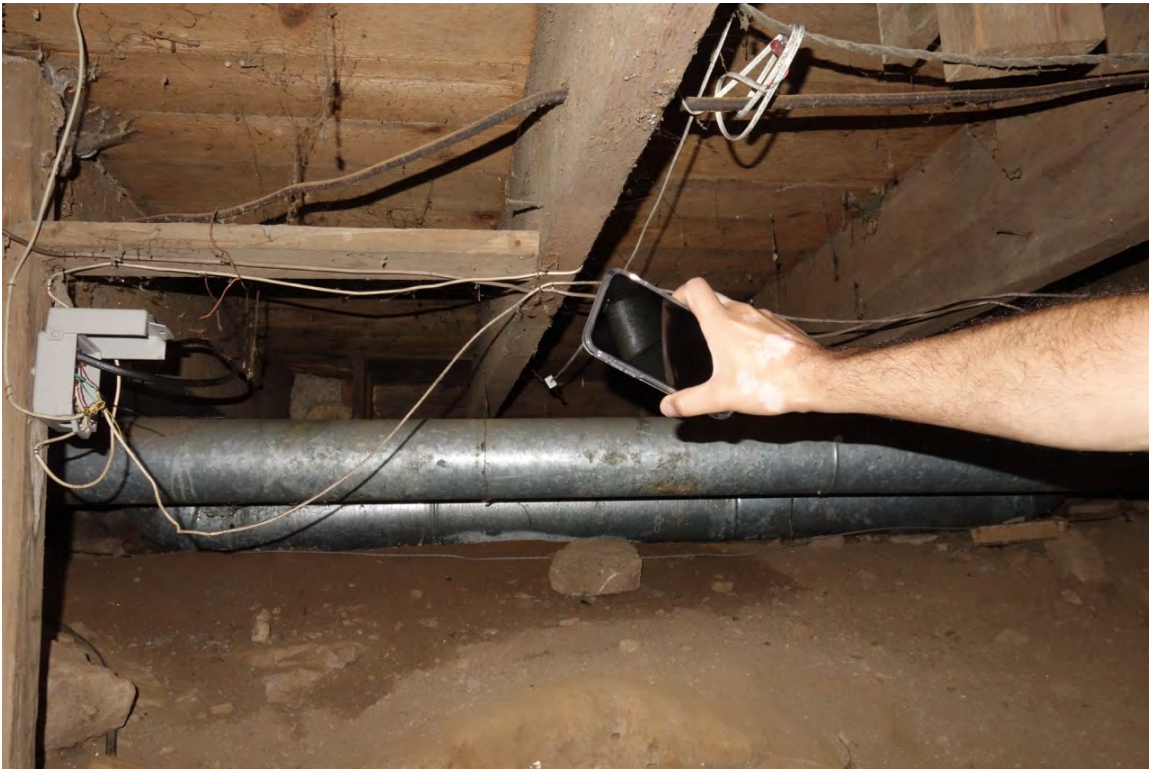
CRAWL SPACE & FLOOR FRAMING BELOW THE FRONT PART – narrow boards

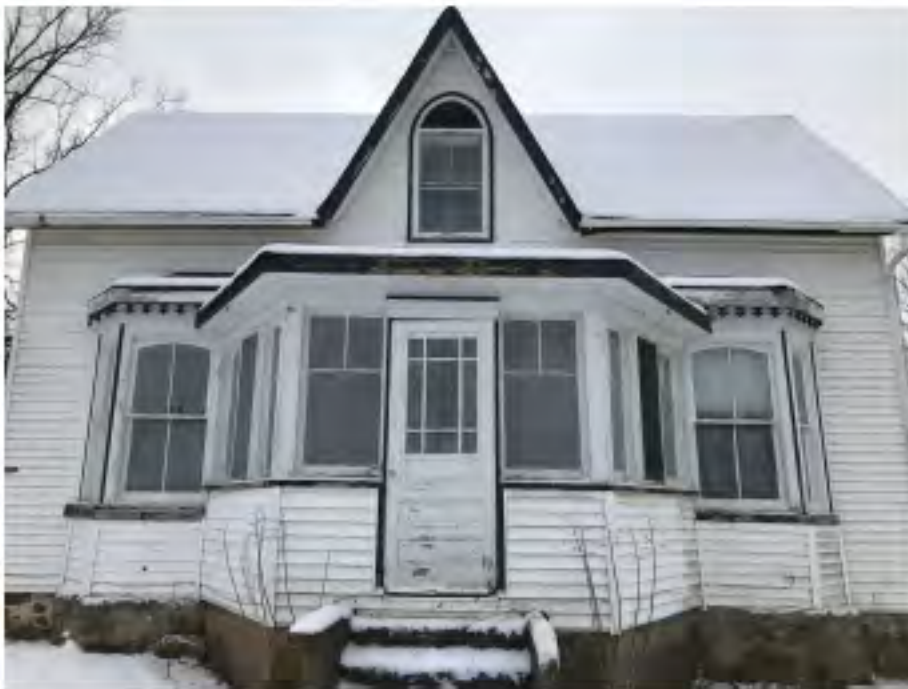
Centre gable	YES
Decorative woodwork	<u>NO</u>
Round arched window	YES
Wood shutters	<u>NO</u>
Wood cladding	<u>NO*</u>
Decorative woodwork	<u>NO</u>
Bay windows	YES**
Segmental windows	YES
Verandah	<u>NO</u>
Symmetrical façade	YES
Centre door	<u>NO</u>
Main elevation intact	<u>NO***</u>
Original Location	<u>NO</u>

6507 JANE STREET, Kilbride – heavily altered example – LOW INTEGRITY

*original boards under 2 layers of modern siding are in very poor condition – this alteration is 'irreversible'

**structural issues noted – the bay windows were added in the 1870s and are separating because of failure of the foundation – see *Structural Report* by Mark Shoalts

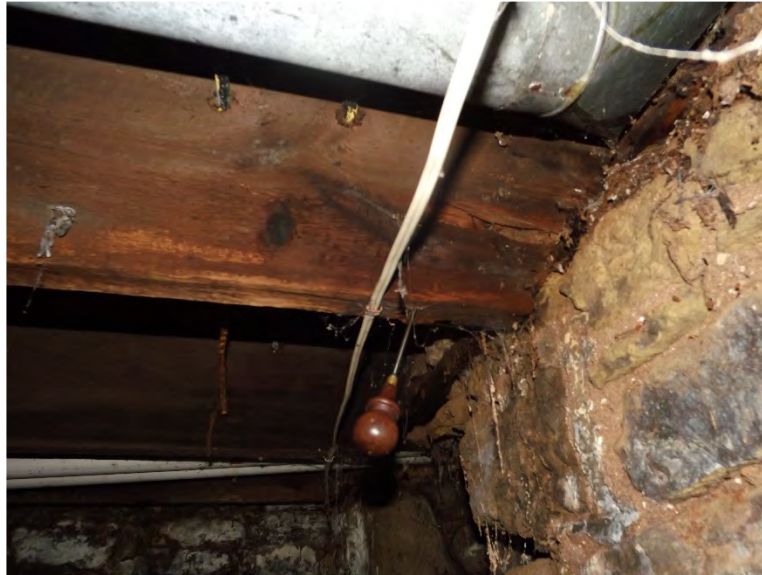
The stone basement of the house is in as good condition as any of the foundation, which is not to say it is good. The space is barely sufficient for utilities and cannot be used for storage because it is very damp. The dampness has been bad enough and prolonged enough to rot floor joists, plates, and floorboards.

Damp wall, rotten plate, and awl inserted 2" into joist

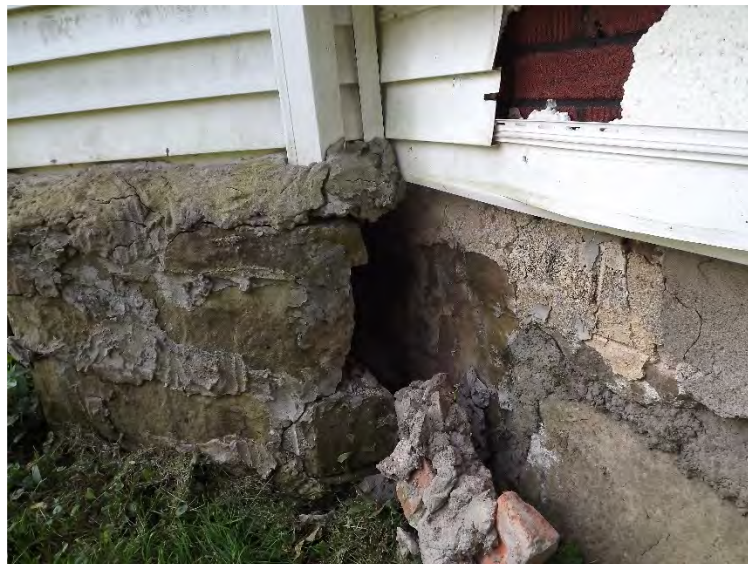
The front portion of the house has a crawlspace with an exposed earth floor, which was too low to permit access to much of the wood structure but it can be expected to be in similar condition to the accessible parts of the structure. The various additions of bay windows and porches have poor foundations improperly added to the existing foundation, with poor repairs that are themselves failing. If the building were better structurally, the best that could be said about the foundation would be that it needs replacing but unfortunately the additions have been poorly done and would be difficult to lift and retain in order to build a new foundation.

Bay window foundation and later repairs have failed

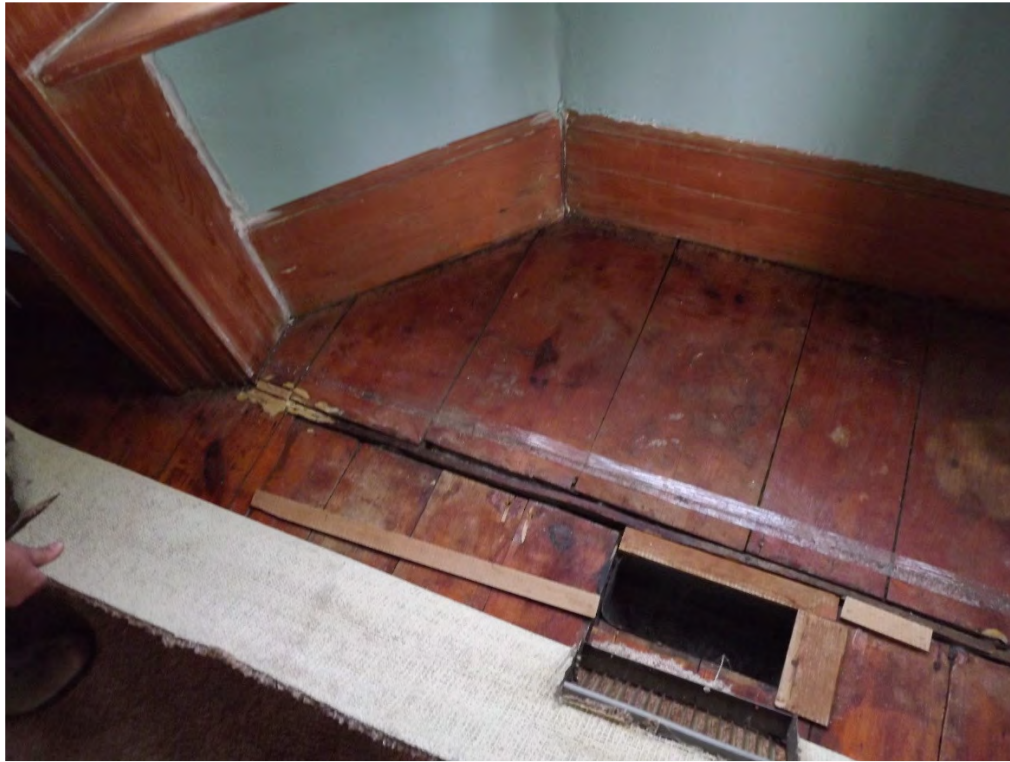
Bay window floor showing poor connection

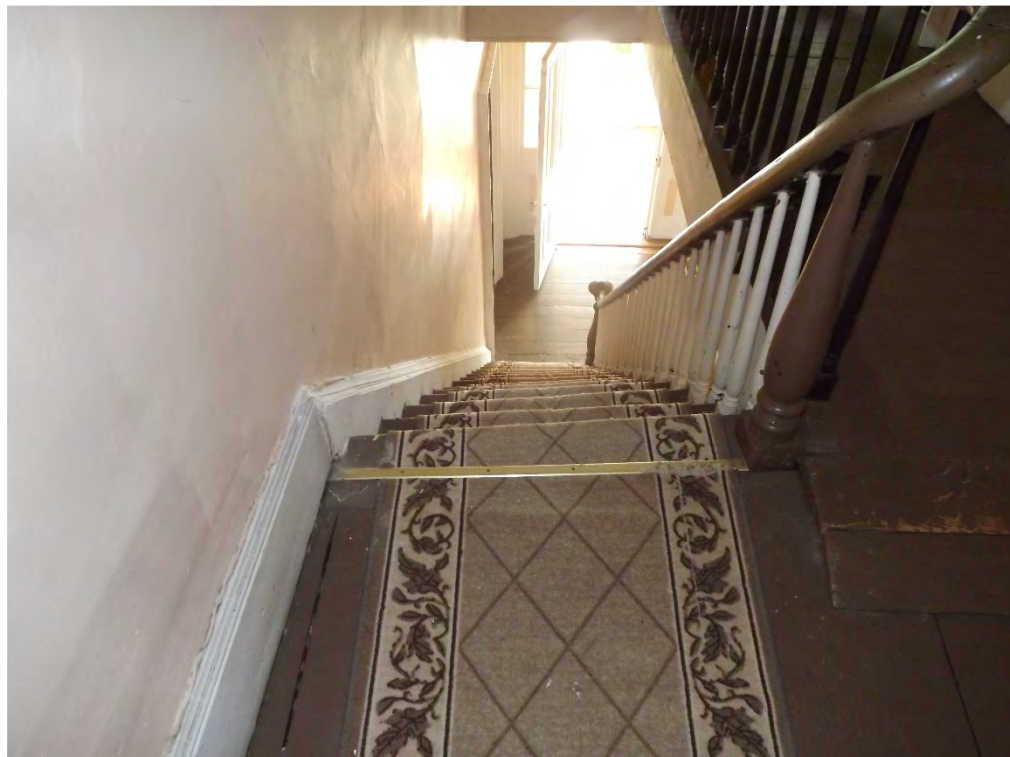
As indicated earlier, the floor and stairs in the centre hall have been distorted to meet an incompatible floor height in the rear wing. This is difficult to remedy without separating the two sections and building an intermediate connecting level.

Twisted stairs and tapered ramp on landing

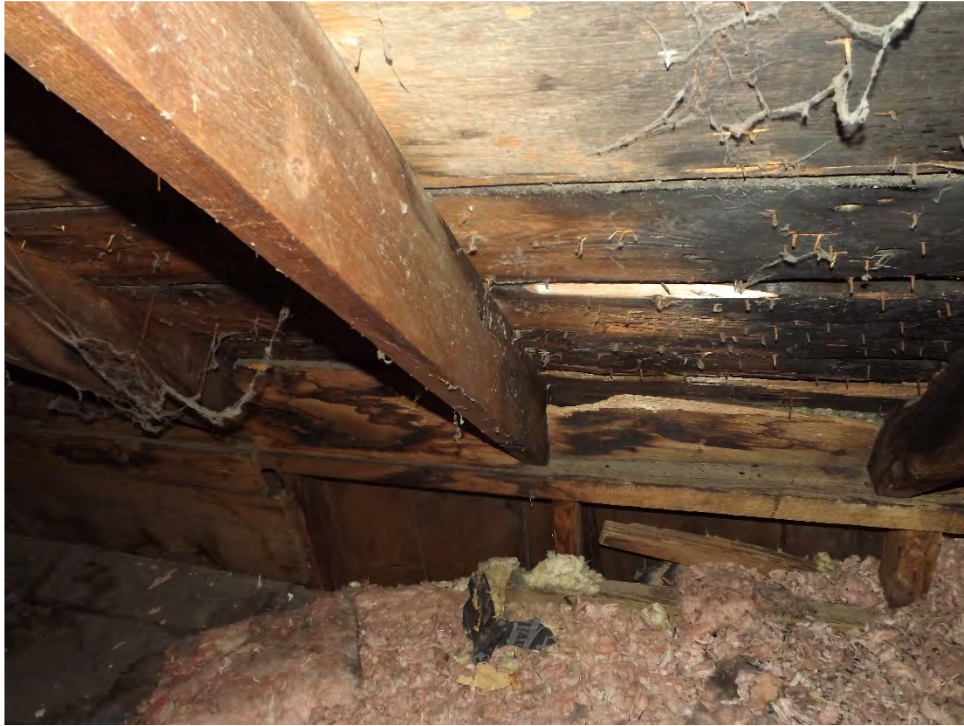
Balloon framing and circular sawn lumber; note the charring from a fire
