ARBORIST REPORT

with Tree Survey Plan and
Tree Preservation/Removal Plan

2069 Lakeshore Road
Burlington, Ontario

Revised: April 12, 2022

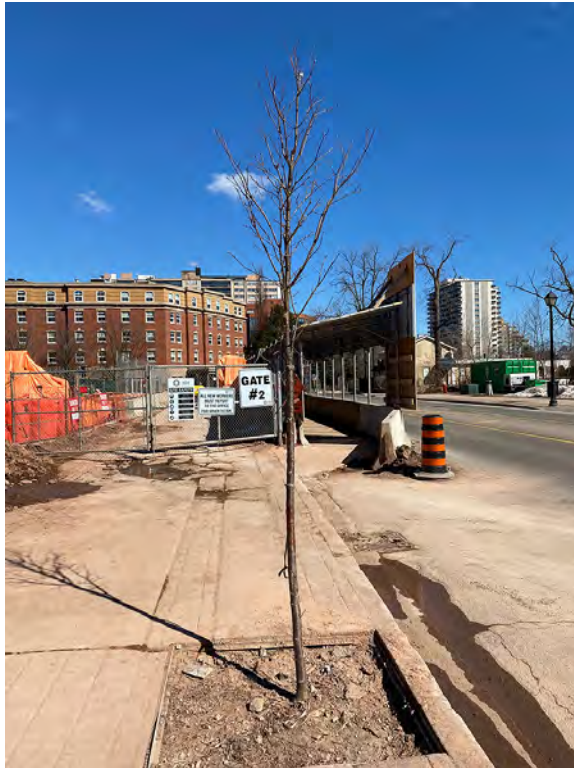
Tree T1A Tree has been removed by others

Description: Trees T1A and T2 are recently planted street trees presumably installed by the City. As shown in the photos these trees are unprotected and adjacent to a construction site. Their condition and soil materials appear less than ideal.

Reason for Removal: Due to the health condition and planting soil we are recommending these trees be removed. In addition they are located in conflict with the new Downtown Streetscape Guidelines.

These trees will be replaced as part of the proposed streetscape landscape plan by the 2069 Lakeshore development where they will be in compliance with the Downtown Streetscape Guidelines.

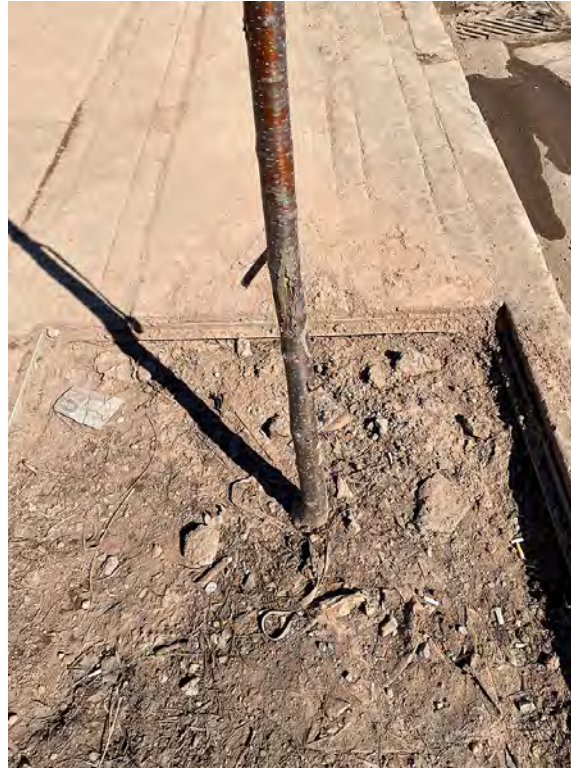
Tree T1A - Trunk Damage and Soil

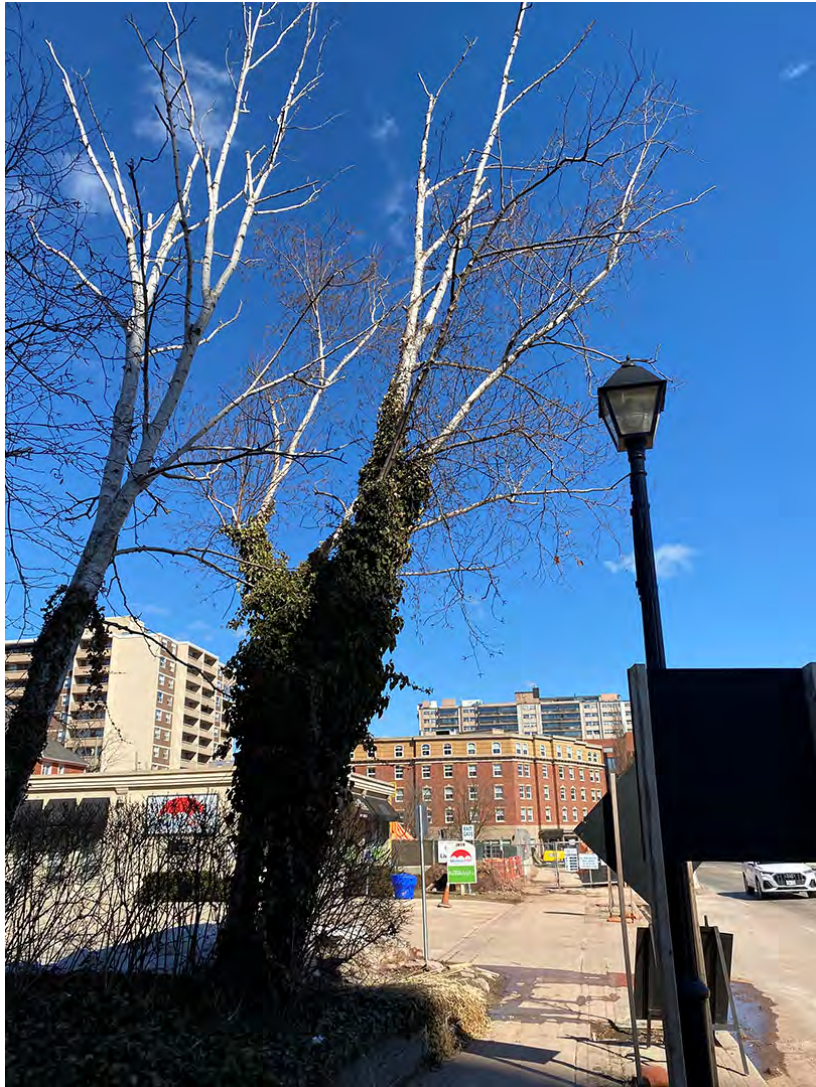
Tree T3 Tree was removed by Property Owner fall 2021

Description: This birch tree is located on private property elevated behind a retaining and in extremely poor condition.

Reason for Removal: The existing health and structural condition dictates its removal due to potential danger to the public on the immediately adjacent municipal sidewalk.

In addition it would be in conflict with the proposed development and Downtown Streetscape Guidelines

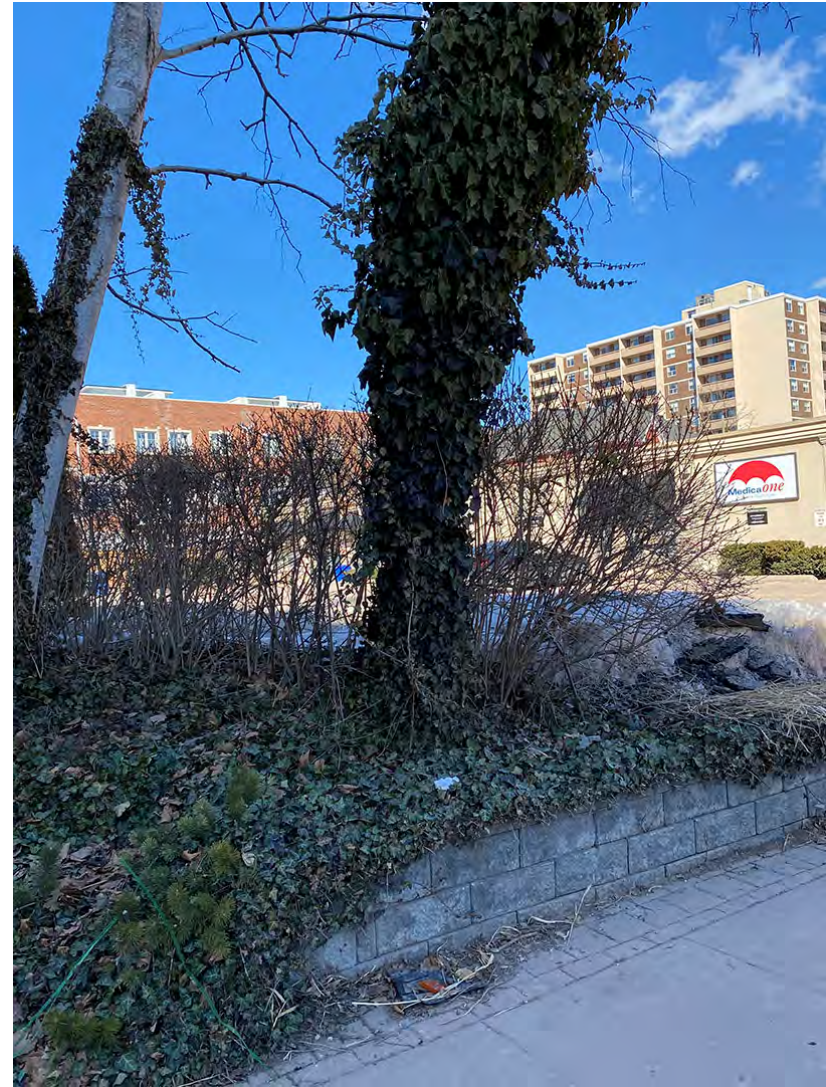
Tree T3 - Base Tree was removed by Property Owner fall 2021

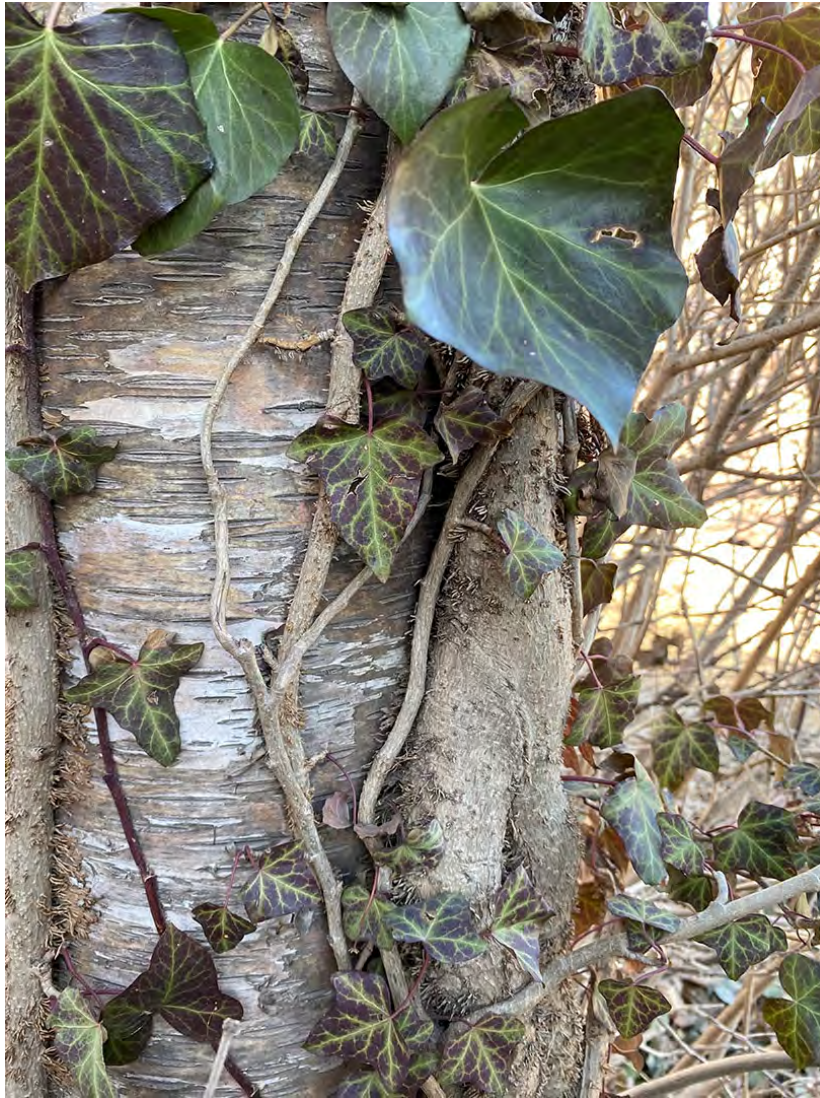
Tree T3 - Trunk with Vines

Tree was removed by Property Owner fall 2021

Further visual evidence supporting the removal of Tree T3

This tree will be replaced as part of the proposed streetscape landscape plan by the 2069 Lakeshore development

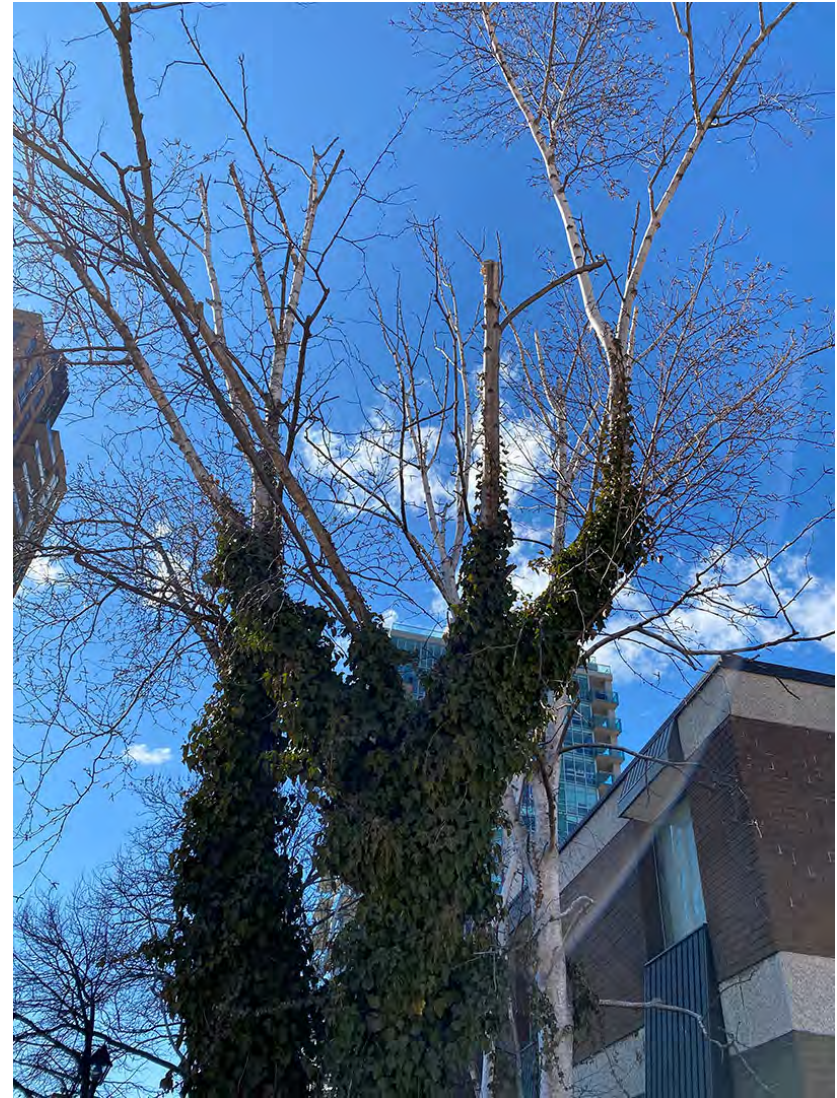
Tree T3 - Canopy

Tree was removed by Property Owner fall 2021

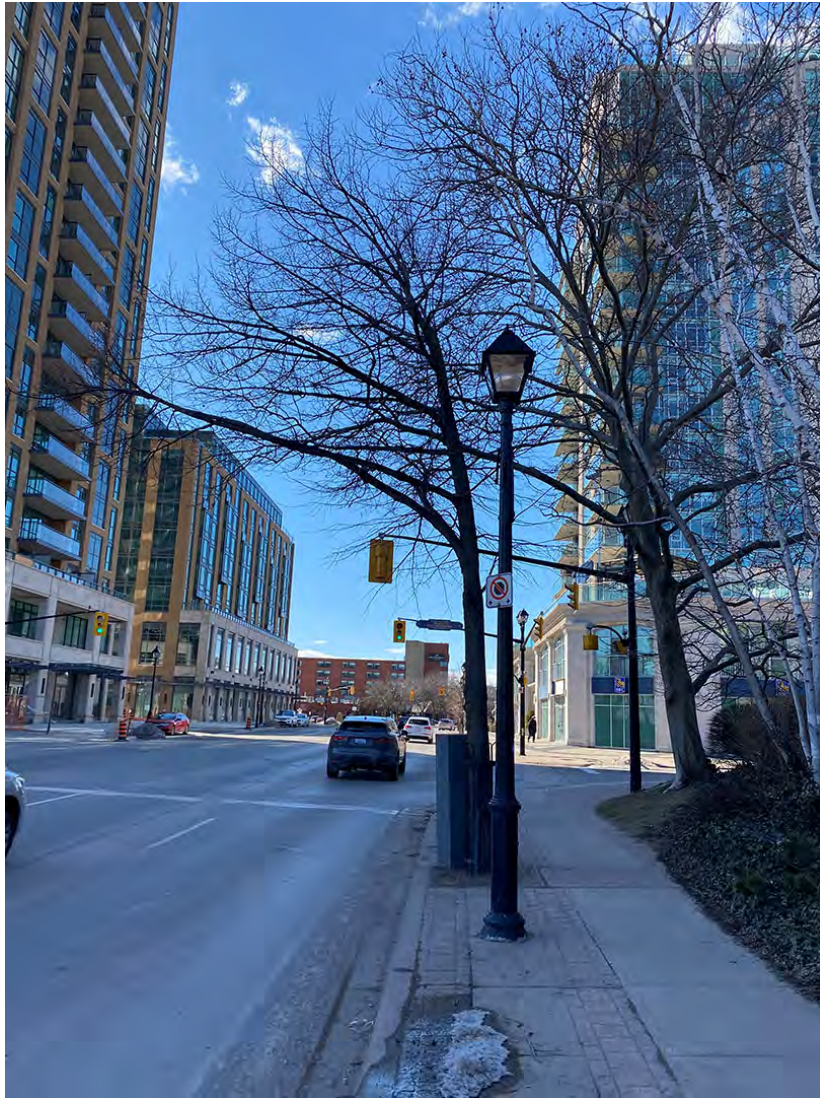
Tree No.	Tree Species	DBH (cm) *	MTPZ (m) **	Crown Diameter (m)	Trunk Integrity	Crown Vigour & Structure	Plant Condition *** Health & Structure Elements	Observations & Comments
4	Little leaf linden <i>Tilia cordata</i>	25.5	2.4	7	Poor to Fair	Poor	Poor	- Within City Right of Way (Lakeshore Road) - Street tree with tree grate and guard; poor crown form - Asymmetrical crown form completely over road. - tree in tree grate with appearance of heavily soil Recommend removal and replacement with proposed streetscape works for 2069 Lakeshore
5	White birch <i>Betula papyrifera</i> Tree has been removed by owner fall 2021	12, 22, 15	2.4	6	Poor to Fair	Poor	Poor	- On Private Property on Subject Site - Trunks diverge with north trunk dead; - dieback present in other stems; <20% crown mortality; - imbalanced crown form. Recommend removal because of condition
6	London plane tree <i>Platanus x acerifolia</i>	58	3.6	14	Fair	Fair	Fair	- On Private Property on Subject Site - base of trunk +/- 1m above adjacent sidewalk grade - Large spreading tree located at street corner; - trunk with no major defects; defined root flare; - crown with minimal mortality; lower crown pruned - lower branches to the west in conflict with sidewalk. Removal required to accommodate development

Description: Little Leaf Linden tree located in the public right of way that F+A has deemed to be in Poor condition due to its planting location, soil condition and one sided canopy hanging over the Lakeshore Road. In addition, its location is in conflict with the new Downtown Streetscape Guidelines paving and planting details. Originally recommended for removal, City staff have disagreed on its condition and recommended its preservation so it will remain in place. **After further review of the detailed design, City staff have concluded that this tree cannot be retained, and identified that this tree be subject to removal.**

Tree 4 is to be ~~preserved~~ removed. After further review by the City of the detailed design, it was identified that this tree cannot be retained.

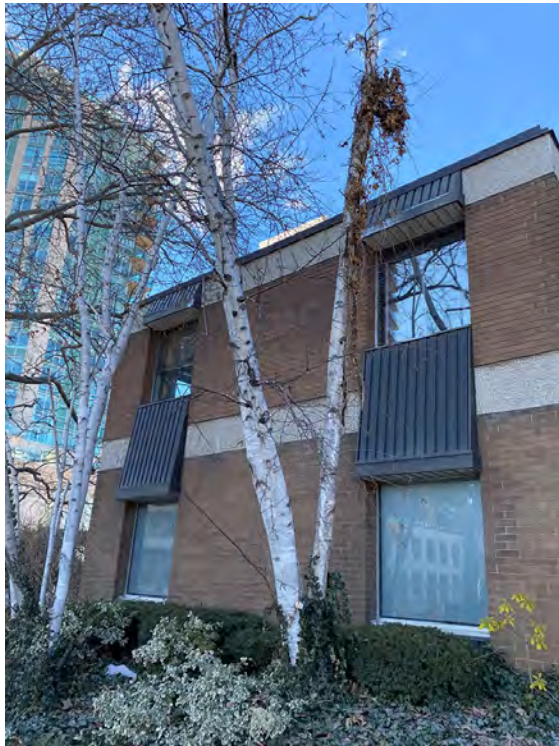
Tree 5 Tree was removed by Property Owner
fall 2021

Description: Tree 5 is a Birch located on private property and in overall poor condition.

Reason for Removal: Primarily for its poor health condition and potential danger to the public on the municipal sidewalk, however it is also in conflict with the proposed development.

These trees will be replaced as part of the proposed streetscape landscape plan by the 2069 Lakeshore development

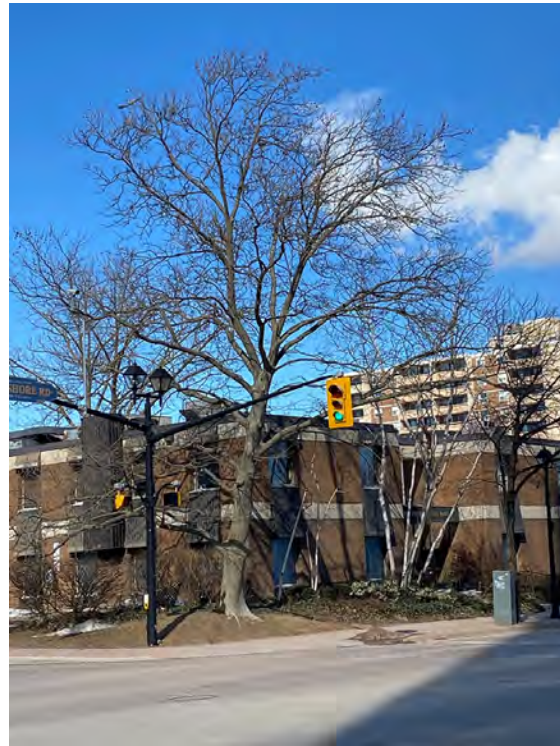
Description: Tree 6 is a London Plane tree located on private property and in overall fair condition.

Reason for Removal: The preservation of this tree would not be possible due to its elevated trunk base setting would be in conflict with the implementation with the new Downtown Streetscape Guidelines. In addition its location and canopy would be in conflict with the proposed development.

Tree T6 is recommended for removal to accommodate the Downtown Burlington Streetscape and the proposed development

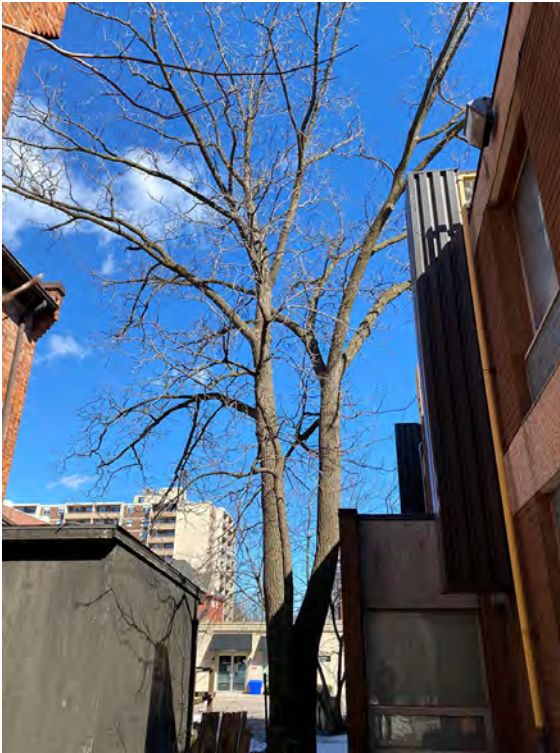
7	Black walnut <i>Juglans nigra</i>	49 & 47.5	3.0	14	Fair	Fair	Fair	- On Private Property on Subject Site - Large spreading two-stemmed tree; stems split at approx. 0.5m; girdling root present; minimal deadwood present; SE stem with trunk sweep form; thinning crown condition; some crown cleaning appears to have occur Removal required to accommodate development
8	Norway maple <i>Acer platanoides</i>	19	2.4	6	Very Poor	Poor	Very Poor	- Within City Right of Way (Pearl Street) - Small street tree with tree guard; poor trunk and crown vigour; deadwood present; poor crown form. Recommend removal and replacement with proposed streetscape works for 2069 Lakeshore
9	Norway maple <i>Acer platanoides</i>	18.5	2.4	5	Very Poor	Poor	Very Poor	- Within City Right of Way (Pearl Street) - Street tree with tree guard; trunk with lean; - tree located in small square shaped soil opening; - deadwood in crown; low crown vigour. Recommend removal and replacement with proposed streetscape works for 2069 Lakeshore

Description: Tree 7 is a Black Walnut located on private property and in overall fair condition.

Reason for Removal: This tree is located in the middle of the proposed development site making its preservation not possible

Tree T7 is required to be removed to accommodate the proposed development

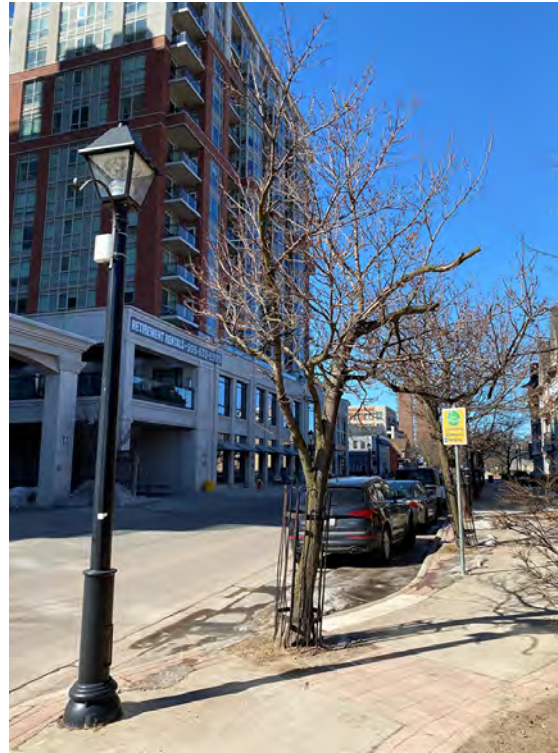
Description: Tree 8 is a Norway Maple located in the public right of way and in overall very poor condition.

Reason for Removal: The preservation of this tree is not recommended due to its overall health condition and conflict with the implementation with the new Downtown Streetscape Guidelines. In addition, it is also in conflict with the proposed driveway of the development.

This tree will be replaced as part of the proposed streetscape landscape plan by the 2069 Lakeshore development

Tree T8 is required to be removed to accommodate the driveway of the proposed driveway

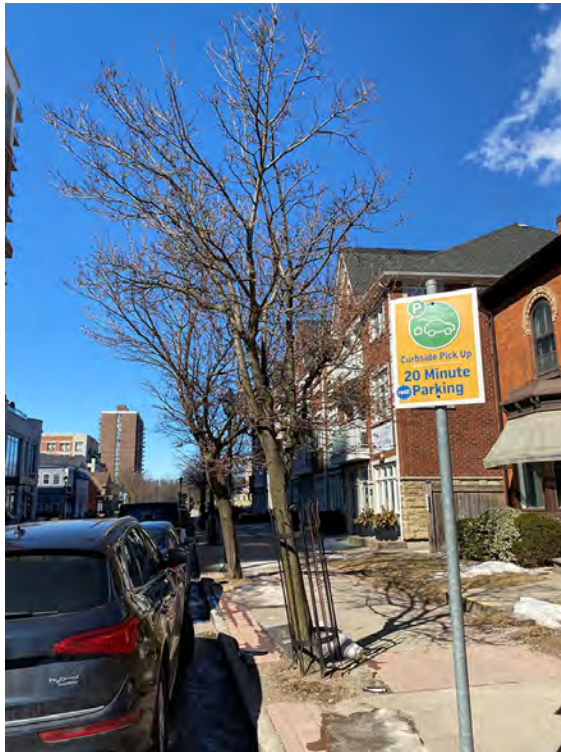
Description: Tree 9 is a Norway Maple located in the public right of way and in overall very poor condition.

Reason for Removal: The preservation of this tree is not recommended due to its overall health condition and conflict with the implementation with the new Downtown Streetscape Guidelines.

Trees T9 and T10 are recommended for removal due to health condition and to accommodate the Downtown Streetscape

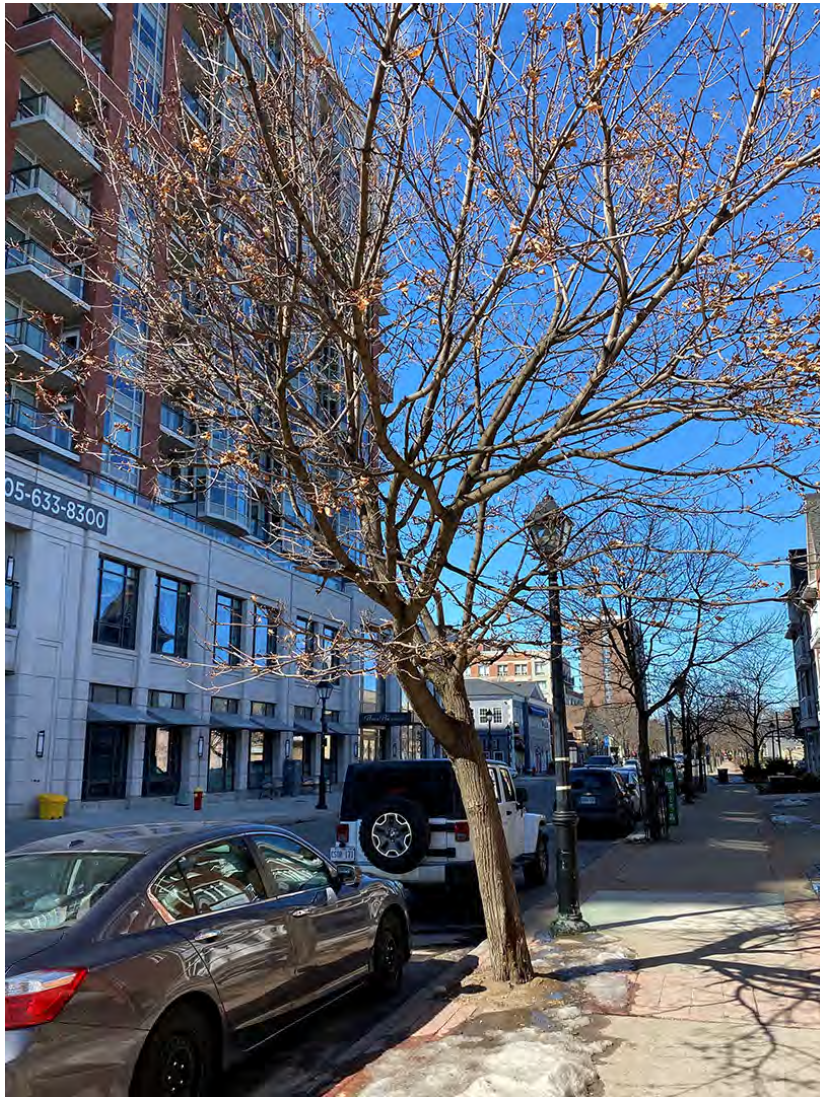
10	Norway maple <i>Acer platanoides</i>	28	2.4	7	Poor	Poor	Poor	- Within City Right of Way (Pearl Street) - Street tree with tree guard; trunk with vertical scar; - trunk lean; low crown vigour; - crown predominately on S & W sides – poor form. Recommend removal and replacement with proposed streetscape works for 2069 Lakeshore

Description: Tree 10 is a Norway Maple located in the public right of way and in overall poor condition.

Reason for Removal: The preservation of this tree is not recommended due to its overall health condition and conflict with the implementation with the new Downtown Streetscape Guidelines.

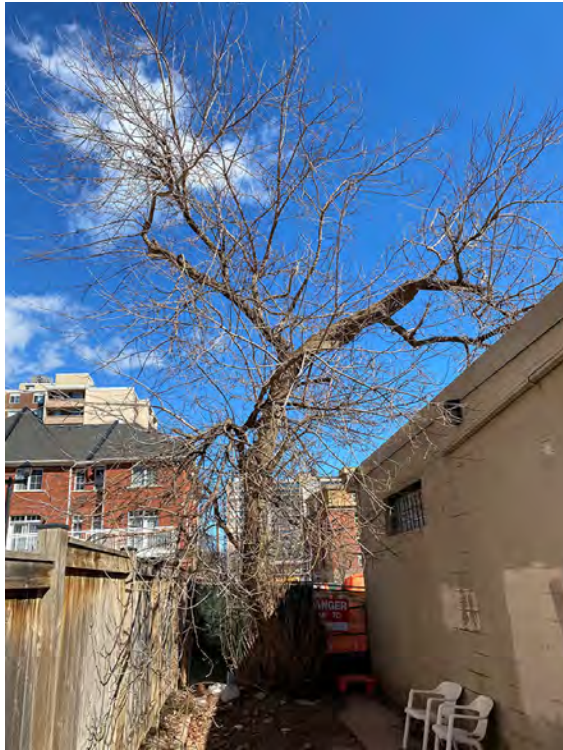
Tree No.	Tree Species	DBH (cm) *	MTPZ (m) **	Crown Diameter (m)	Trunk Integrity	Crown Vigour & Structure	Plant Condition *** Health & Structure Elements	Observations & Comments
11	Manitoba maple <i>Acer negundo</i>	51.5	3.6	16	Very Poor	Very poor	Very poor	<ul style="list-style-type: none"> - On Private Property on Subject Site - one major trunk stem recently removed - cavity in smaller trunk in old branch stub; - previously observed fungal growth at tree base; - large vertical white-faced scar & rot site at 5-6m - stem overhanging building; profuse epicormic branching. Recommend removal because of condition

Description: Tree 11 is a Manitoba Maple located on private property and in overall very poor condition. One major trunk has previously been removed to accommodate the construction of the adjacent development as shown in the middle photo above. The remaining tree has a major ascending branch with a scar and rot site (shown in the above right photo) which should be removed for the safety of the existing building.

Reason for Removal: This tree should be removed primarily due to its overall health condition and potential danger to the existing building. It is also in conflict with the proposed development.

Tree T11 is are recommended for removal due to health condition and to accommodate Downtown Streetscape
