ARBORIST REPORT

PROPOSED SELF STORAGE FACILITY 1770 APPLEBY LINE CITY OF BURLINGTON

ISA CERTIFIED ARBORIST MATTHEW GEHRES ON-1114A OUR PROJECT NO: 19-5379

REVISED AS PER FORESTRY COMMENTS – May 5, 2022

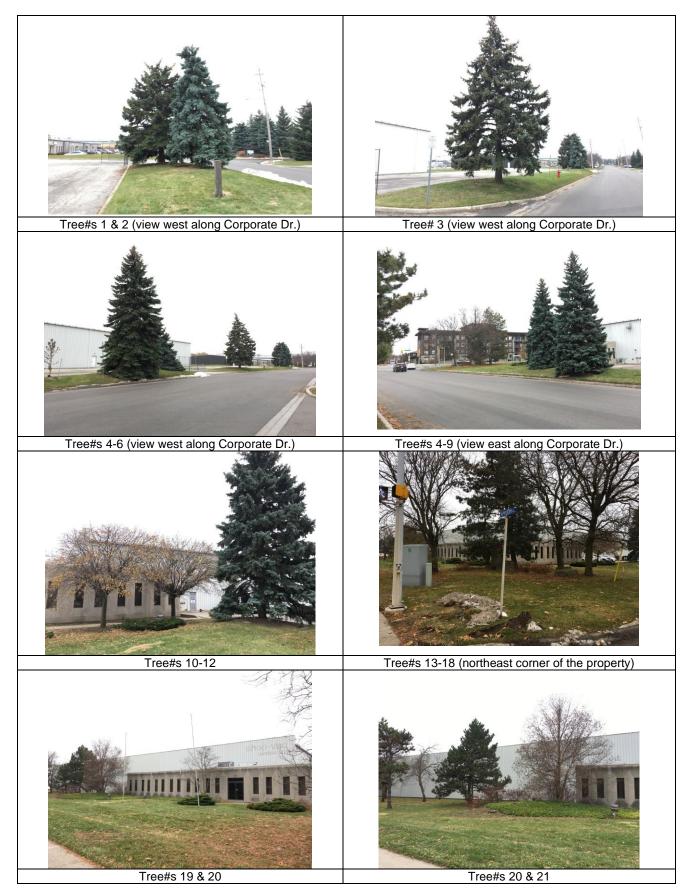
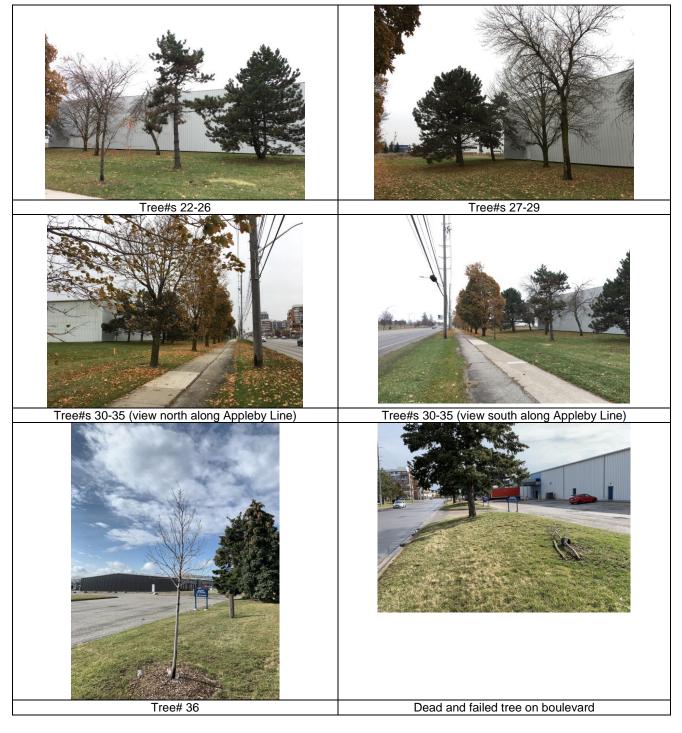
Appendix B – SITE PHOTOGRAPHS

The row of eight Colorado Blue Spruce trees along the Corporate Drive frontage are in good overall heath and condition with the exception of one tree which appears to be in a state of decline. Three, recently planted trees including two Sweetgum and one Redpointe Maple are also situated along the Corporate Drive boulevard. A fourth tree has since died and has failed. Only a small stump remains. A mixed grouping of Mature Honey Locusts and Austrian Pine trees occur at the northeast corner of the site. The Honeylocust trees are in good health and exhibit somewhat asymmetrical forms. The Austrian Pine trees are in fair condition and exhibit one sided and leaning forms due to their dense spacing. A number of semi-mature Ash and Austrian Pine trees flank the east frontage of the existing warehouse. The Ash trees are in a general state of decline likely due to EAB infestation. Most of the Austrian Pine trees are also in poor condition with varying amounts of dieback throughout. Several, semi-mature Columnar Norway Maple trees flank the Appleby Line boulevard. These trees all appear to be in generally good health and condition.
