**Mirkwood Engineering**  
Structural Engineers

July 13, 2020

re. Structural Review of Fire Damaged Residence  
398 Mountain Brow Road, Burlington, ON  
Our Project Number 20081

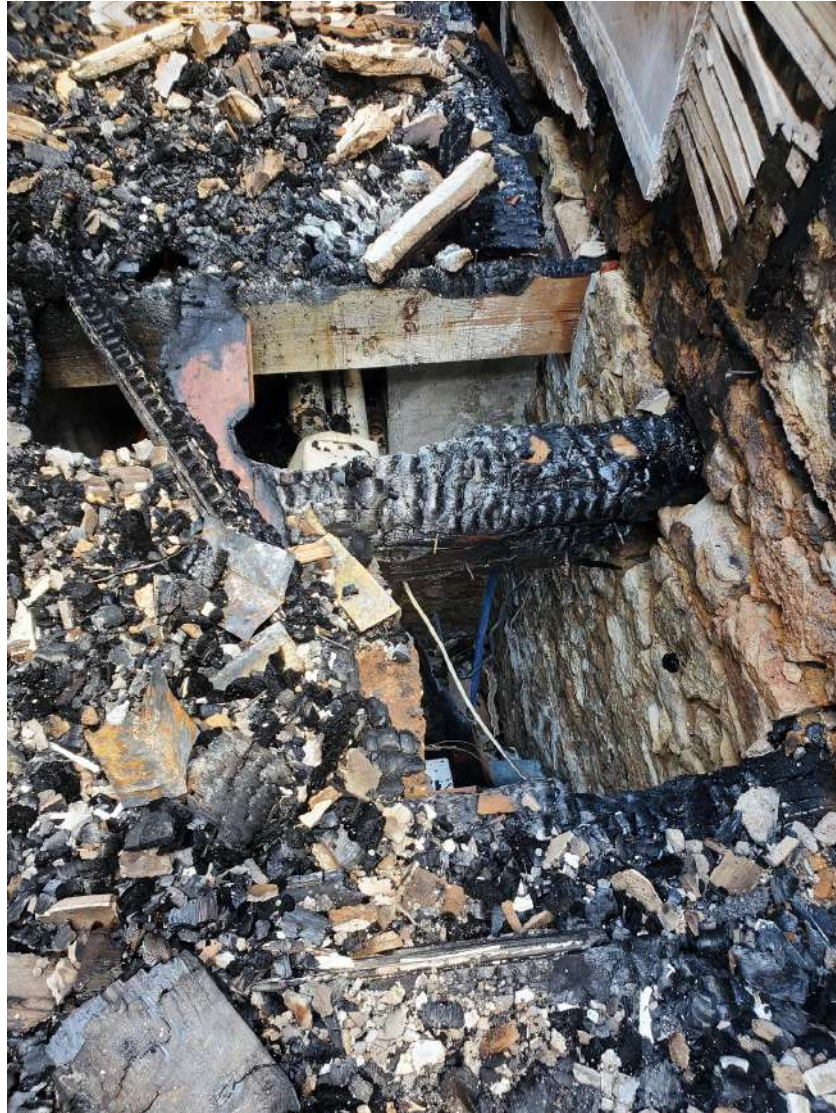
**Figure 1: Typical Condition of Interior Ground Floor Framing (Over Basement) on South 2/3 of Building**

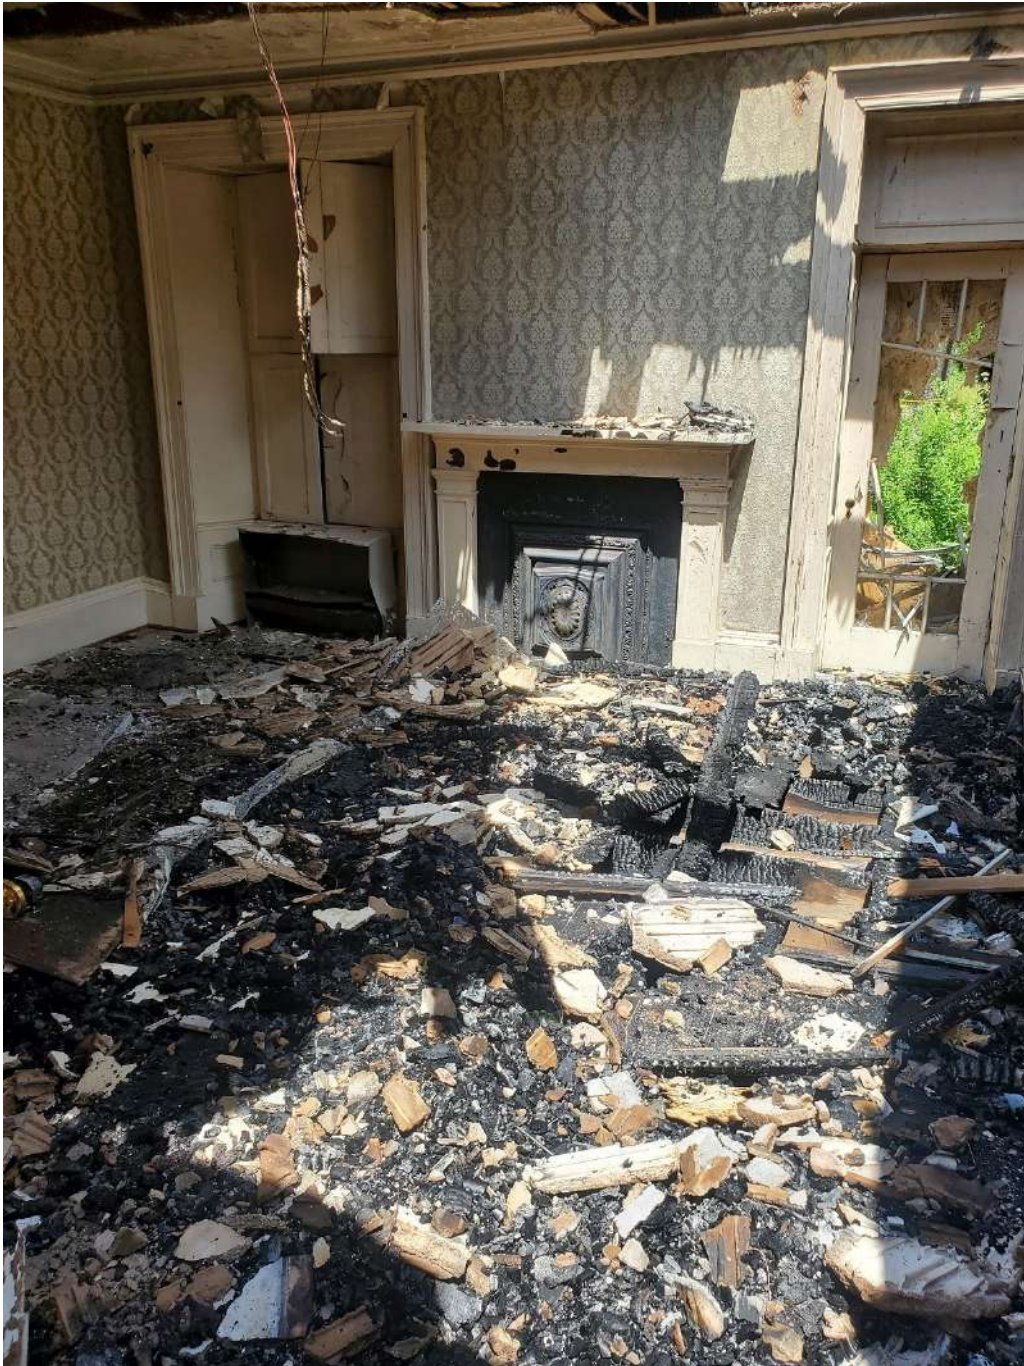
**Figure 2: Typical Condition of Interior Ground Floor Framing (Over Basement) on South 2/3 of Building**

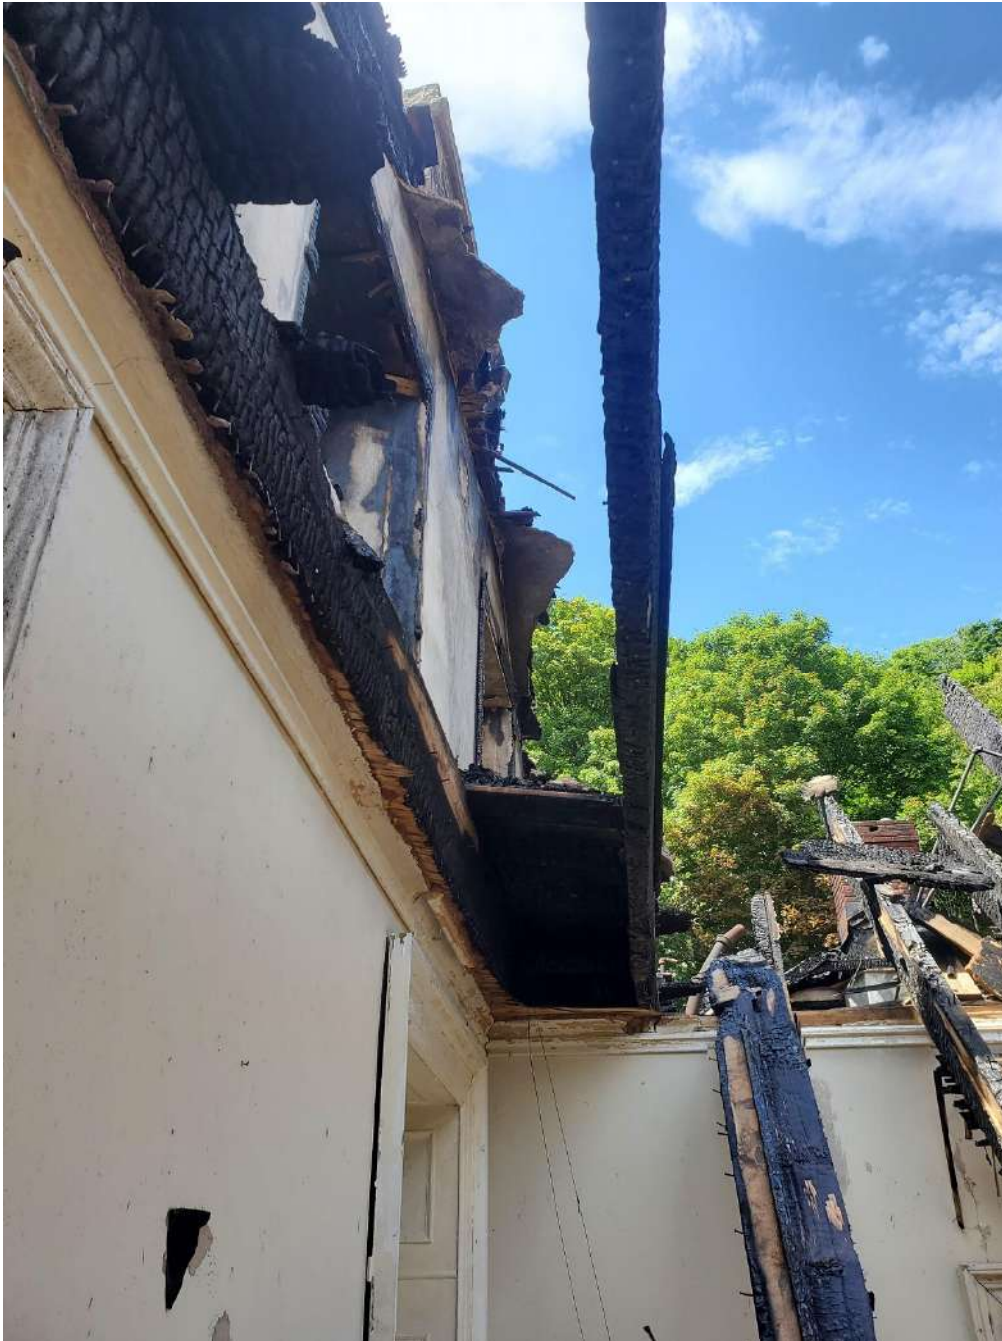
**Figure 3: Typical Condition of 2<sup>nd</sup> Floor and Roof Structure on South 2/3 of Building**

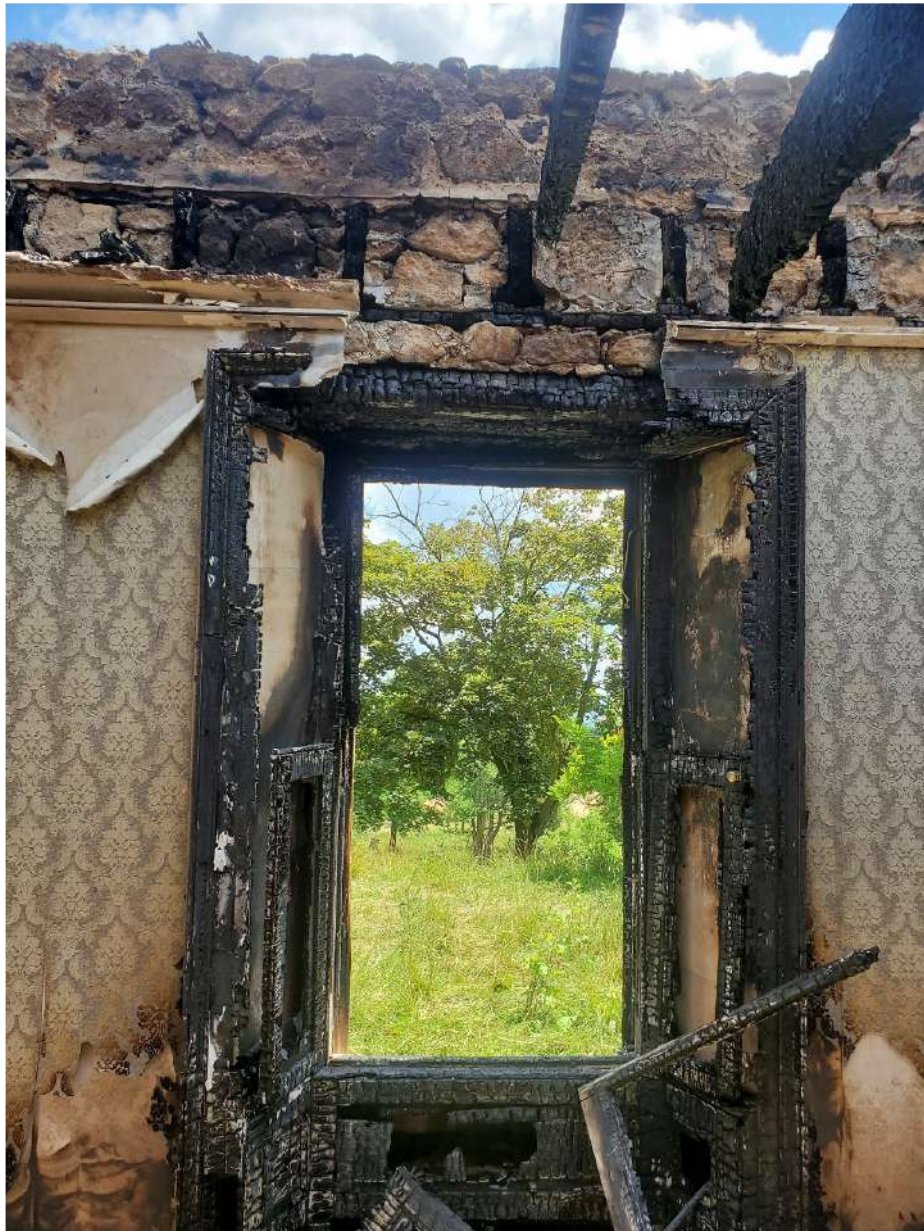
**Figure 4: Typical Condition of 2<sup>nd</sup> Floor and Roof Structure and Exterior Walls on South 2/3 of Building**

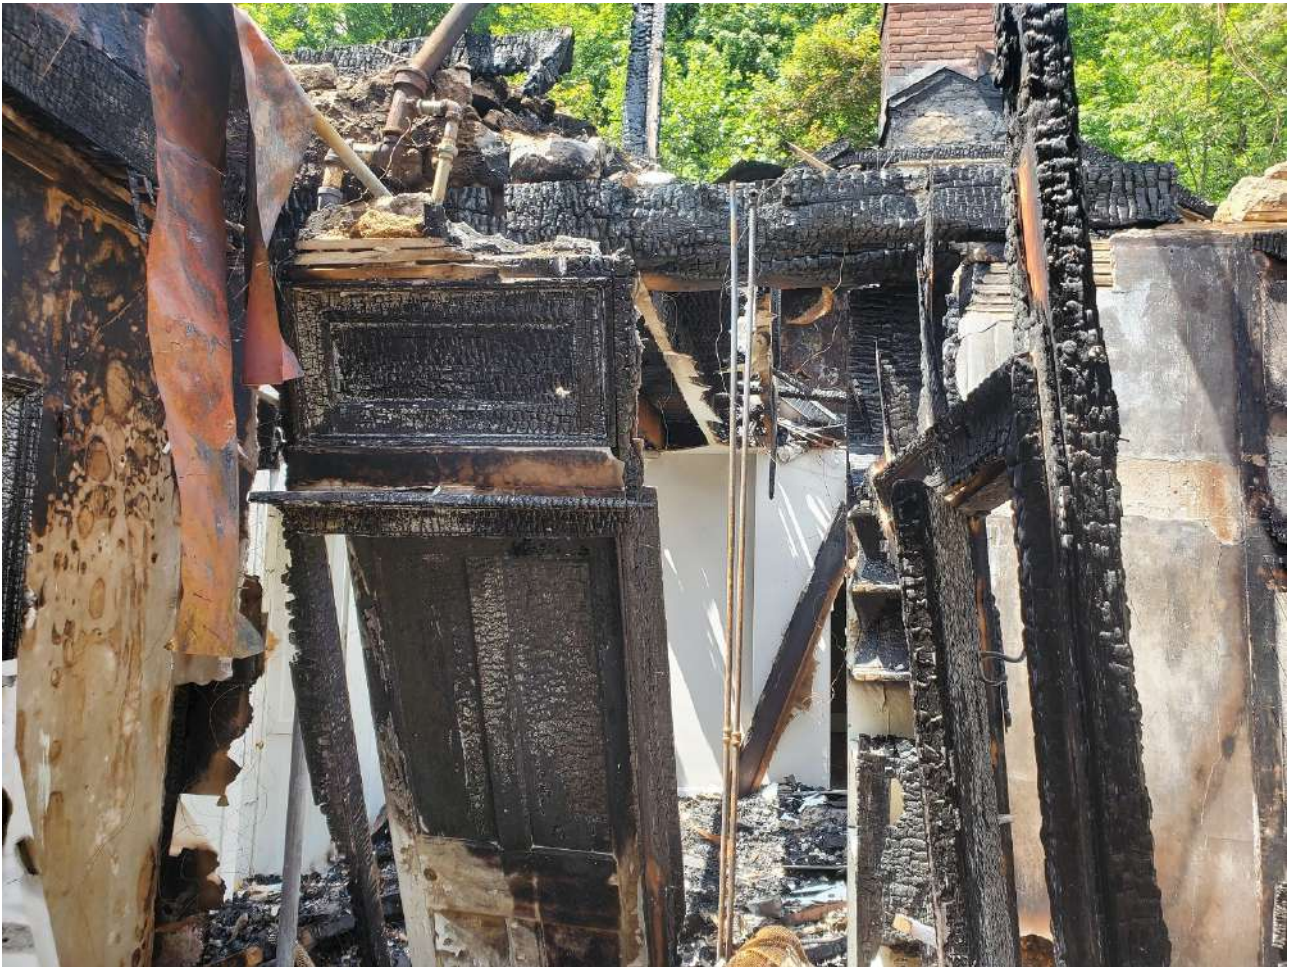
**Figure 5: Condition of Much of the Remaining Interior Structure on South 2/3 of Building**

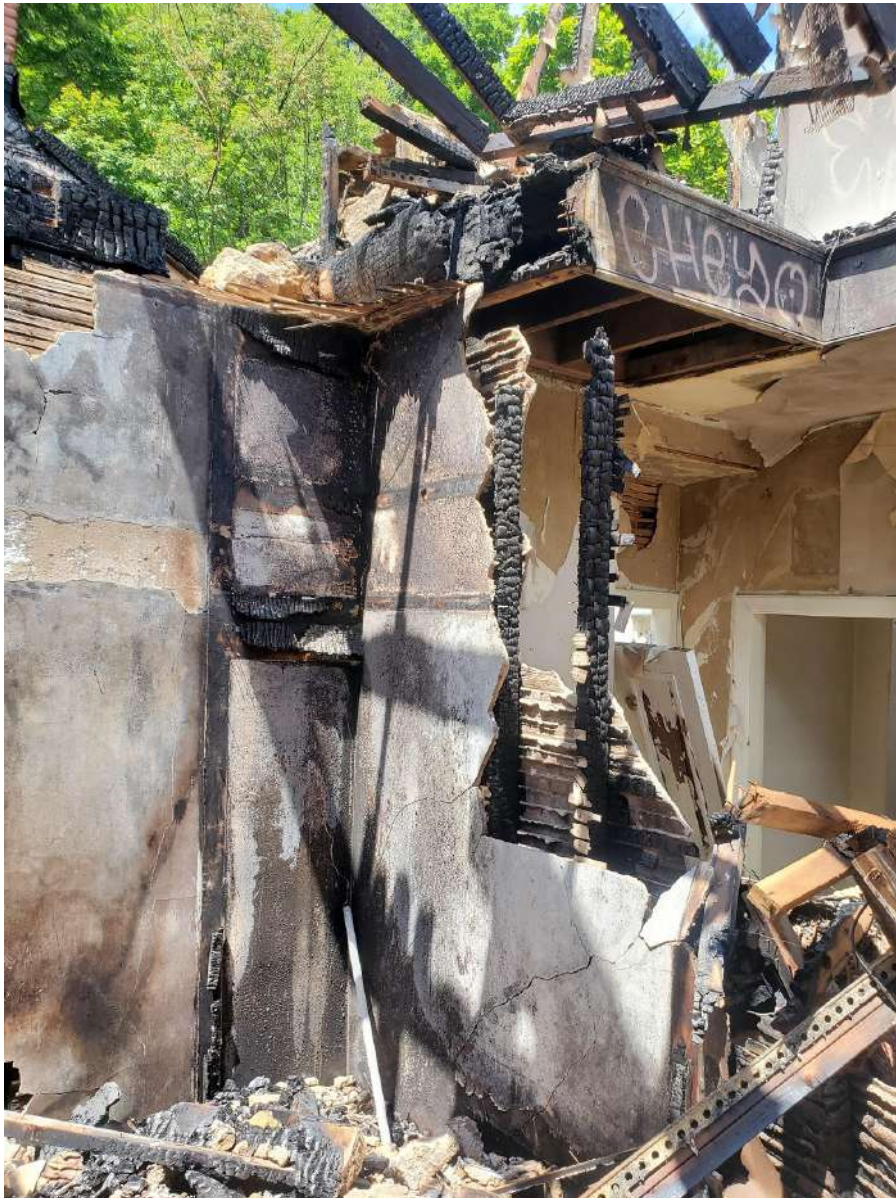
**Figure 6: Condition of Much of the Remaining Interior Structure on South 2/3 of Building**

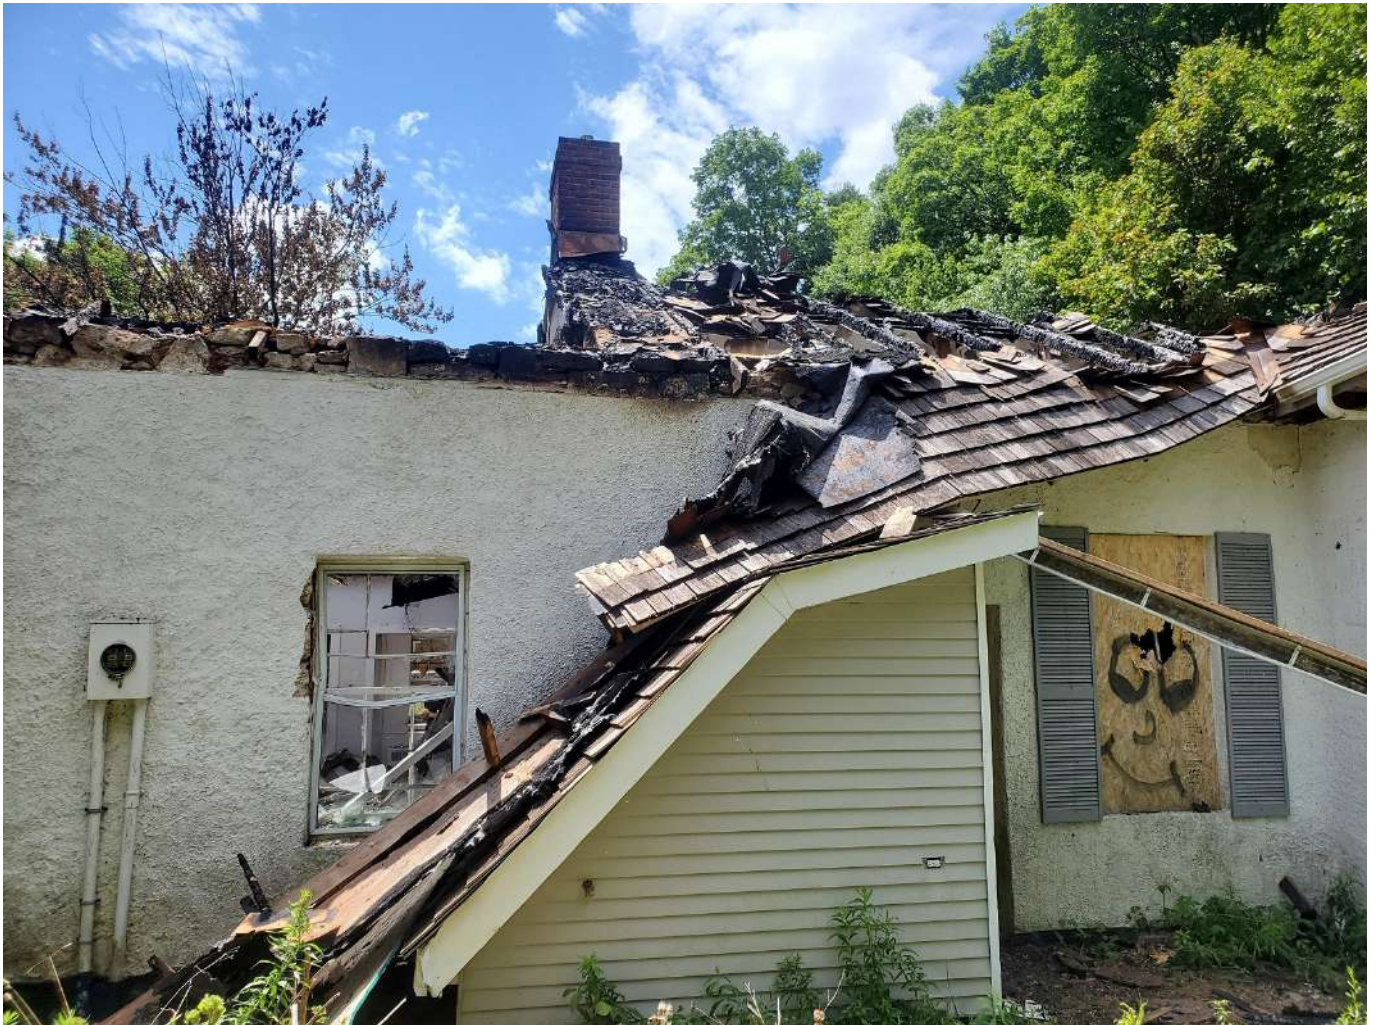
**Figure 8: View From Outside of Building Looking West Showing Guttered Roof Structure to South and Fire Damage Extending Partially over North Portion of Building**

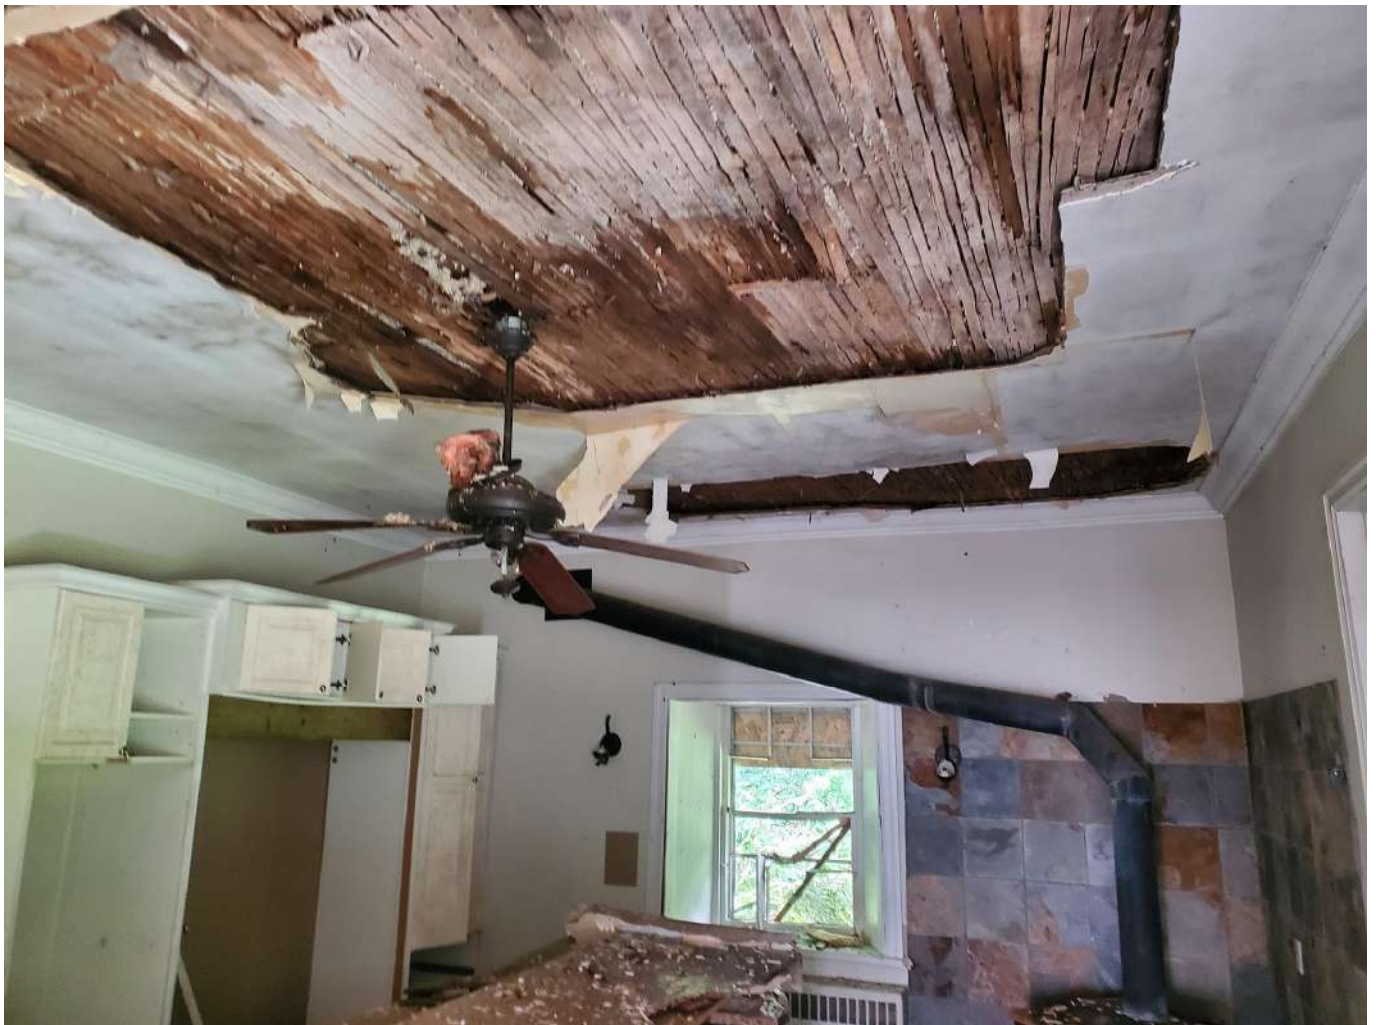
**Figure 9: Water Damage to Structure in North-most Portion of Building**
