603 Woodland Avenue, Burlington, Ontario
DENG File # n/a

1 April 2022

Revised 12 October 2022

Arborist Report - 603 Woodland Avenue, Burlington, Ontario

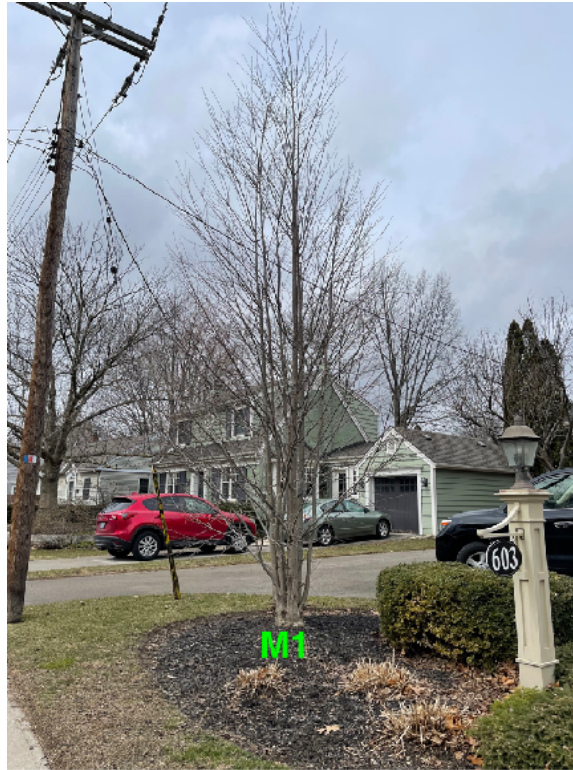
Tree number M1 is a 9, 9, 9, 10cm dbh Maple Red (soft maple) that is growing on the municipally owned boulevard. This tree is in fair condition and requires a tree protection zone of 2.4m.

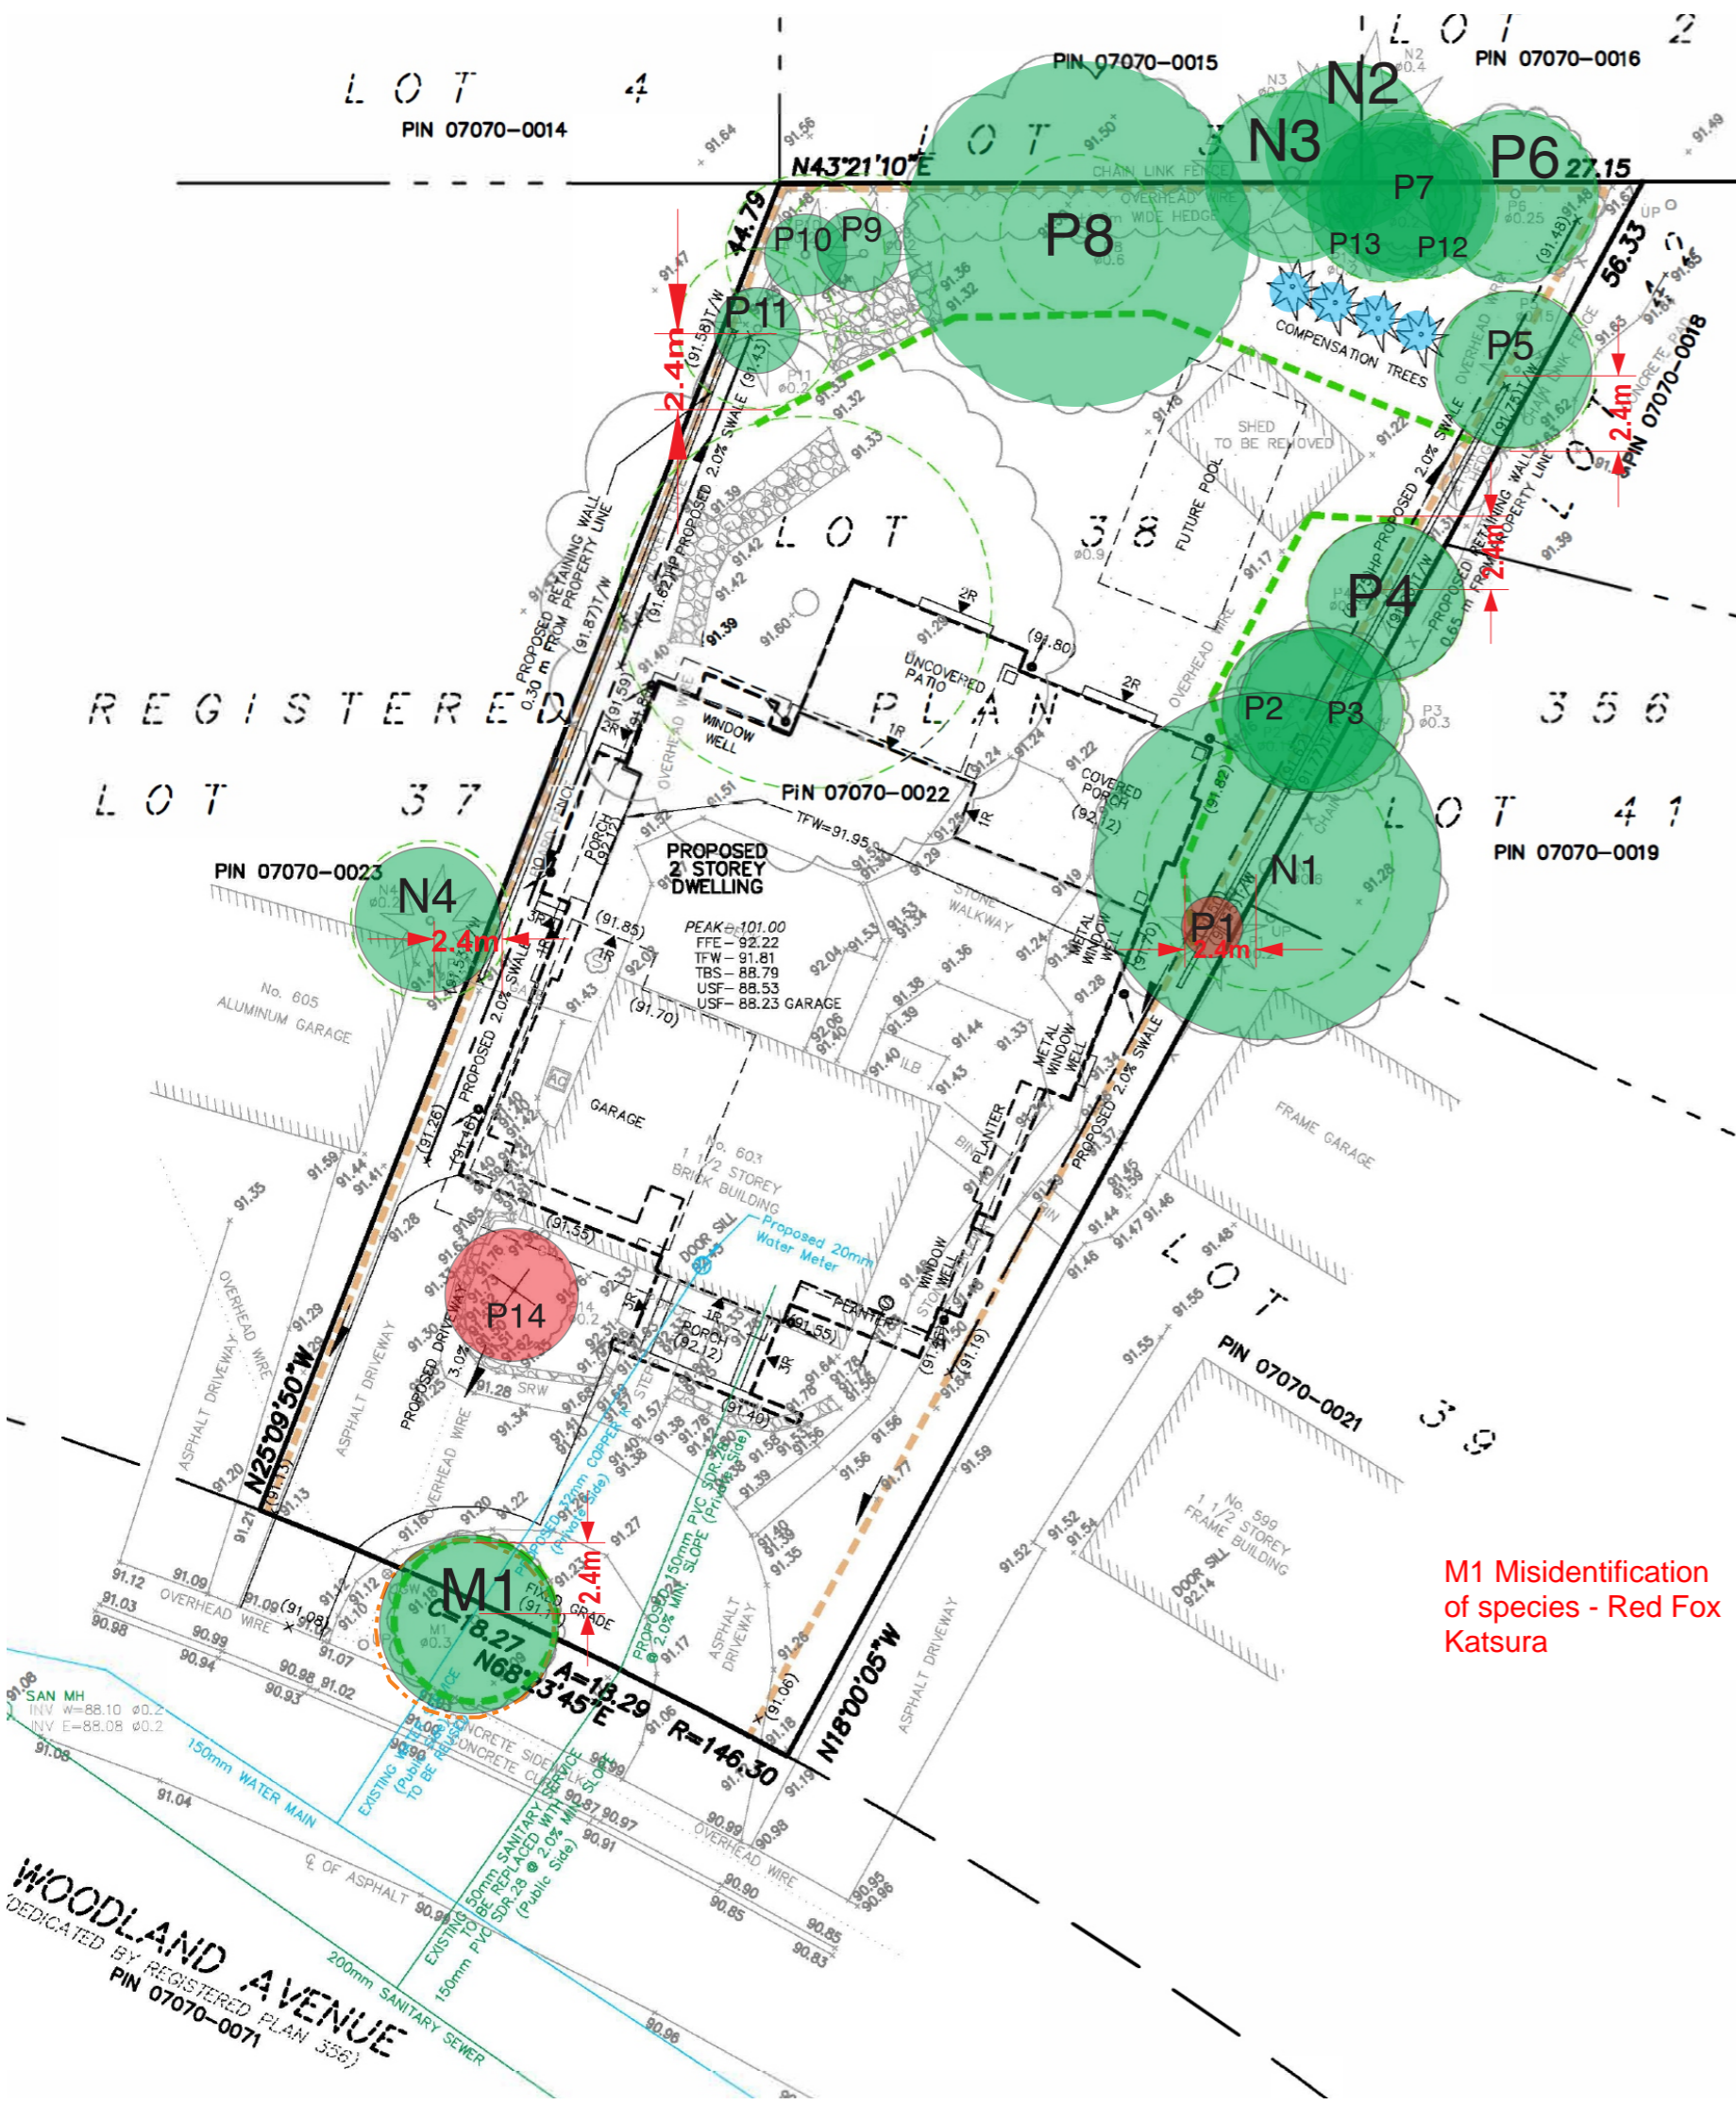
SHEET
Tree Protection Plan

Tree number P1 is a 15cm dbh Cedar White that is growing near the east property line of the subject property. This tree is in fair however it is recommended for removal due to development impacts.

Tree number P14 is a 12, 15, 16cm dbh Japanese Lilac that is growing near the west side of the front yard on the subject property. This tree is in poor condition and is recommended for removal due to its current state and development impacts.

M1 Misidentification of species - Red Fox Katsura

All protective tree hoarding shall be installed prior to commencement of any construction activities as per City of Burlington specifications.
