HERITAGE IMPACT STUDY
4210 INGLEWOOD DR.
BURLINGTON, ON
JUNE 19, 2017

Overview:

This report is prepared to address the proposed re-development of the existing single family dwelling at 4210 Inglewood Dr., Burlington ON.

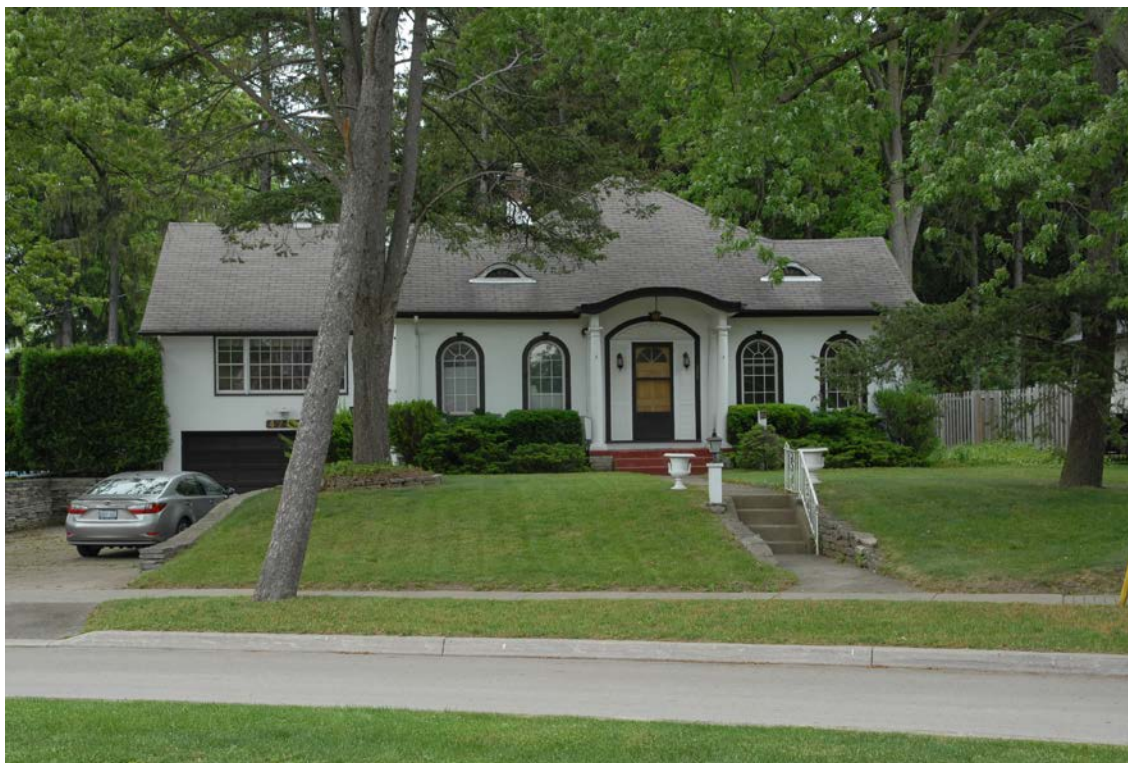
Front Elevation

The building is clad in white painted stucco. The stucco overhangs the foundation slightly. The stucco was inspected by chipping away an inconspicuous portion and this revealed a layer of expanded metal lath and older stucco below, so clearly the finish has been renewed at some time. The exterior is generally in good condition, with some minor cracking observed. Roof is asphalt shingle and in fair condition.

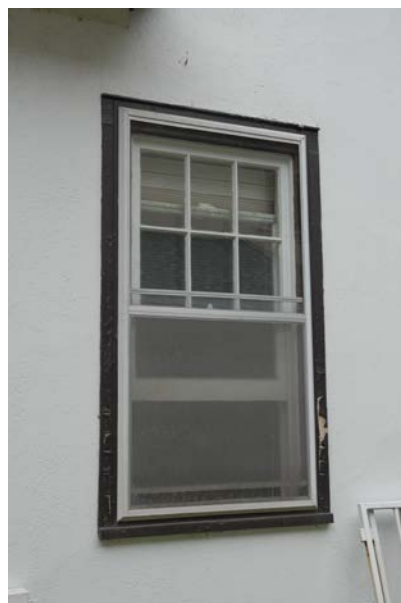
Main floor windows in the original building are for the most part original wood double hung single glazed units, some with later metal storms fitted on the exterior. The original windows appear to be in fair condition – although the sash cords are missing in most cases. There are unusual leaded glass panes in an Arts & Crafts pattern flanking the fireplace on the north elevation. These have been fitted with plexiglass sheets on the interior. All of the windows have simple painted wooden trims on the exterior. The face of these trims are very nearly flush with the stucco finish – a clear indication that the stucco has been renewed. These trims would typically be proud of the stucco finish.

Typical window detail showing trim flush with stucco, original double hung sash, later metal storm

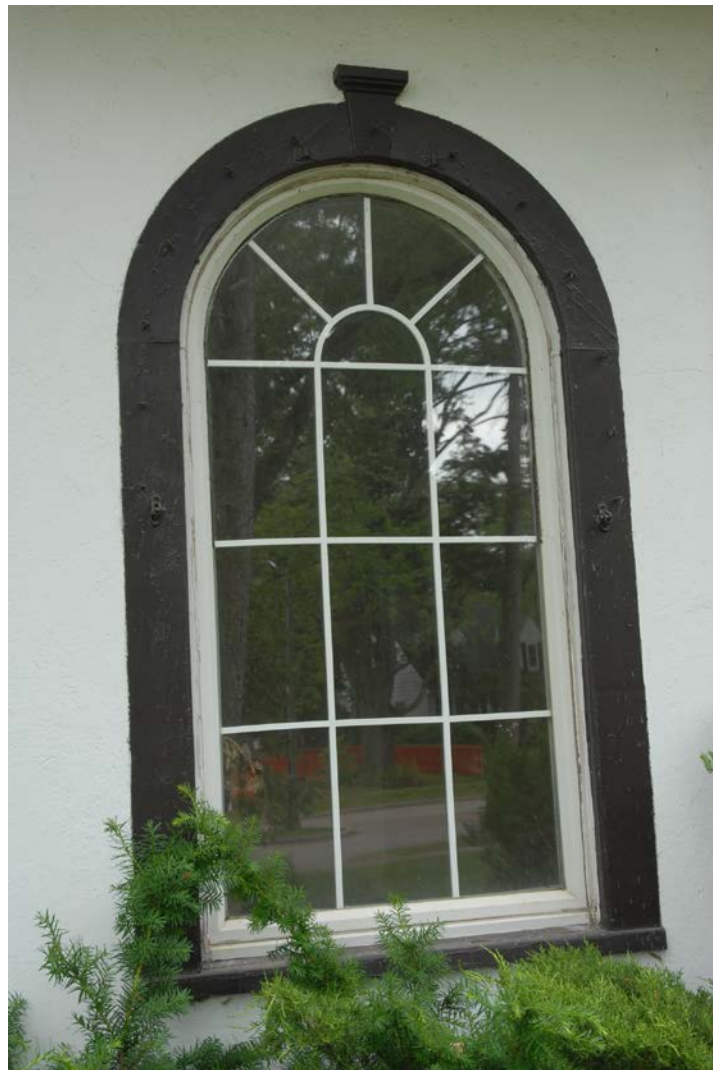
Across the front of the house are four round head windows. These are the only round windows in the building. Detailed examination of these windows reveals that they are not original to the building. They are vinyl thermal units with false muntins that have been set into older wooden rectangular frames. The interior trims are rectangular and match the trims in the rest of the house. As part of this investigation the interior trims of one of these windows was removed to reveal a painted, rectangular older frame. The location of the former sash, weights and rollers can be clearly seen. Likely these round head windows were installed contemporaneously with the stucco replacement because no evidence of the former square openings is visible from the exterior. The windows have a manufacturing date of 1992 visible on them. This gives us a good indication of the timing of this work.

Round head vinyl windows along front elevation

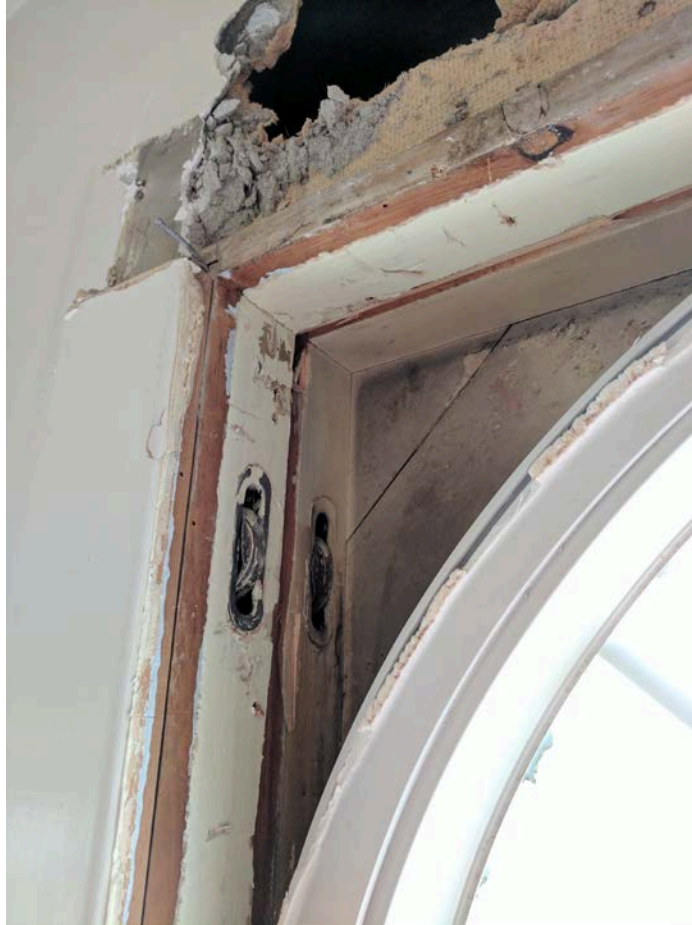
Interior detail of round head window showing older frame, pulleys

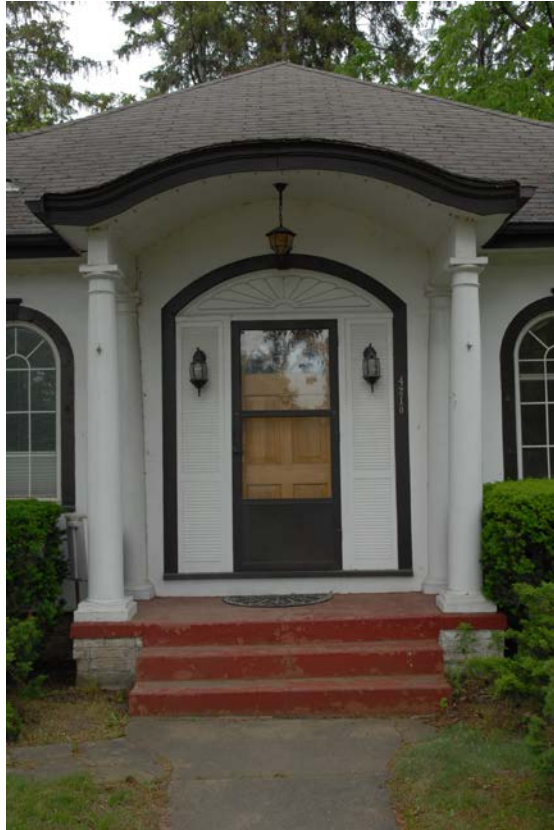
The front porch is a prominent feature of the building and is in fair condition. The wood detailing and trim around the columns and ceiling is remarkable by its simplicity and lack of embellishment. There is a surprising lack of craftsmanship here. There is a sagging in the porch roof which has caused the wood columns to splay outward. It could not be determined without further destructive investigation if the porch was original to the building or added later, however the fact that the curve of the porch roof is matching in radius to the arc above the front door, which is likely a later addition, creates some potential that the porch, too, was added later. The porch floor is painted concrete supported on a brick

foundation. This is the only brick foundation on the building and this lends credence to the possibility that it may have been added later, however the deterioration of the brick and of the concrete floor makes clear that this has been in place for a long time. It is also possible that the brick foundation and concrete floor may be older than the roof above.

Front porch, door and trim detail

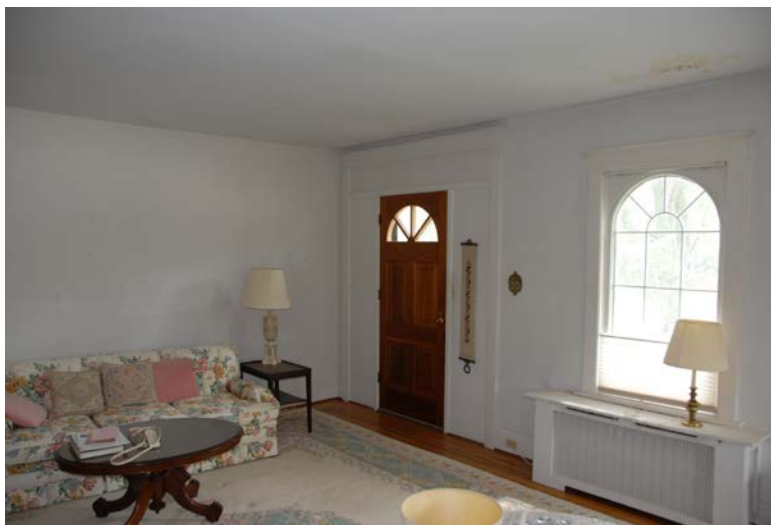
The existing front door is a newer four panel wood unit with a star-burst half-round glass motif above. Flanking the door from the exterior is an unusual trim made up of wooden shutter panels and above the door is a curved raised panel detail of unknown origin. The door, shutter panels and the curved detail are items that would typically have been available for purchase at lumber stores in the mid to late 20th century. They are not attractive and almost certainly not original to the building. The interior trimwork around the front door appears to be original. It is rectangular and implies over-sized rectangular sidelights and a rectangular transom. This was almost certainly the original detail.

Front door from interior. Trim gives likely indication of size and configuration of original transom and sidelights. Note rectangular trim on round head window at right

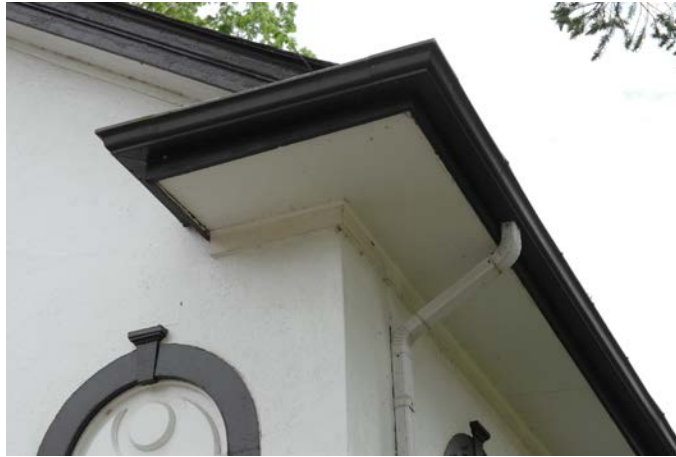
One interesting detail is that while the trims around the windows are nearly flush with the stucco finish, indicating that they were in place before the most recent coat of stucco was applied, at the top of the stucco wall there is a simple frieze consisting of a painted board with quarter-round moulding. This frieze is located on top of the stucco, indicating that it was placed there after the stucco application. This frieze is continuous around the entire home, except that under the curve of the porch roof there is only the quarter-round trim. The presence of this obviously later frieze trim is likely indicative that changes were made to the soffit contemporaneous to the stucco application and lends further support to the idea that the curving porch roof is not original.

Newer frieze detail. Note that this is mounted on top of stucco as compared to window trims

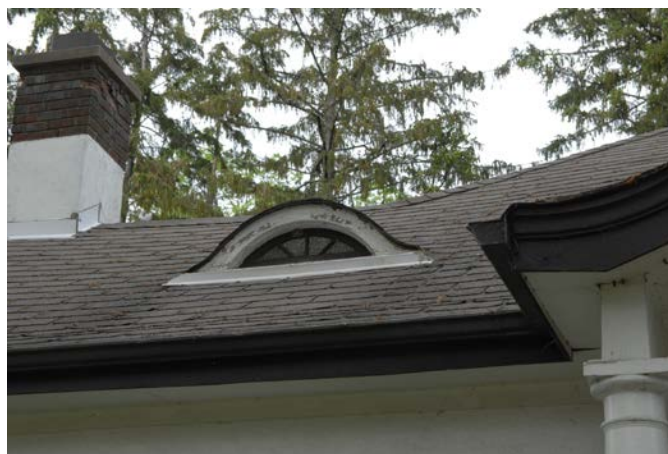
Eyebrow dormer

On the roof on the front elevation are two symmetrically placed eyebrow dormers. These appear to be rather undersized but they are quite prominent on the elevation. They are painted wood with a large aluminum flashing at the junction with the roof. Examination of this area from the attic space reveals that they are not original to the building. The holes to accommodate them were crudely cut and the framing material around them clearly does not match the remainder of the roof.

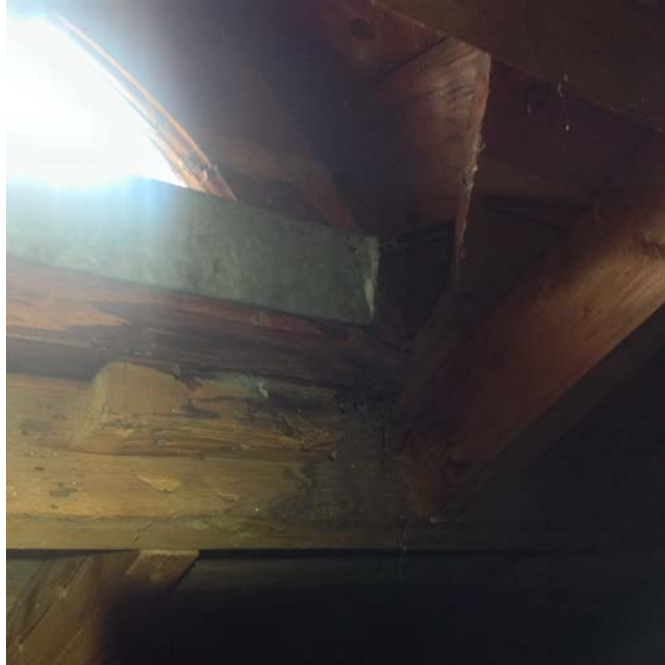
Eye brow dormer from attic. Note crude craftsmanship, dissimilar materials

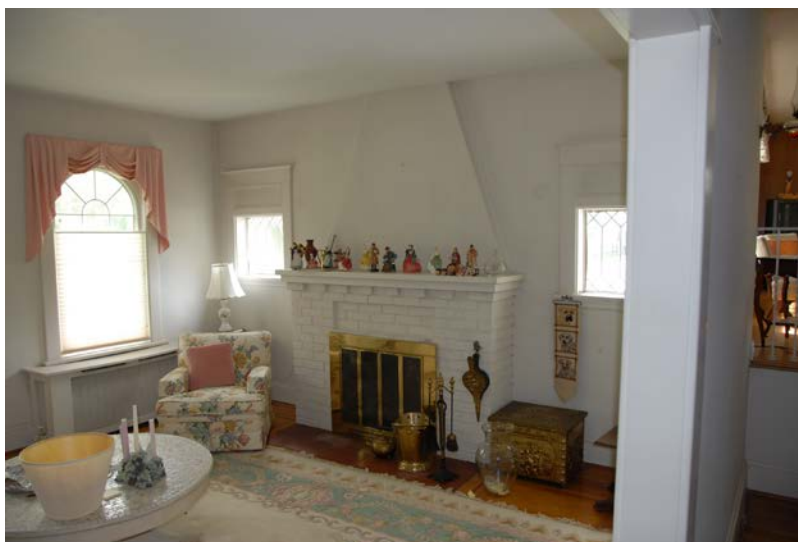
Interior trims and finishes are generally original and in good condition. The kitchen and bathroom has been replaced as would be expected in a building of this age. Trims are simple painted flat profiles without obvious detail, with architrave type trims at the doors and windows. This is all very typical of an Arts & Crafts aesthetic, which was popular at the time of original construction. Handrails, newels and balusters are painted metal which was typical at the time of the 1961 addition. The main floor fireplace is original and features interesting brick Arts & Crafts detailing.

Original brick fireplace
