Burlington Agricultural & Rural Affairs Advisory Committee (BARAAC)
December 16, 2020

**Re: Soil Survey and Canada Land Inventory (CLI) Assessment
Nelson Aggregate – Burlington Quarry West Extension
Part Lots 1 and 2
Concession 2 (Former Nelson Township)
City of Burlington
Region of Halton**

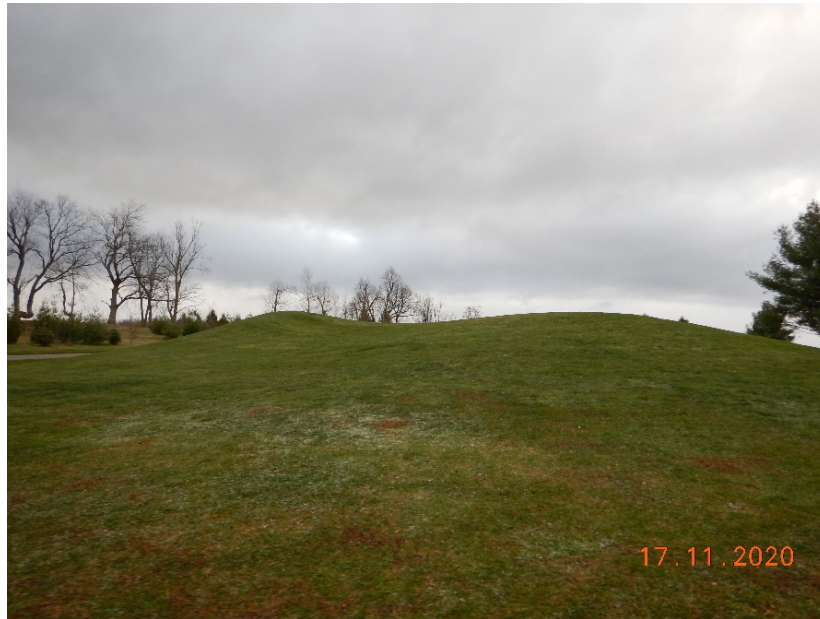
Photograph of landformed hills adjacent to the fairways.

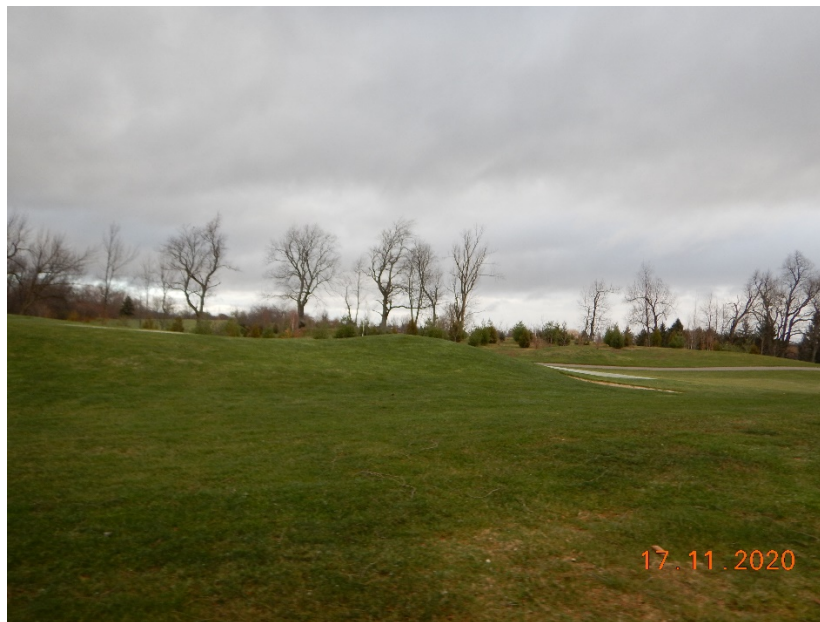
Photograph of landformed hills along fairways.

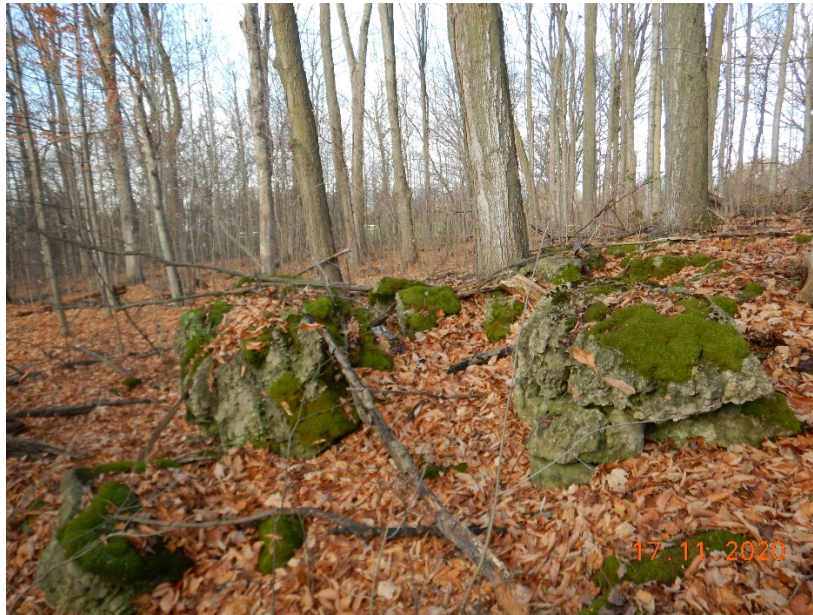
Photograph of large area of bedrock outcrop.

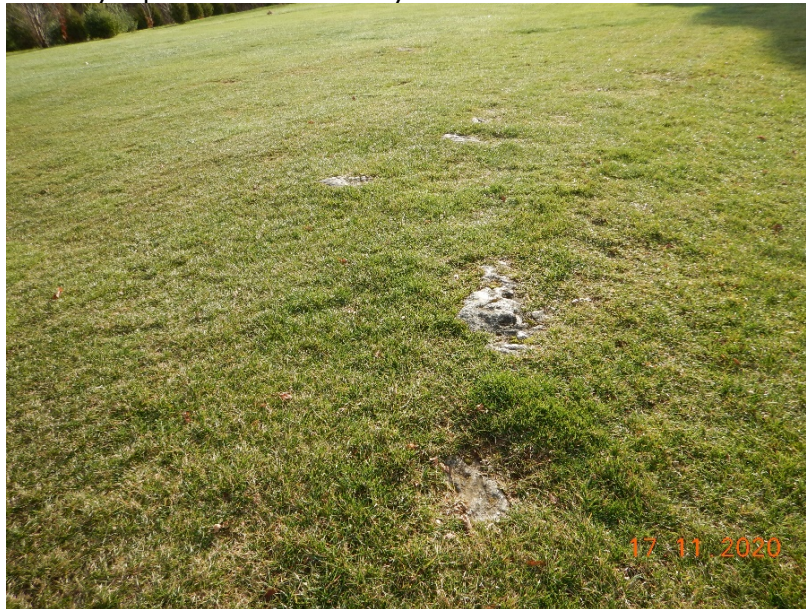
Bedrock outcrops were observed as large areas of rock and boulder materials adjacent to the fairways, and as smaller areas that were barely exposed within the fairways.

Photograph of small area of exposed bedrock.

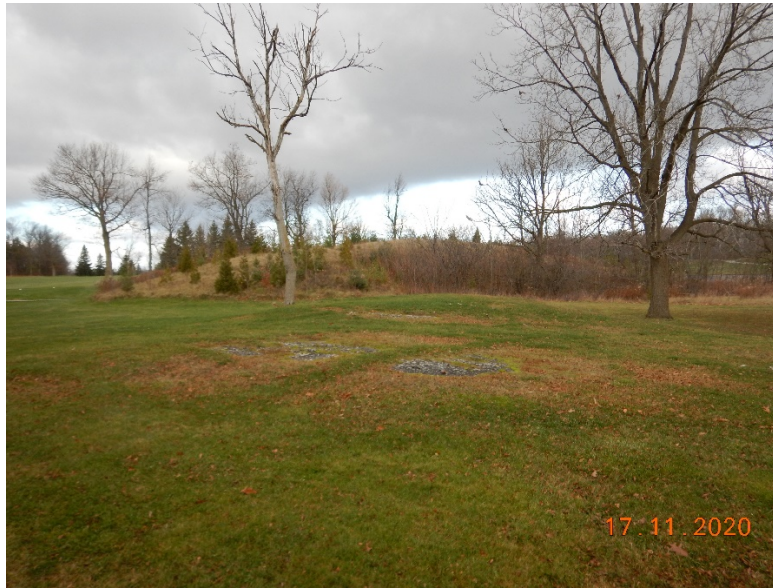
Photograph of exposed bedrock and sculptured landscape along edge of fairway.

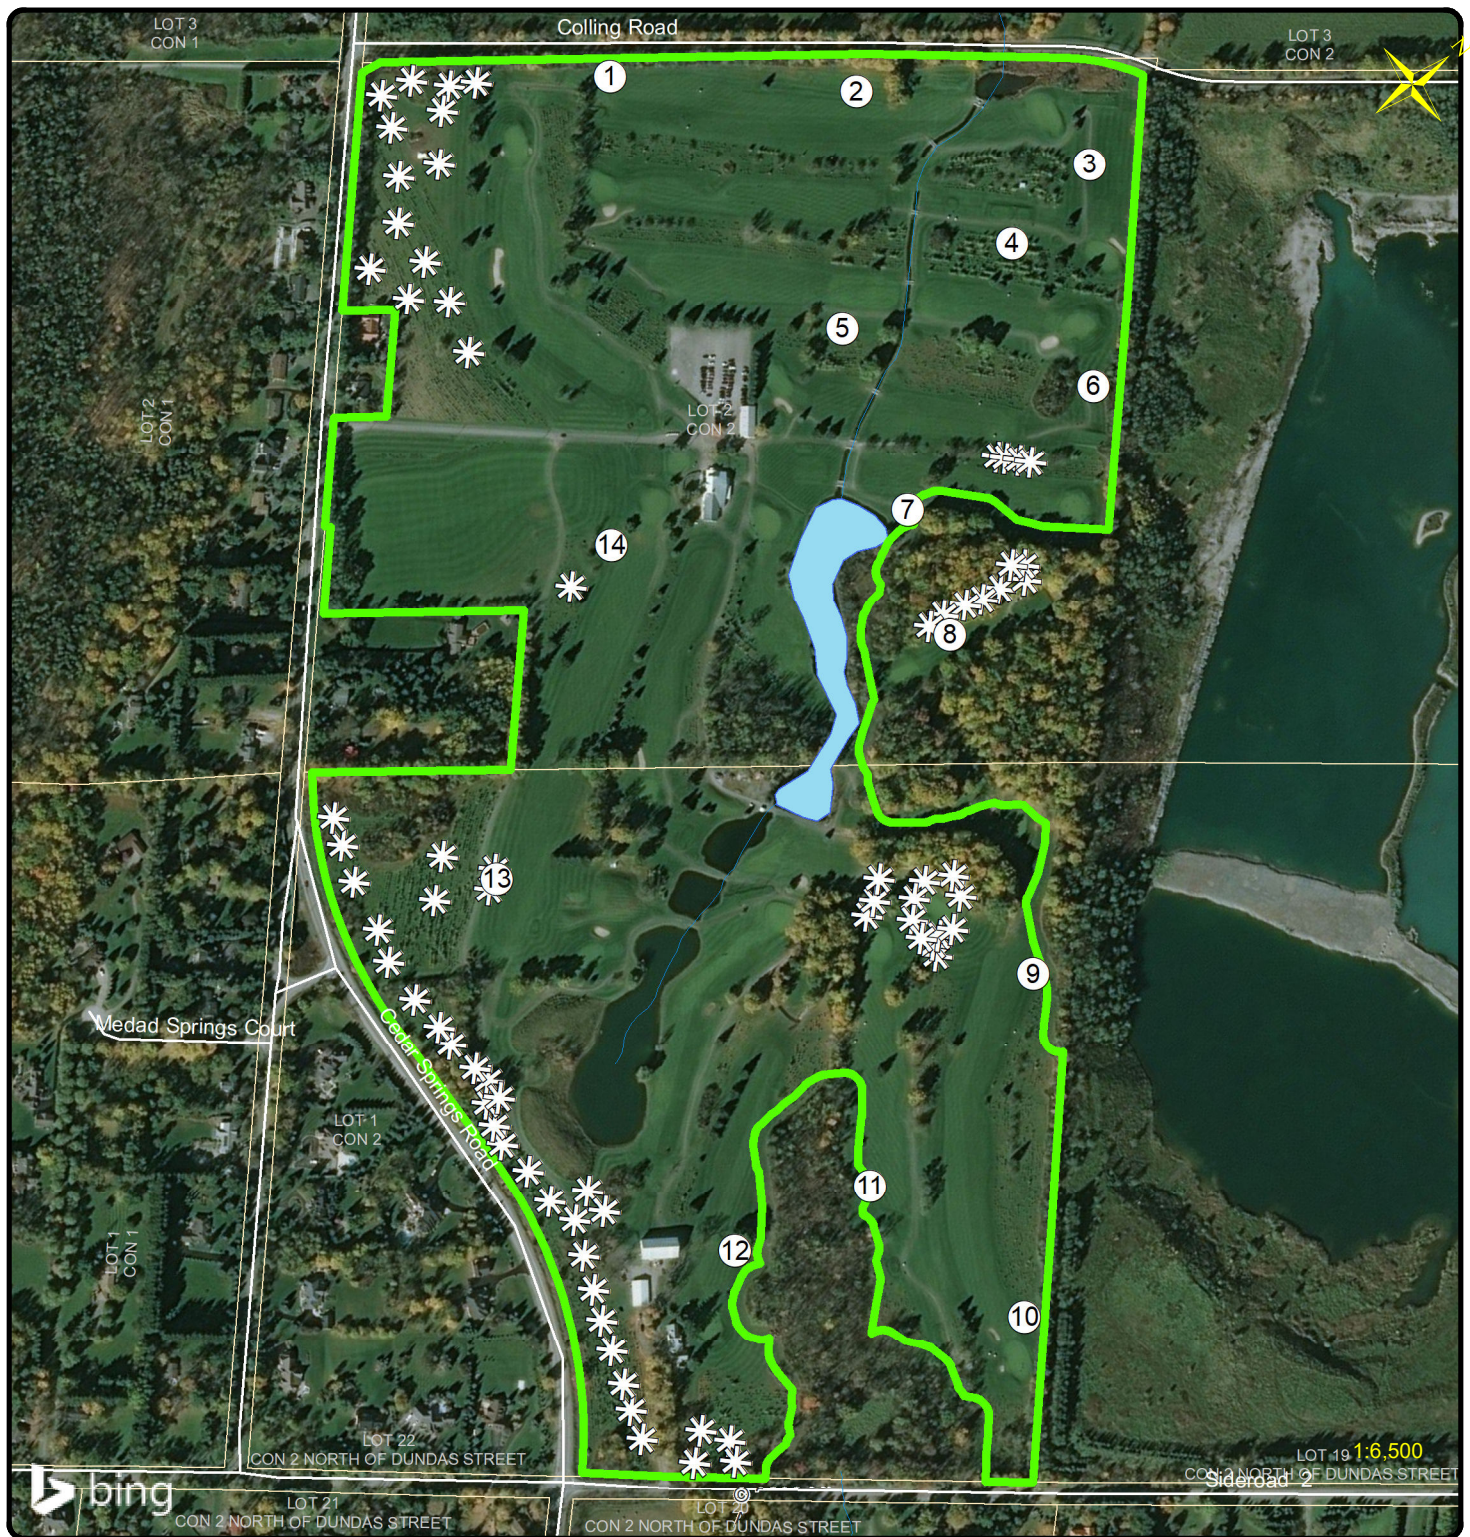
Figure 2

It is evident from Table 1 that there was little information that could be determined from the soils on this site due to the landforming processes that were completed as part of the construction of the golf course.
