Arborist Report

Dawn Victoria Homes
5209 Stonehaven Drive,
Burlington, ON

City File No.: 510-01/17
Halton Region File No.: 24T-17001/DB-1011

~~July 9, 2021~~
November 5, 2021

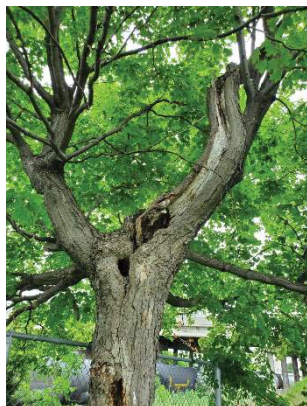
Tree 1 (Neighbouring) – Large trunk cavity

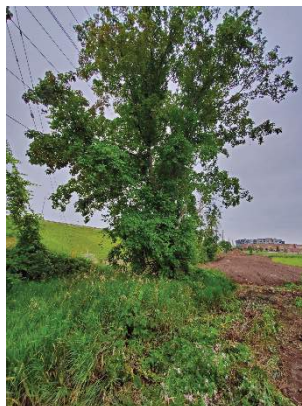
Tree 2 (Subject Site)

The 3 Subject Site Trees recommended for removal were found to be dead/dying (Trees #3 and #4) and/or in a serious state of decline (Tree #2). It is expected that these trees will become hazardous if not removed prior to construction. The condition of Tree #2 at the time of inventory and general species intolerance (Red Maple) of construction related disturbance suggest it will not survive the proposed works.

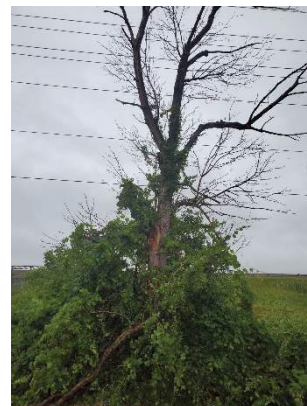
Tree 3 (Subject Site) – Dead/Dying Ash

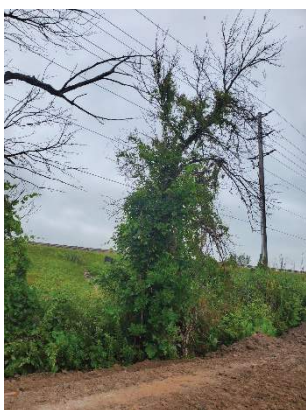
Tree 4 (Subject Site) – Dead/Dying Ash

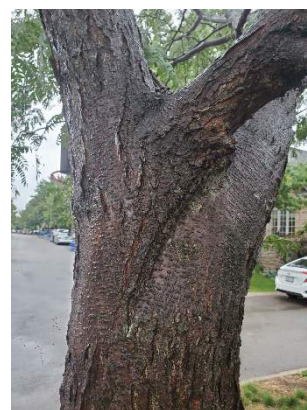
Tree 6 (Public) – Included bark at union

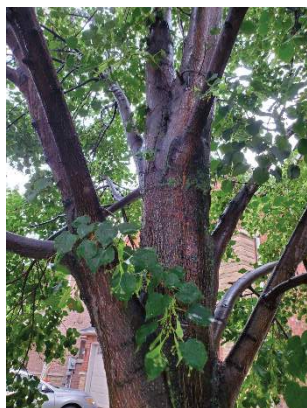
Tree 9 (Public) – Co-dominant leaders and included bark

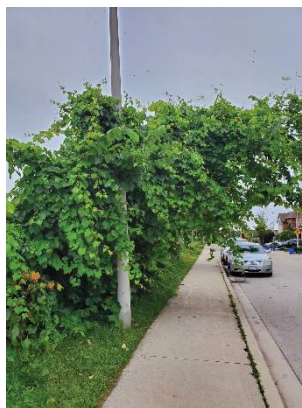
Tree 10 (Public) – Severe lean due to grapevine growth

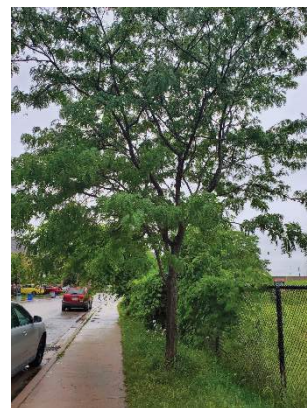
Tree 11 (Public)

Tree #11 (Public) is recommended for removal due to direct conflict with proposed servicing. In discussion with the City of Burlington Urban Forestry Department, it was determined the degree of mtpz encroachment from proposed servicing on Tree #11 would make preservation unfeasible.

11	Thornless Honeylocust	<i>Gleditsia triacanthos var. inermis</i>	15	D	Good	4		conflict with proposed servicing; tree recommended for removal in discussion with Burlington Urban Forestry	Public	REMOVE
12	White Pine	<i>Pinus strobus</i>	4	D	Dead	–	Dead standing snag (0.5m ht.)		Public	SAVE

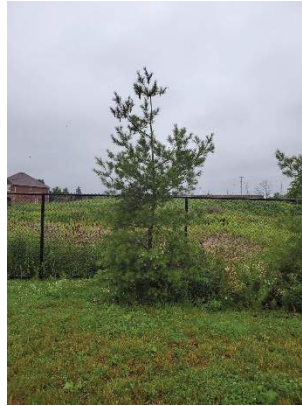
Tree 15 (Public)

Two trees (#15 & #17) are identified as to be preserved with non-fatal injury due to minor mTPZ encroachment (3-12%) due to a proposed retaining wall. This degree of encroachment is considered minimal and not expected to cause irreversible damage. Further, the two trees

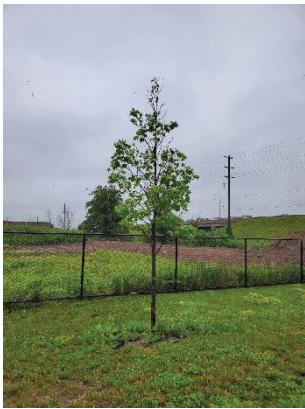
Tree 18 (Public) – Leader showing signs of decline

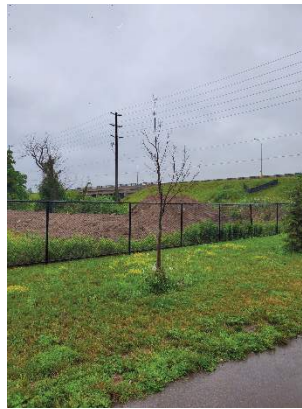
Tree 19 (Public) – Dead deciduous tree

A total of 18 Trees (1 Neighbouring, 17 Public) are recommended for preservation due to sufficient distance from the proposed works. Tree #19 was recorded as dead at the time of inventory, however, it is recommended for preservation as it is on Public property and its size and location make it unlikely to become hazardous.

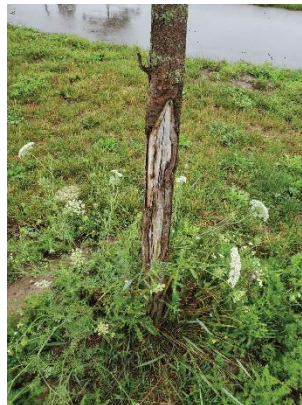
Tree 19 (Public) – large stem wound

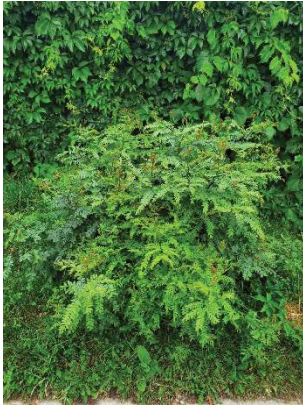
Tree previously removed by others in Stonehaven Drive ROW (Thornless Honeylocust)

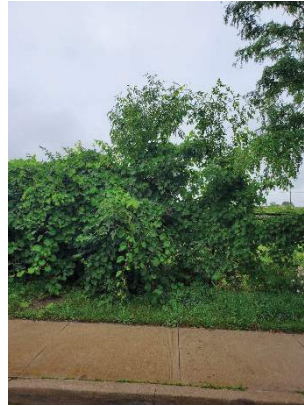
Tree previously removed by others in Stonehaven Drive ROW (behind grapevine covered fence) (Ash species)

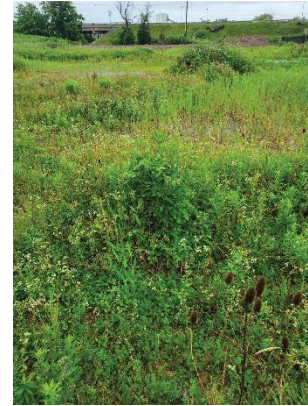
Tree previously removed by others just beyond Stonehaven Drive ROW (Ash species)
