Appendix B of PL-61-22- Photographs

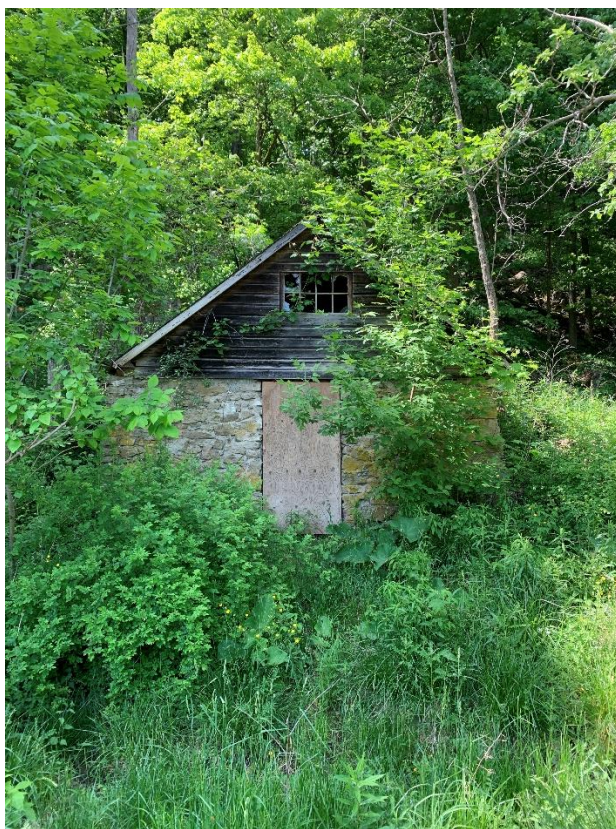
Ice House Exterior (2022)

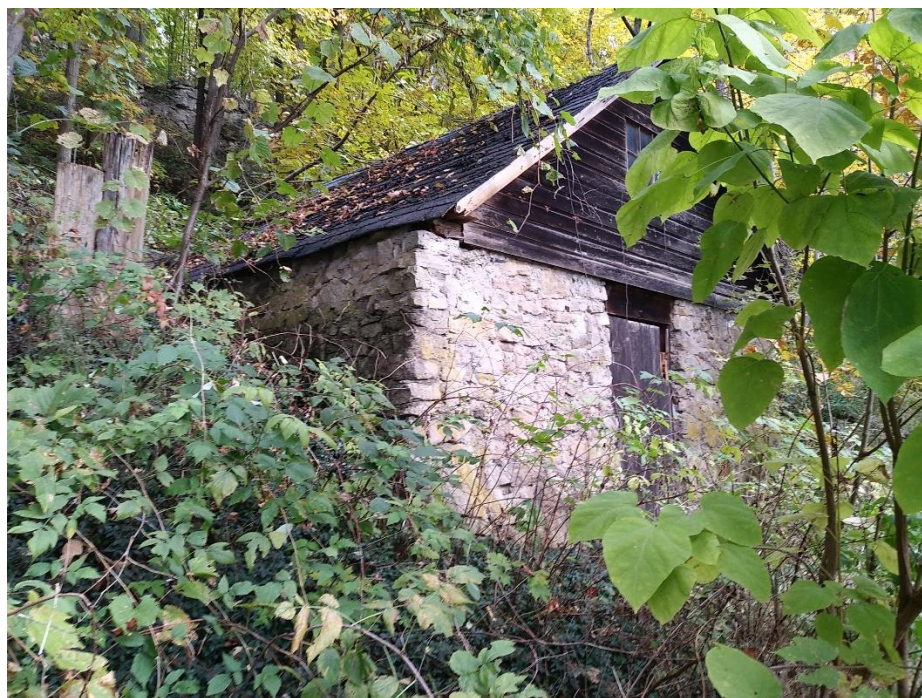
2018 Exterior Photo

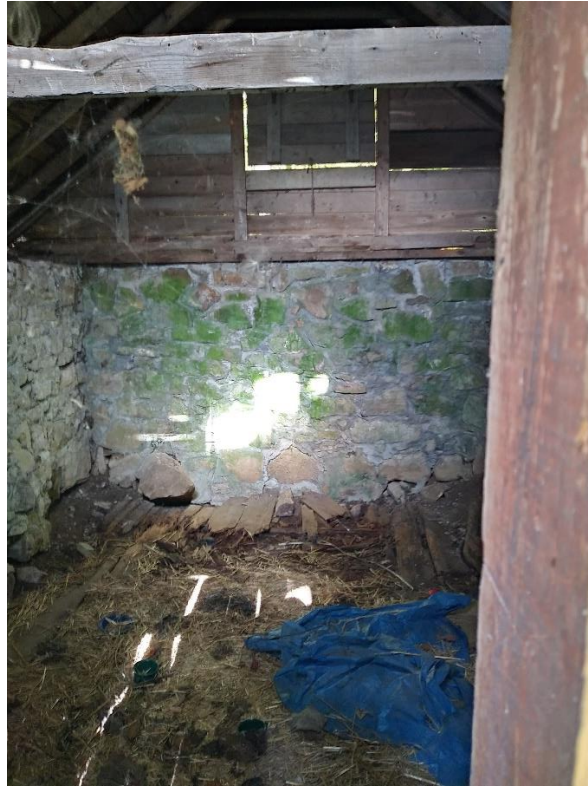
Ice House Interior

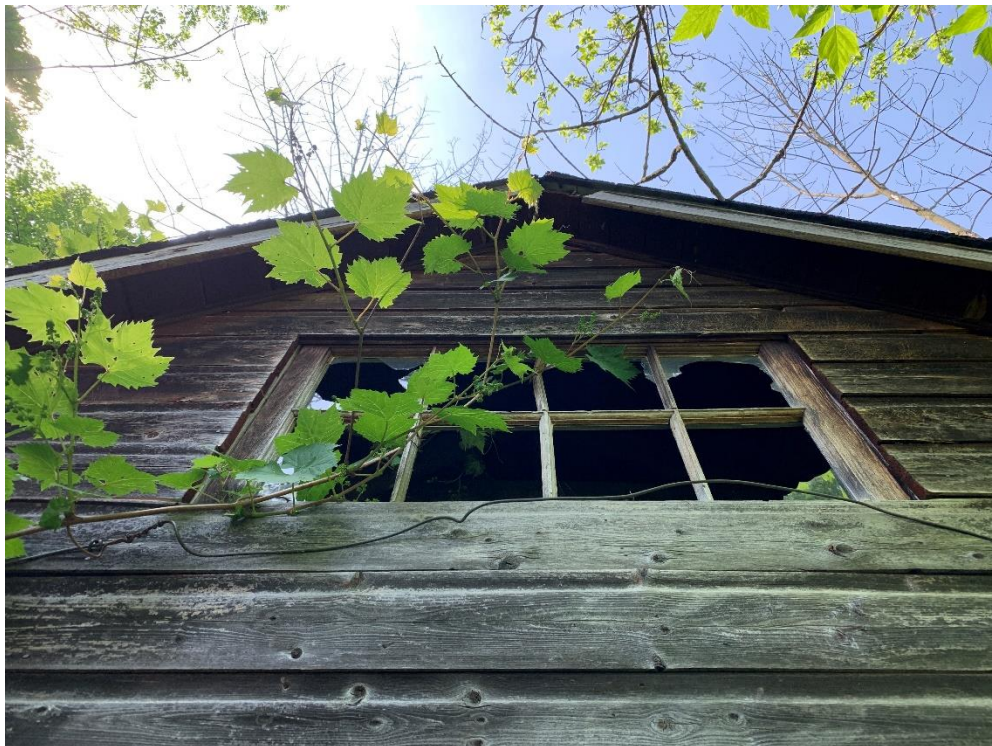
Broken window in gable end

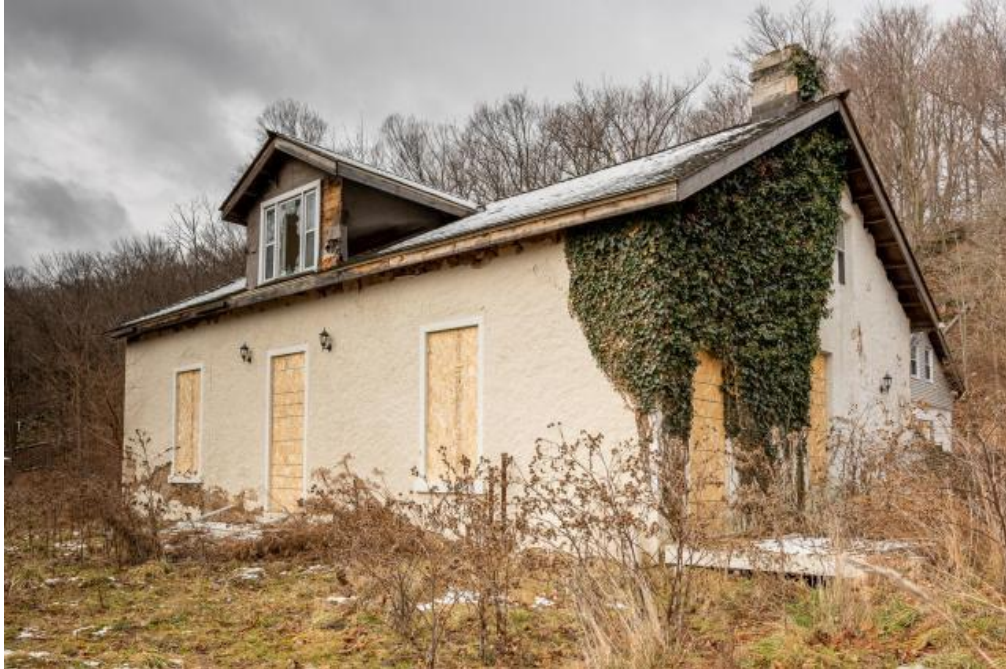
Main house south (front) elevation before the fire (2020)

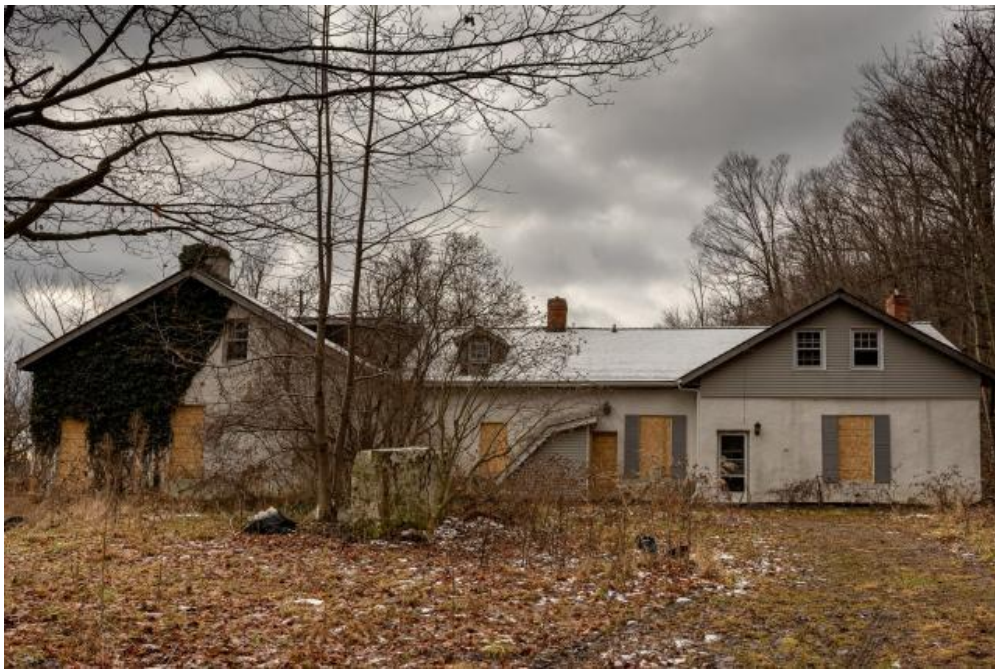
Main House east (side) before the fire (2020)

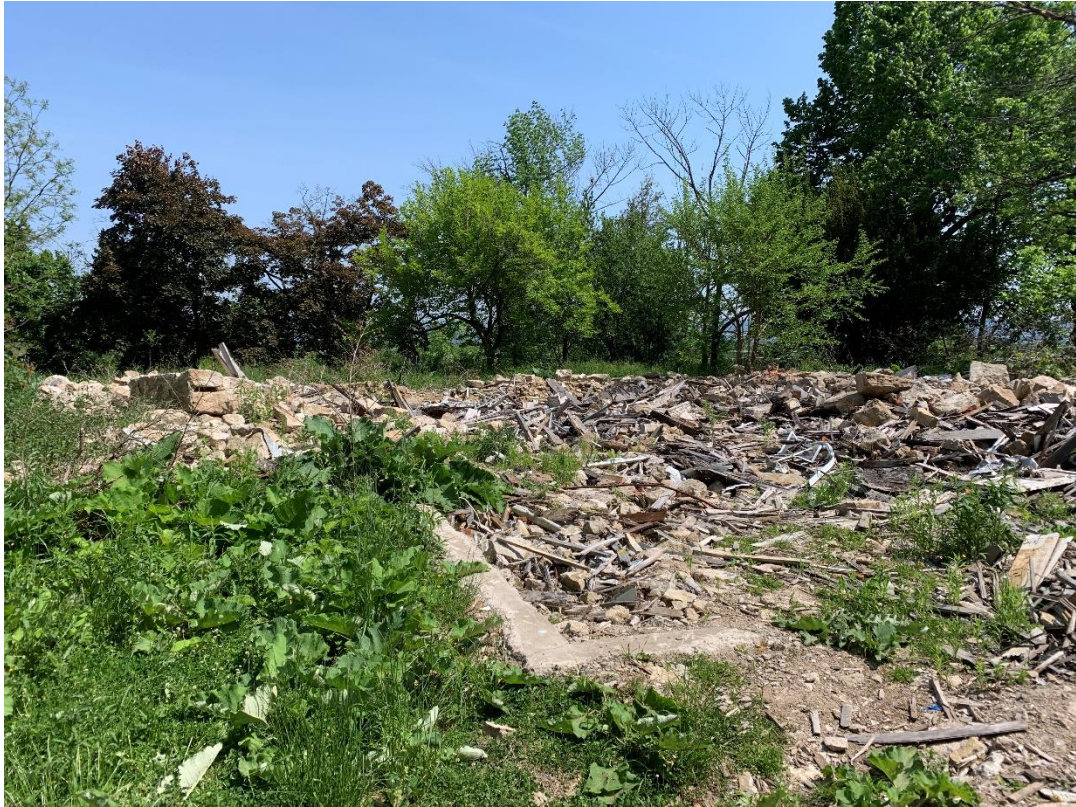
Demolished main house after the fire -View south towards Burlington Bay

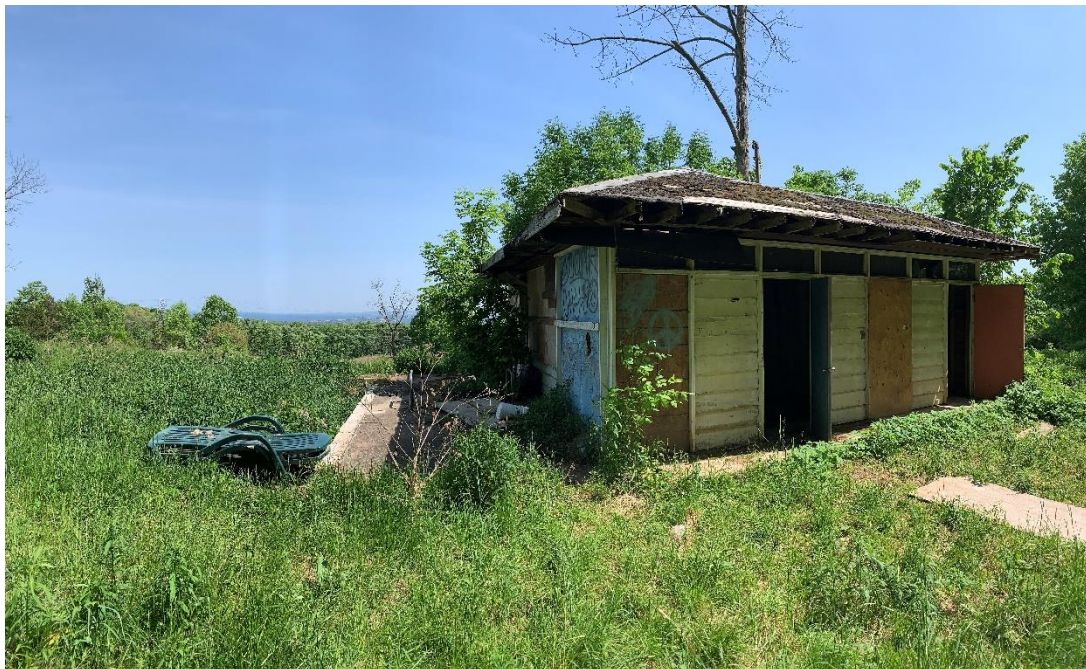
Cabana Building (No heritage significance)

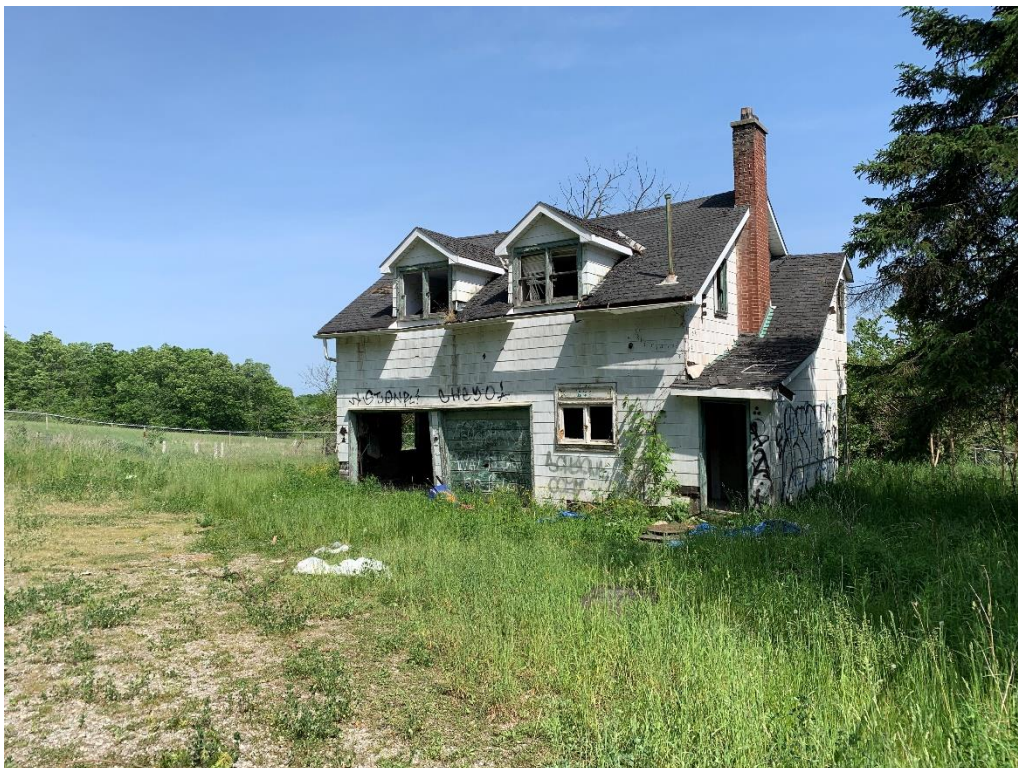
Accessory Building #2 (No heritage significance)
