Description of Property	
Street Address	1437 Elgin Street
Lot/Concession	Plan 74, Part Lot 57
Common Name	The David Bastedo House
Photo(s)

Date of Site Visit	October 23, 2014
Associated Photos (Provided by the City or Historic Photos)

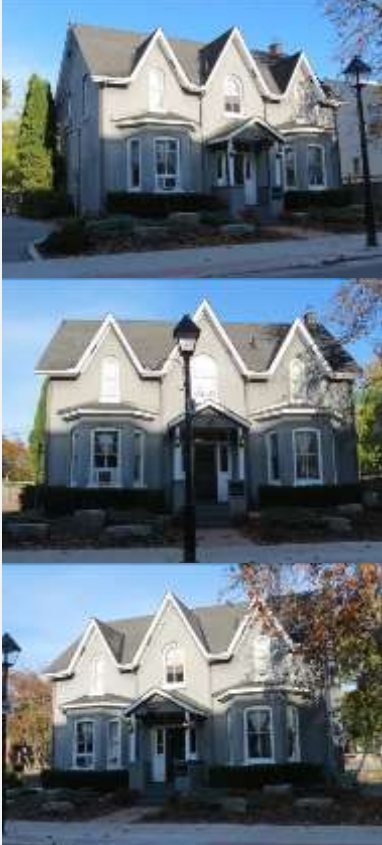
Style and Design	
Comments/Description	<ul style="list-style-type: none"> • Good example of a Victorian vernacular residence • Large one-and-a-half storey solid brick structure • End gabled roof • Symmetrical façade features three gables with arched windows • First storey features two projecting bay windows with segmented arched windows • Central front entrance with a divided transom and half sidelights • Windows have radiating voussoirs and dressed stone sills
Rating Category	• Good – 6
Rating Number	6/10

Integrity	
Comments/Description	<ul style="list-style-type: none"> • Brick has been painted • Original shutters and gingerbread removed • Small gabled portico added • Heritage award for maintenance in 1989
Rating Category	• Minor changes to heritage attributes but character retained – 8
Rating Number	8/10

Conclusions	
Total Ranking Number	78/100
Recommendation	<ul style="list-style-type: none"> Property should remain on the Municipal Heritage Register
Discrepancies Identified	
Further Research Required for Register	
Sources Consulted	<p>LACAC "1437 Elgin Street"</p> <p>Burlington Post. "Bastedo farmhouse carries link to city's beginnings" Accessed online at: http://www.insidehalton.com/opinion-story/2987850-bastedo-farmhouse-carries-link-to-city-s-beginnings/</p>

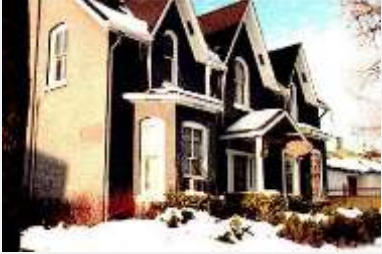
<p>Caption: 1437 Elgin Street, ca 1989 Source: Burlington Historical Society Digital Collections Accessed at: http://vitacollections.ca/burlingtonhistoricalsociety/7953/data?n=16</p>
