Asset Management Workshop

Committee of the Whole – January 31, 2019

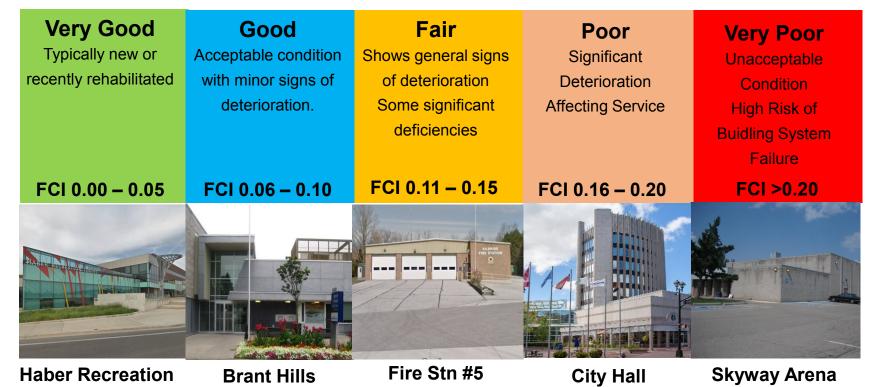
Current Asset Condition – Facility Condition Index (FCI)

FCI is the de facto industry standard for benchmarking building condition across a portfolio of buildings.

Very Goo Typically new recently rehabili	or	Good Acceptable condition with minor signs of deterioration.	Fair Shows general signs of deterioration Some significant deficiencies	Poor Significant Deterioration Affecting Service	Very Poor Unacceptable Condition High Risk of Buidling System Failure
FCI 0.00 - 0	.05	FCI 0.06 - 0.10	FCI 0.11 - 0.15	FCI 0.16 - 0.20	FCI >0.20
	Cond	ition Grade	Buildings	% by Square Metres	
	Very 6	iood	25	33.2%	
	Good		13	9%	
	Fair		15	14.1%	
	Poor		15	20%	
	Very P	oor oo	41	23.7%	
	Total		109	100.00%

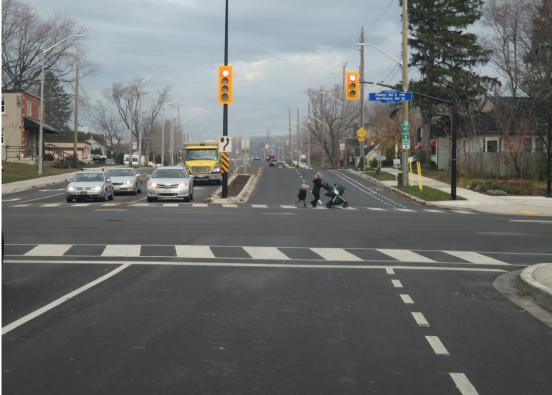
- Pavements:
 - Pavement management system implemented in 1995
 - Road segments mapped in GIS
 - Contracted condition assessments every 5 years (ARAN Vehicle)
 - Annual spring road tours to validate condition deterioration

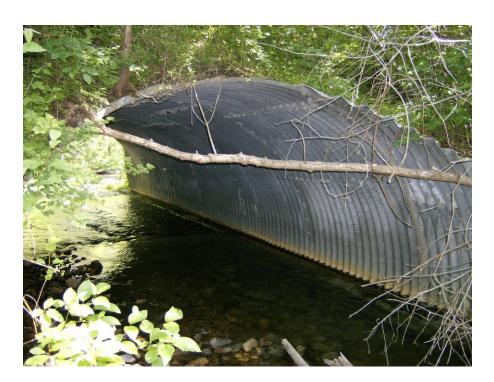
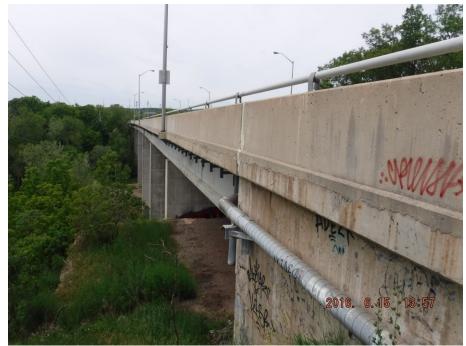
- Bridges & Culverts:
 - Inventory data for Bridges & Culverts is managed in the GIS
 - Structures inspected every 2 years as per provincial legislation (OSIM)
 - Inspections generate a Bridge Condition Index (100 = Excellent, 0 = Failed)

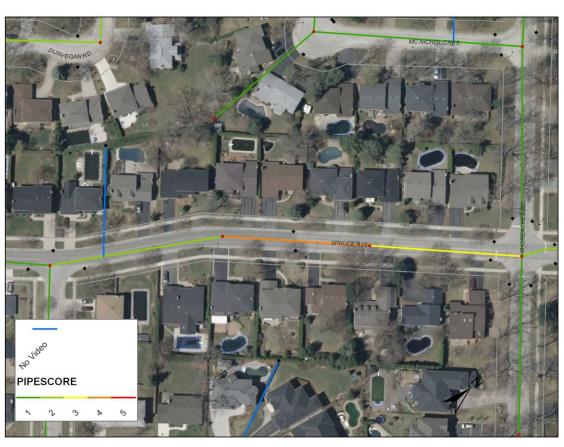
- Storm Sewers
 - Storm sewer lines and structures mapped in GIS
 - Preventative CCTV inspections, pipes inspected on 15 year cycle
 - Inspections generate a PipeScore
 - Thematically visualized in GIS
 - Inspection reports linked to Storm lines in GIS

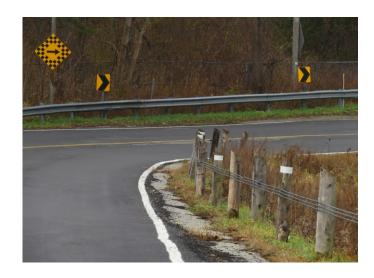
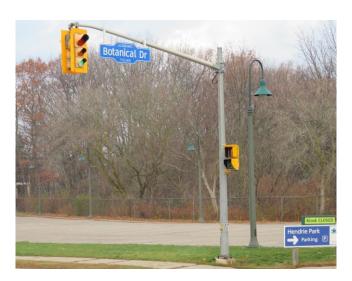
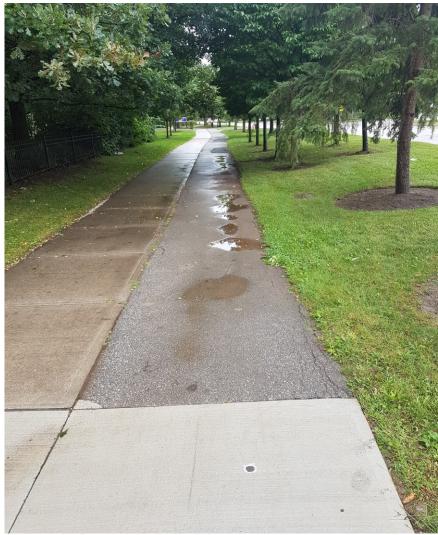
- Pedestrian network
 - Inventory managed in GIS
 - Condition assessment by Roads and Parks Maintenance
 - Tablets used to collect point defects
- Other Linear Assets (Traffic Signals, Street Lights, Guiderails, etc.)
 - Inventory managed in GIS
 - Condition assessments by Transportation Operations

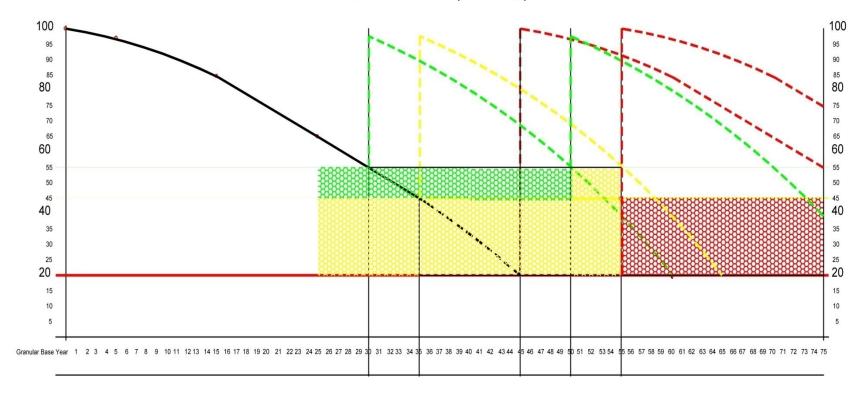
RC01 - Local Residential (with curbs)

- The Decision Support acts as the planning level tool designed to map out the life cycle costs for all Linear assets
- City staff designed custom life cycle events
- Establish cost for the rehabilitation treatments
- 60 year prediction horizon
- Utilize source system data
- "Made in Burlington" solution
- Established in house expertise
- Outputs are meaningful and can be relied upon to make financial decisions.

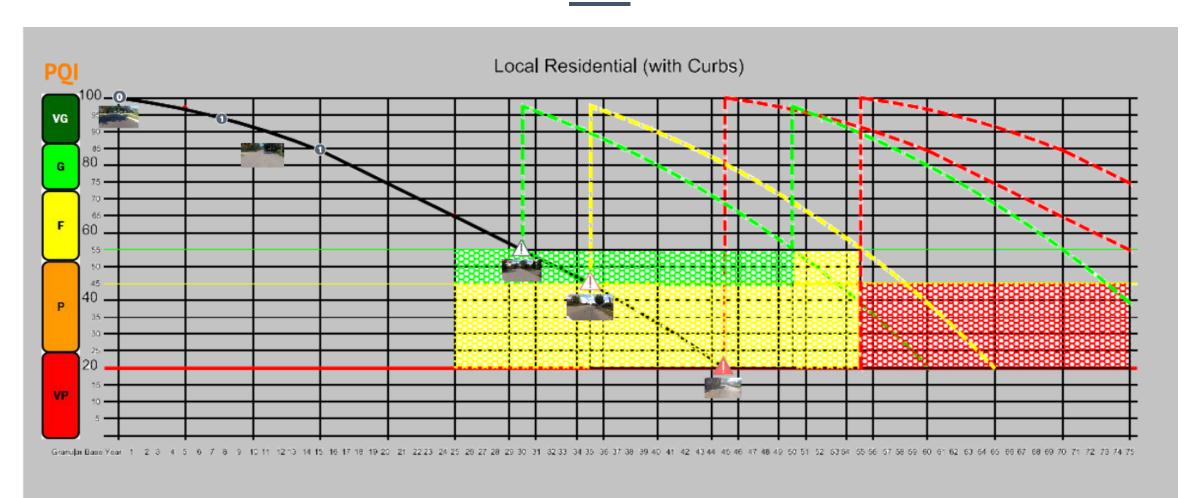
Age of Granular Base (Years)
