2477 QUEENSWAY DRIVE - HERITAGE IMPACT STUDY

ATA Architects Inc. was retained to undertake the Heritage Impact Study of the property listed as 2477 Queensway Drive, Burlington, ON, to evaluate the impact of the proposed development or site alteration on the existing heritage resource(s) and to recommend a conservation plan for the resource(s).

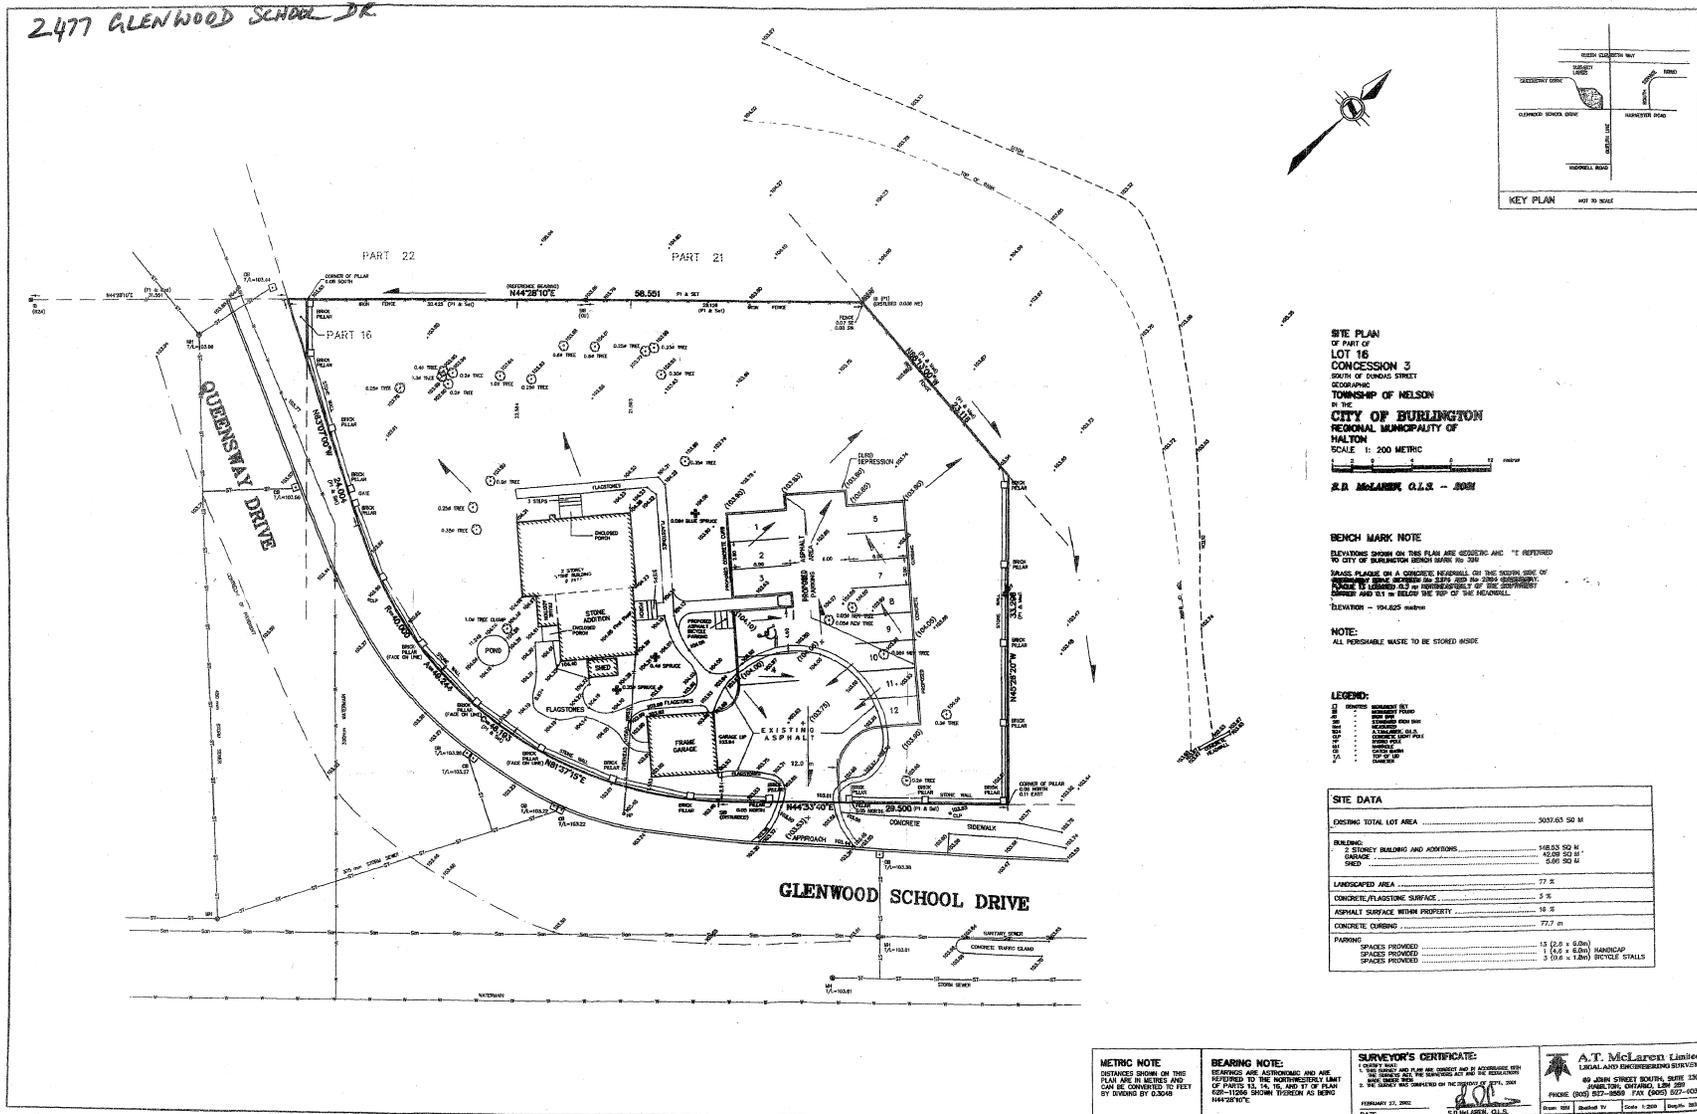
Scan of the existing site plan

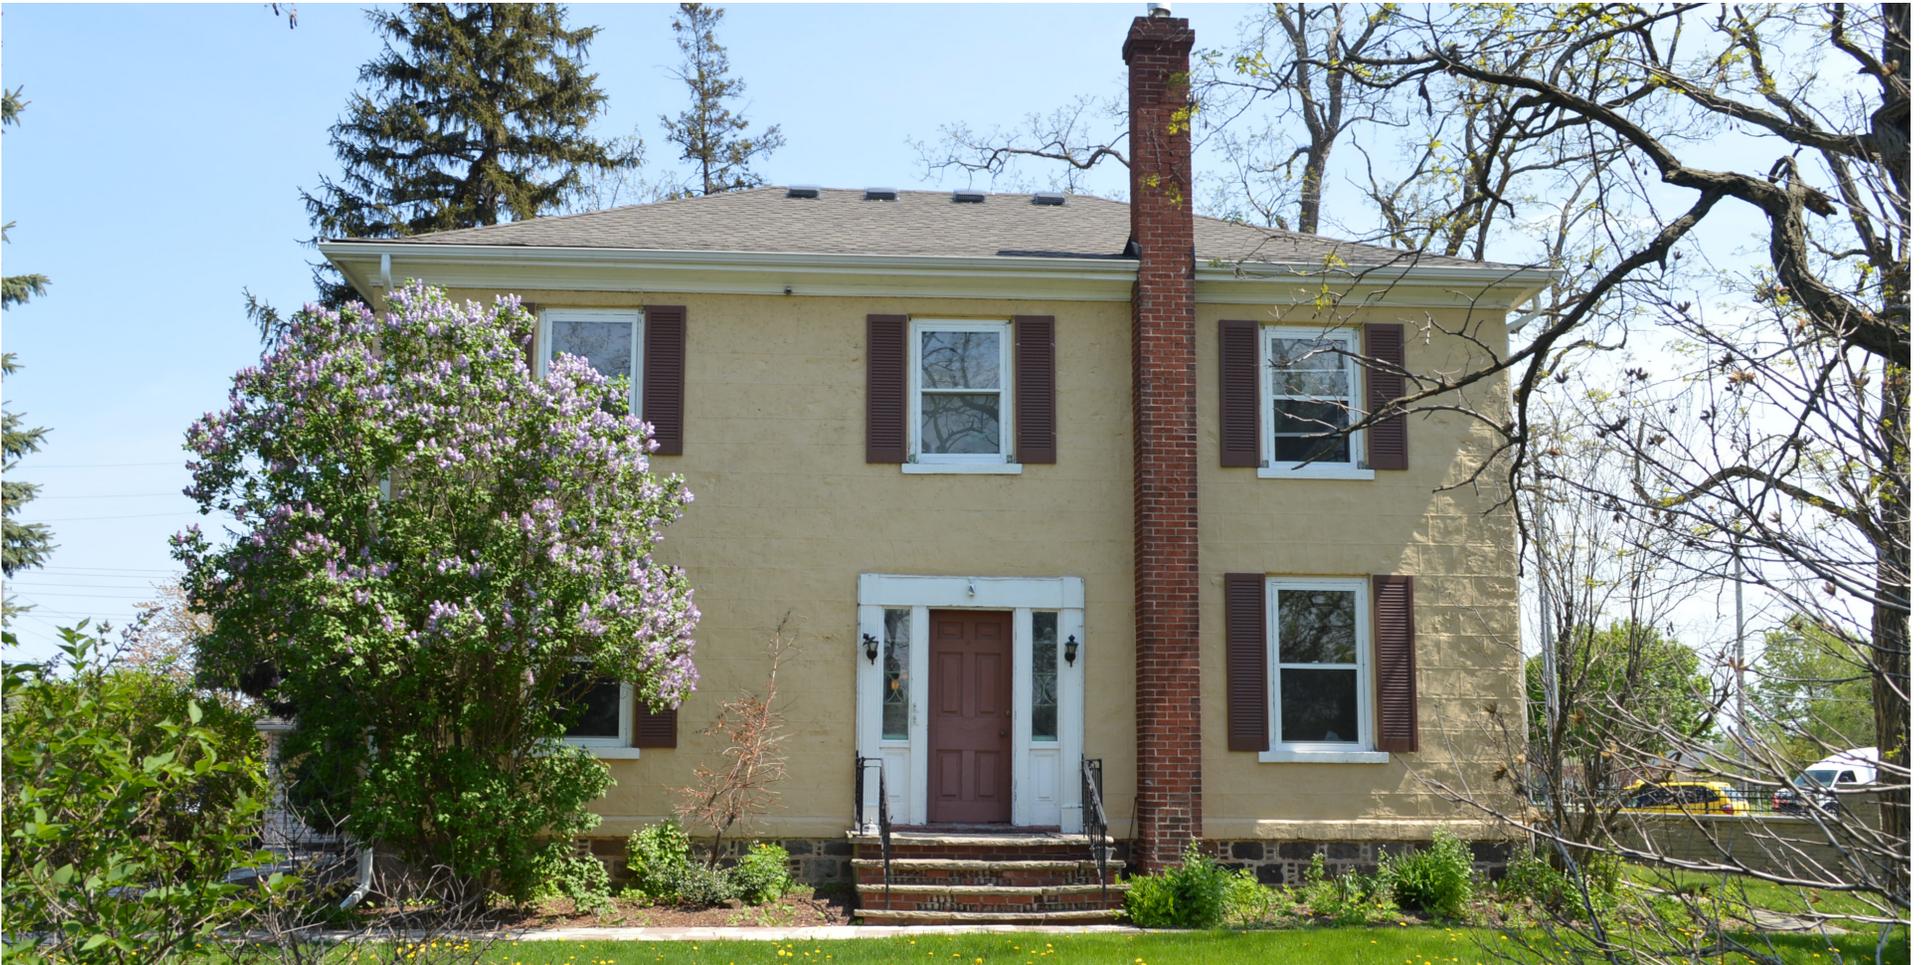
3-bay Symmetrical North Elevation, originally the front of the house

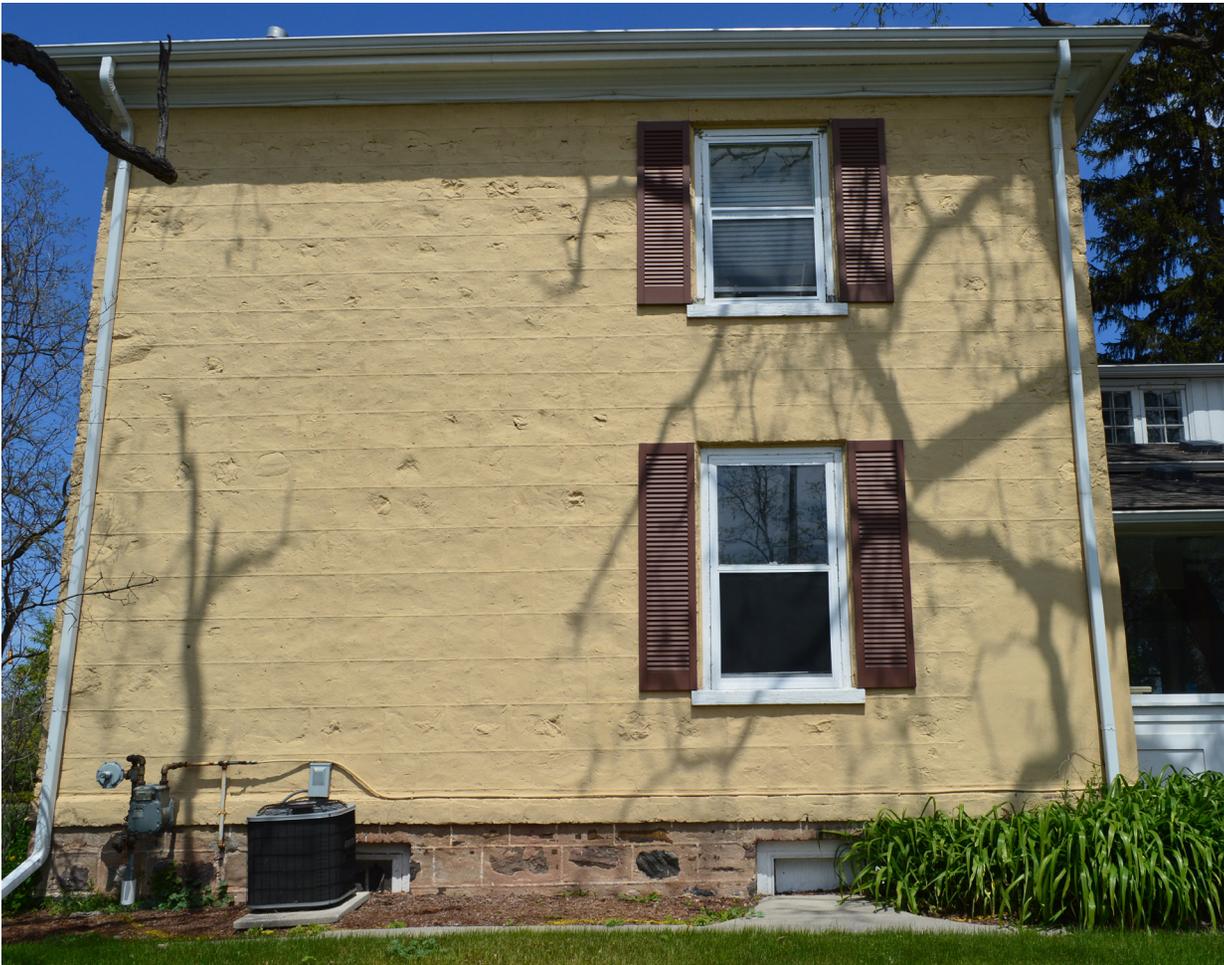
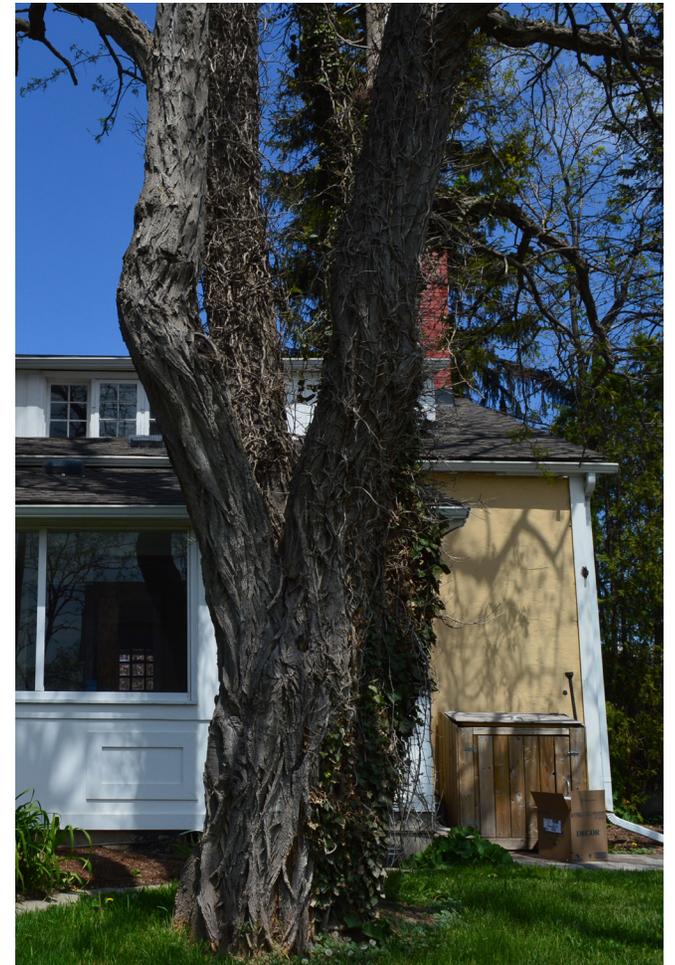
Views of the Western facade with 1 1/2 storey addition

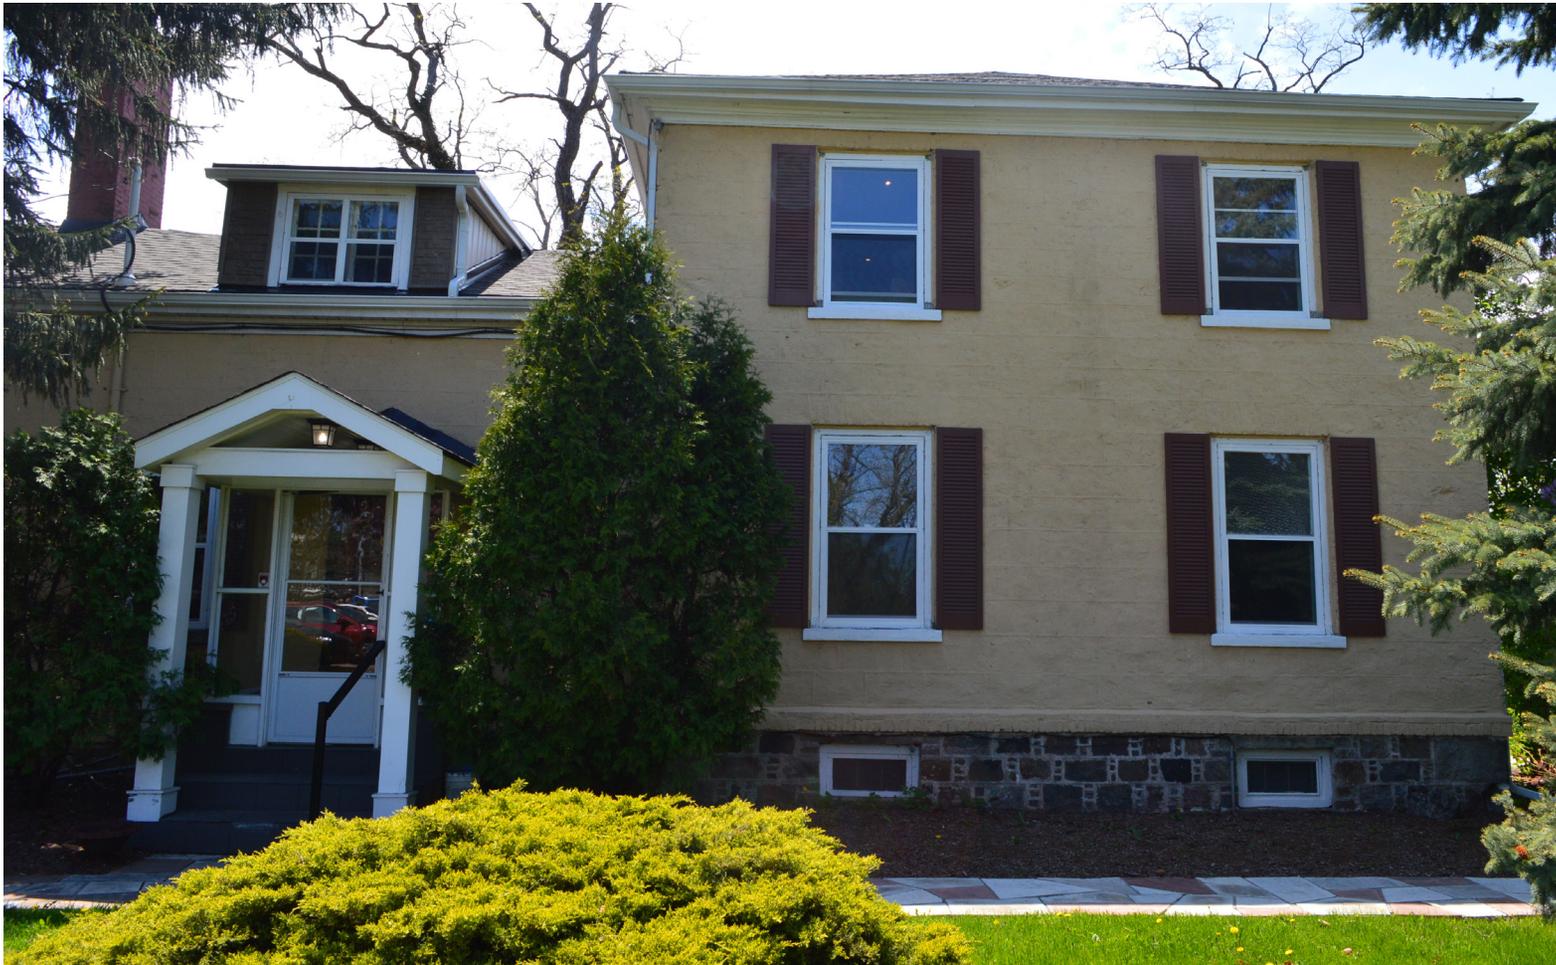
East Elevation, currently used as the main entrance

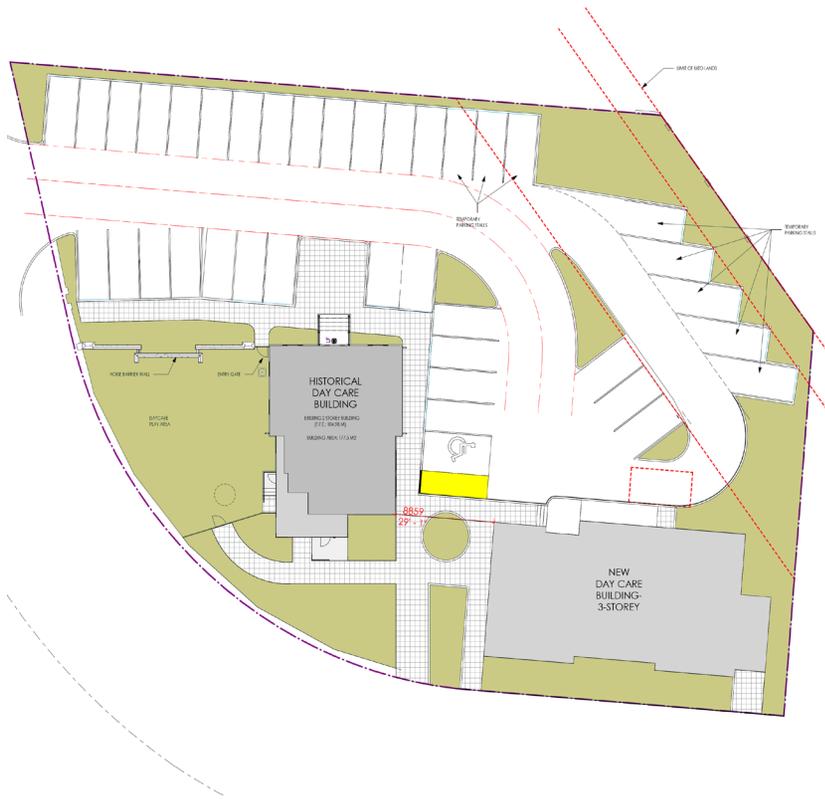
SITE PLAN- 3-STOREY NEW BUILDING

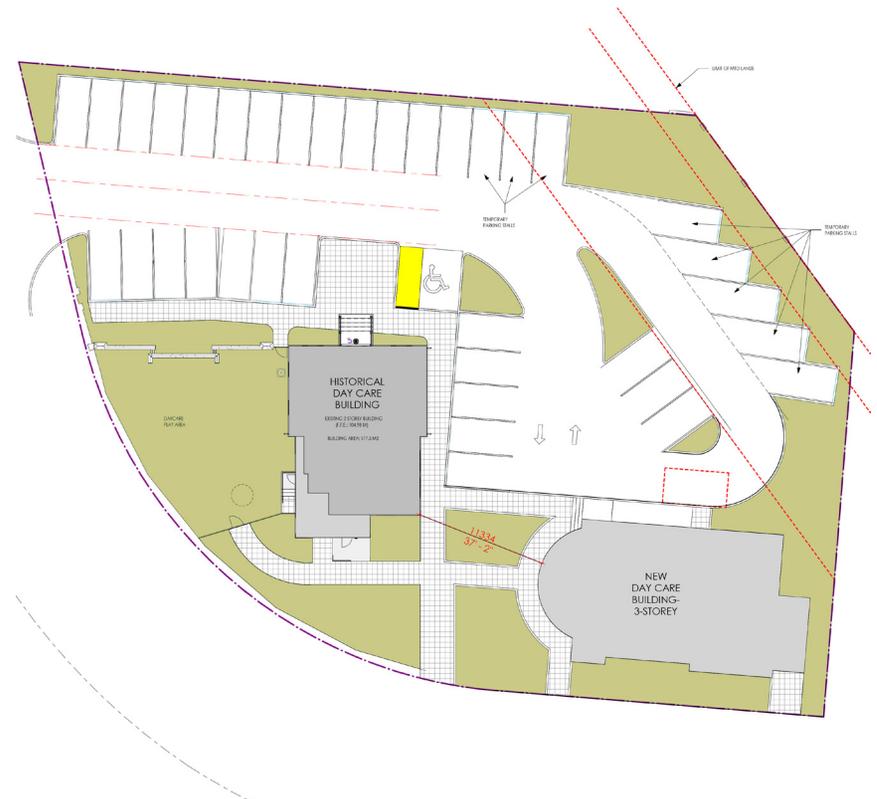
SITE PLAN- 4-STOREY NEW BUILDING

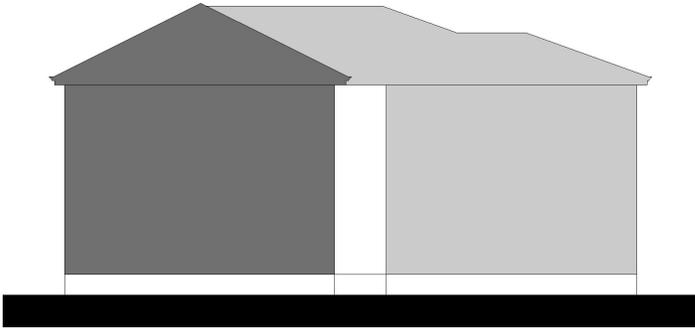
1. Blend the roof of the addition as an extension of the existing roof

The proposed design utilizes Option 1

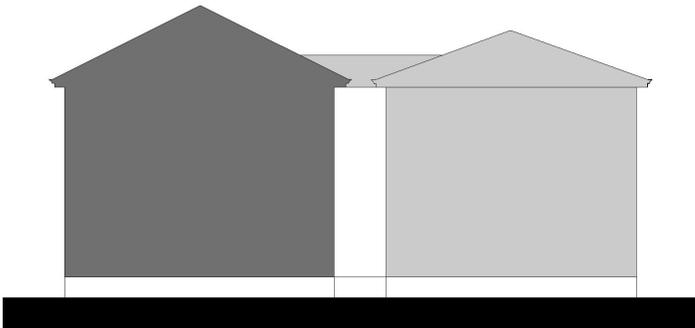
2. Separate the roof of the addition from the roof of the original house with a separate roof form.

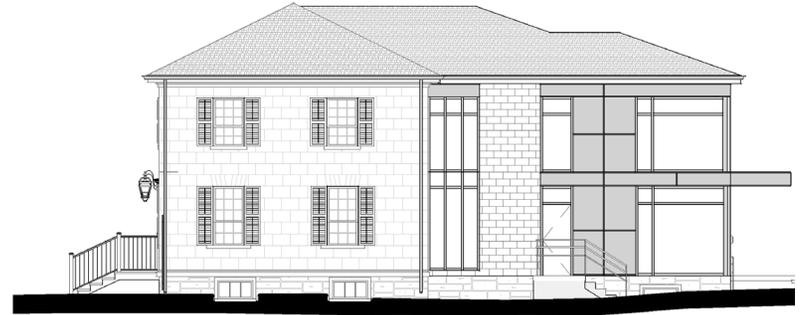
NEW WEST ELEVATION

On the west elevation where the new addition meets the heritage house, the addition is separated by a section of glazing, vertically divided to provide scale and separation.

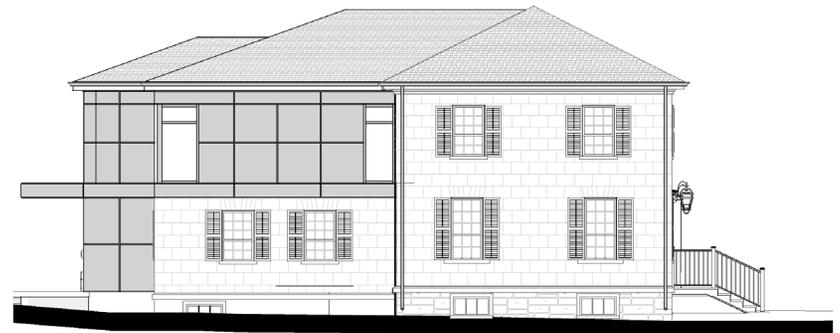
NEW EAST ELEVATION

On the east side the existing wall meets the heritage house as originally constructed. The need for barrier free access meant that the exterior of the east side was not functional and had inadequate space for a compliant ramp.

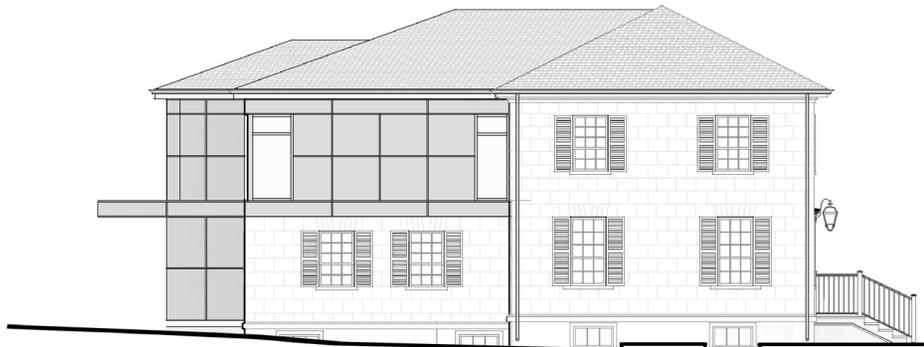
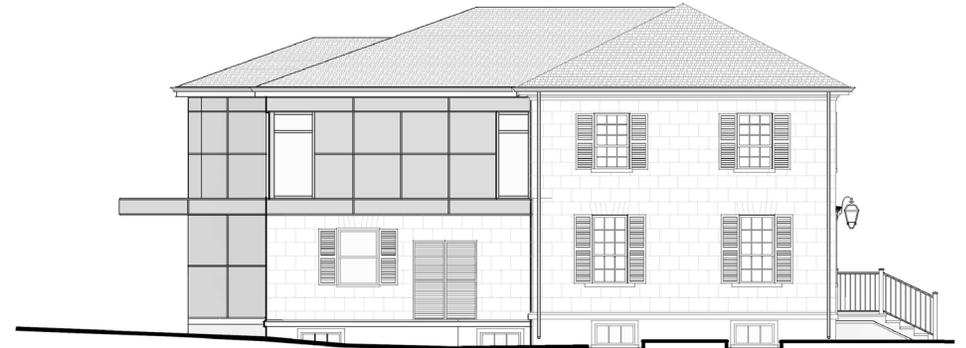
B) EXISTING CONDITION CONTINUED TO SECOND STOREY - HERITAGE WINDOWS

The stone and stucco wall of the existing addition is extended to the metal cornice band, with heritage windows on both levels with no shutters.

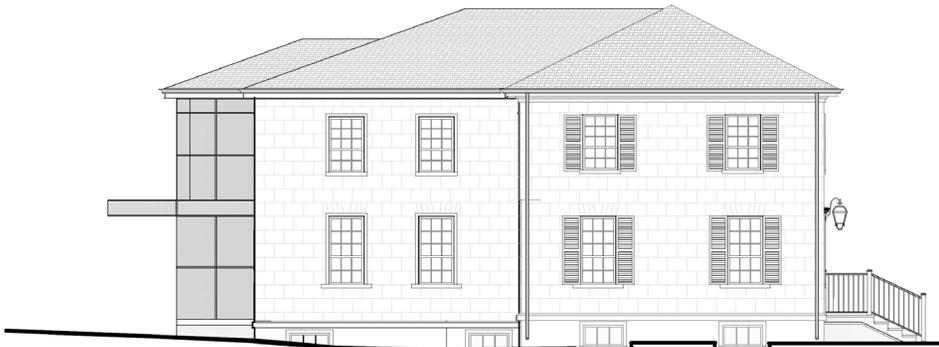
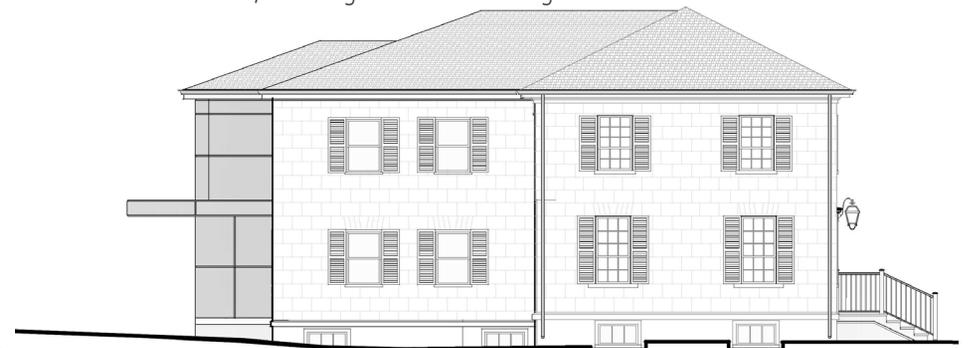
D) EXISTING CONDITION CONTINUED TO SECOND STOREY - NEW WINDOWS

Similar to B, but the windows don't have mullions to differentiate from the heritage house. The shutters remain, matching those of the heritage house.

Note: If B or D are followed, similarly the window and wall treatment would extend not just one storey but two stories to the cornice on the easterly half of the south elevation.

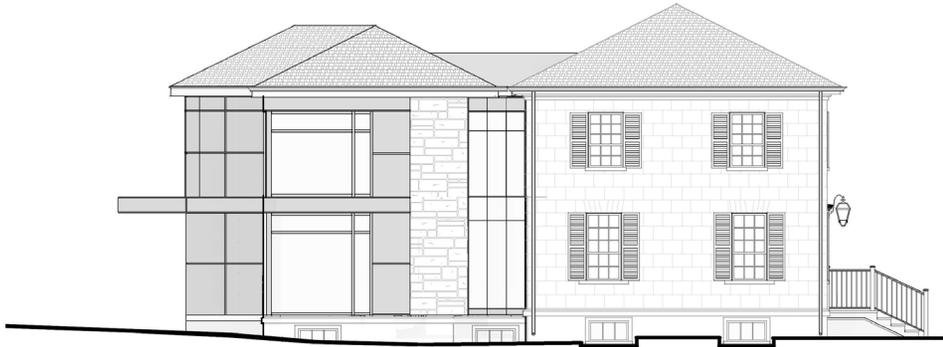
- E) The option not initially considered was the removal of the existing exterior stone walls of the early addition and making the east and west views of the additions symmetrical utilizing the stone reclaimed in lieu of Adair limestone or Ariscraft Architectural stone.
