Heritage Impact Assessment

1134 Plains Road East

April 2021

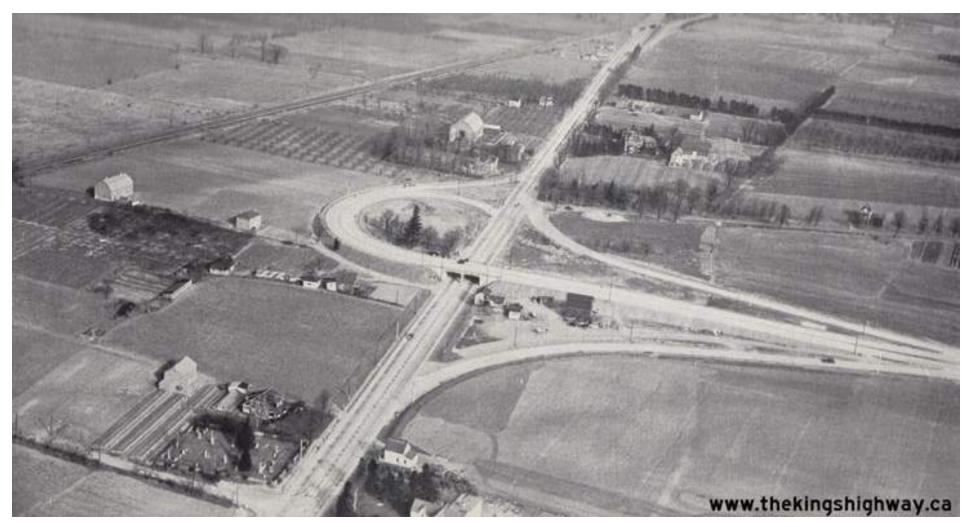
1937, TheKingsHighway.ca The History of Ontario's King's Highways

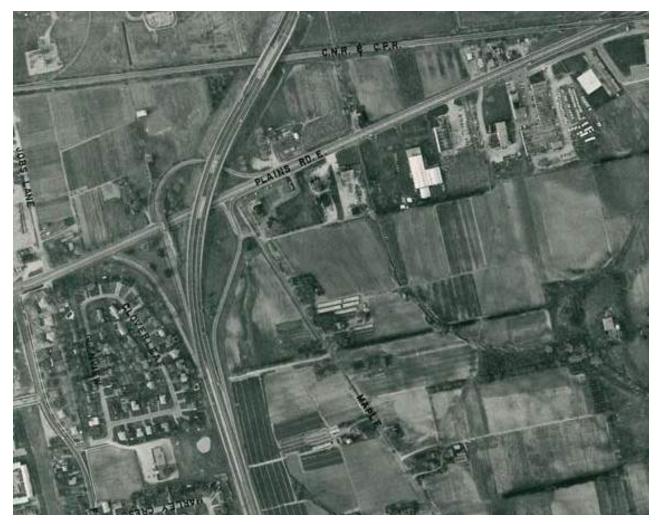
1974, TheKingsHighway.ca The History of Ontario's King's Highways

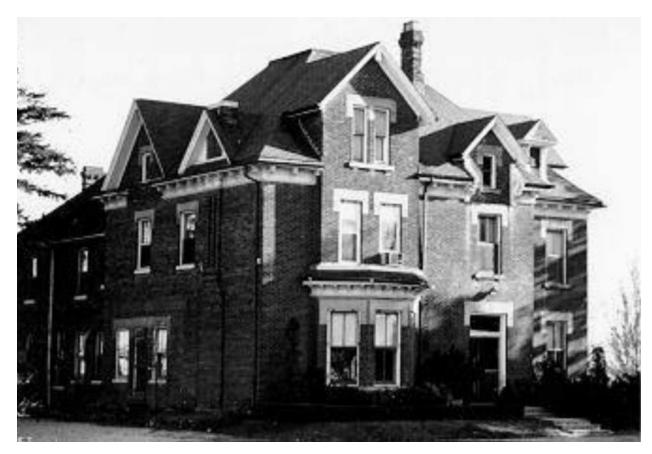
Date: 1974 at 1134 Plains Road East. Photographed by: Paul Beneteau Source: Burlington Historical Society Digital Collections

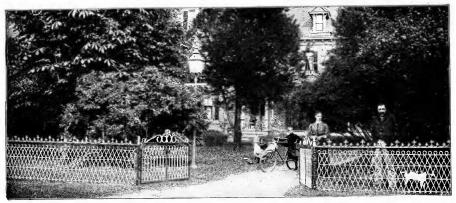
RESIDENCE OF C. G. DAVIS, ESQ., FREEMAN. Built on the old homestead, which has been in the possession of the family for one hundred years.

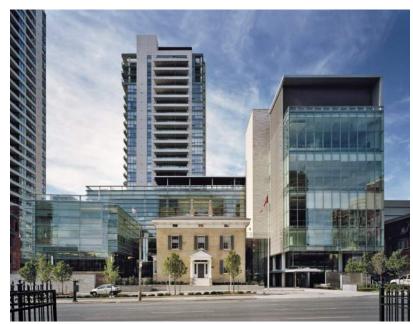
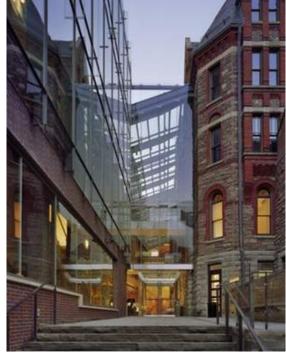
Gladstone Library. Sympathetic contemporary design adjacent to a significant heritage resource: massing, height, facade composition, materials of contemporary additions respect and are distinct yet complementary to heritage resource. Toronto, ON.

Royal Conservatory of Music. Sympathetic contemporary design of link to a significant heritage resource. Toronto, ON.

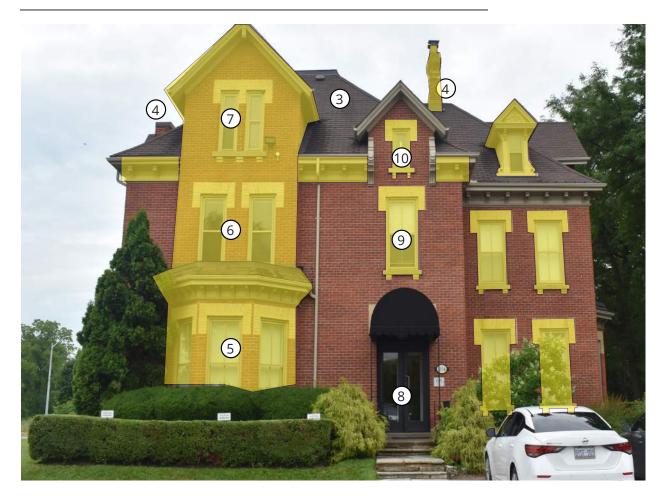
Front Elevation

Legend:

- 1 Rusticated cut-stone foundation
- 2 Asymetric footprint, form and plan

8 Front door with stained glass transom

- (9) Second floor window centered on front door
- (10) Third level stilted gabled dormer centered on front door and window below

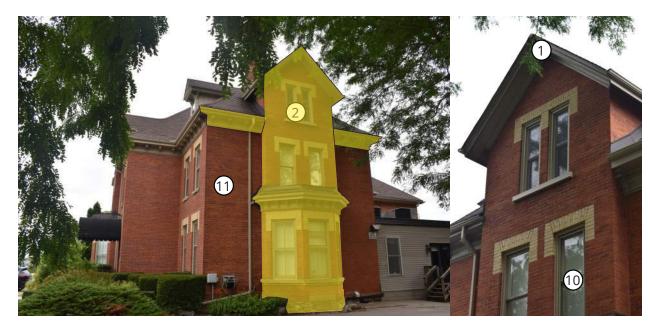
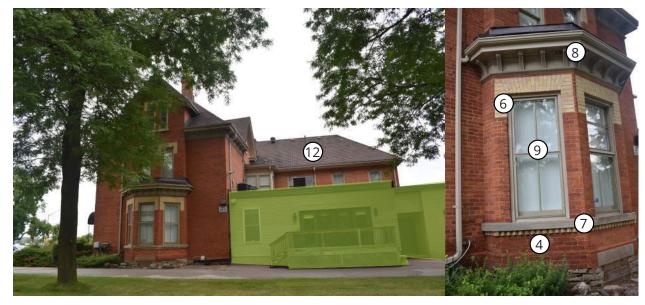
1134 Plains Road East South Elevation Legend: (1) Central gabled dormer with central rectangular window General attributes: (2)Punched windows (3) Exterior red/orange brick: 3 3/8"x 8 1/4" (4) Yellow saw tooth brickwork (5) 2 brick chimneys and dichromatic detailed brickwork Windows with brick flat arches and dressed (6) (7) stone lug sills 8 Painted wood paired decorative brackets at soffits on second floor and bay window Two storey brick addition: 9 - segmental brick arch windows 10 - one over one windows (1) (12) - orange molded brick construction - hip roof (13) - form, massing and location connected at an L- with main house (14)

- field stone foundation

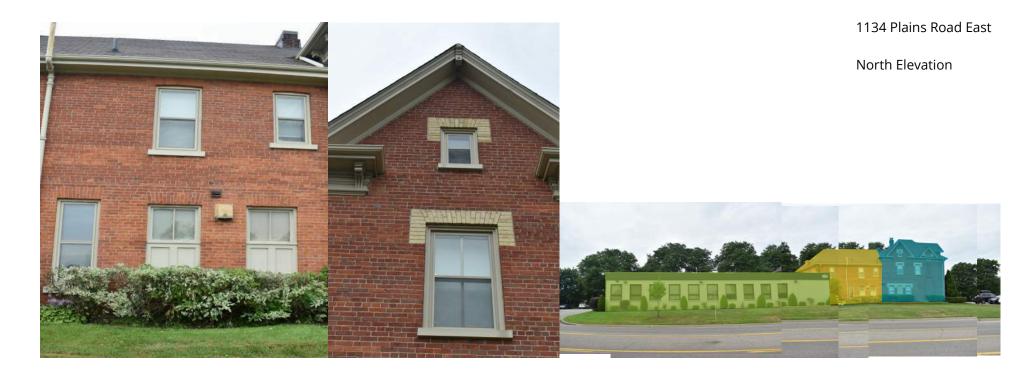
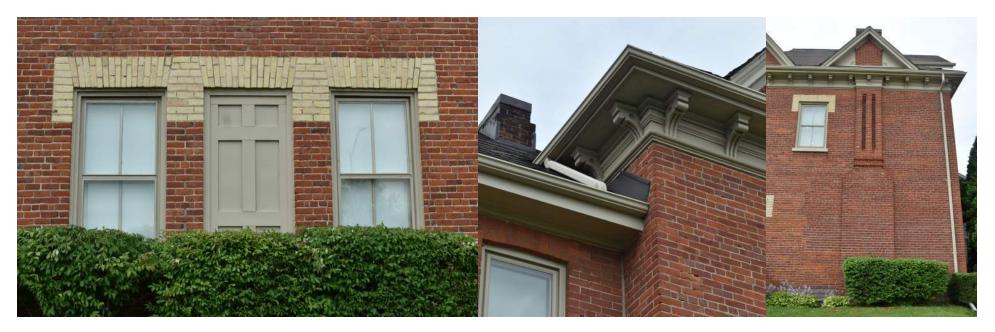
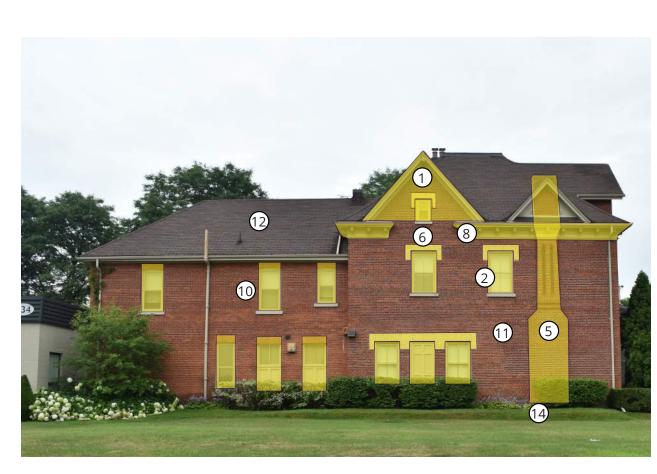
1134 Plains Road East
North Elevation
Legend:
 Central gabled dormer with central rectangular window
General attributes:
(3) Exterior red/orange brick: 3 3/8"x 8 1/4"
 (4) Yellow saw tooth brickwork (5) 2 brick chimneys and dichromatic detailed
brickwork
6 Windows with brick flat arches and dressed
 (7) stone lug sills (8) Painted wood paired decorative brackets at
(8) Painted wood paired decorative brackets at soffits on second floor and bay window
Two storey brick addition:
9 - segmental brick arch windows
10 - one over one windows
1) - orange molded brick construction
12 - hip roof
$\tilde{(13)}$ - form, massing and location connected
at an L- with main house

- (14)
- field stone foundation
