NOTE:
Vegetation inventory undertaken by Nate Torenvliet, ISA Certified Arborist (ON-1782A) on May 29, 2019.

PROJECT
Residential Development
2294-2300 Queensway Drive
Burlington, ON

SHEET
Vegetation Management Plan **L-1**

SHEET
Vegetation
Management Plan

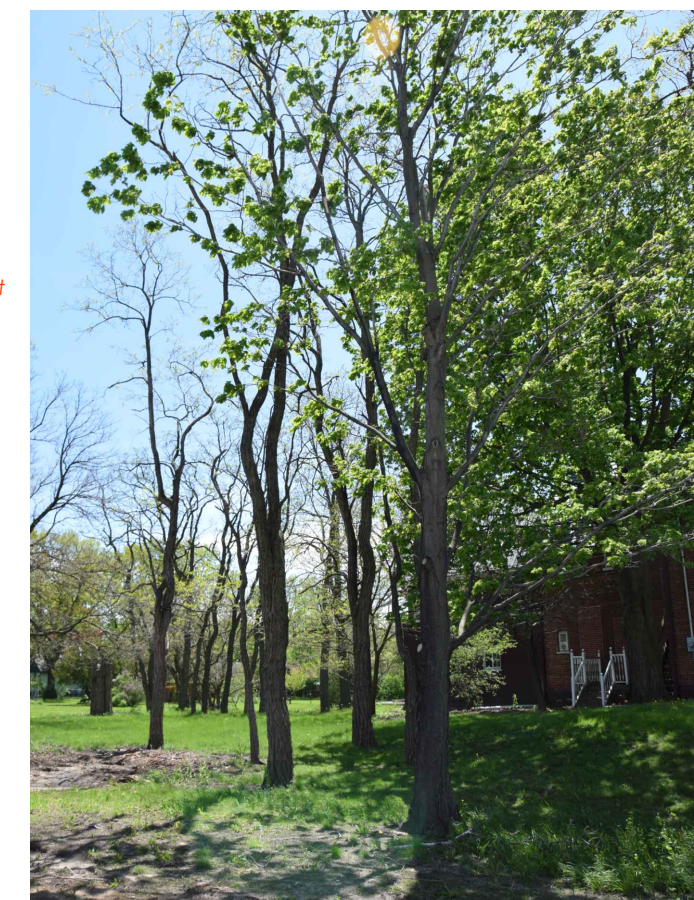
Tree #5 and #6

5	Sugar Maple	Acer saccharum	36	C	Poor	Dead in canopy	Grading within root zone due to proposed building	Shared	SAVE - 23% TPZ encroachment
6	Black Locust	Robinia pseudoacacia	40	C	Good	Off property	Grading within root zone due to proposed building	Private-Neighbouring	SAVE - 4.5% TPZ encroachment
7	Black Locust	Robinia pseudoacacia	36	C	Good	Off property	Grading within root zone due to proposed driveway	Private-Neighbouring	SAVE - 33% TPZ encroachment
8	White Mulberry	Morus alba	50/40/45	C	Fair	Off property	Grading within root zone due to proposed building	Private-Neighbouring	SAVE - 21% TPZ encroachment
9	Black Walnut	Juglans nigra	40	C	Good	Off property	Grading within root zone due to proposed driveway	Private-Neighbouring	SAVE - 3% TPZ encroachment
10	White Pine	Pinus strobus	50	C	Fair	In decline. Off property.	Grading within root zone due to proposed building	Private-Neighbouring	SAVE
11	Colorado Spruce	Picea pungens	40	D	Good	Off property	Grading within root zone due to proposed building	Private-Neighbouring	SAVE

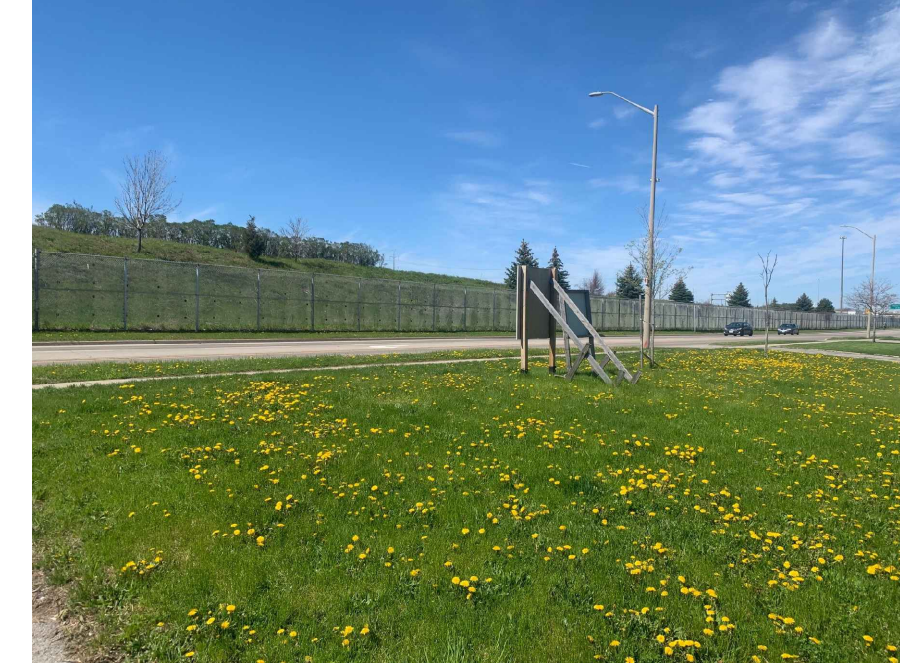
Tree #12 - #14 (#14 Previously Removed)

12	Kentucky Coffee Tree	Gymnocladus dioica	3	D	Fair	-	-	City	SAVE
13	European Hornbeam	Carpinus betulus	3	D	Good	-	-	City	SAVE
14	London Plane	Platanus x acerifolia	3	D	Fair	-	Grading within root zone due to proposed driveway	City	PREVIOUSLY REMOVED
