# Cultural Heritage Landscape #1- Foot of Brant Street

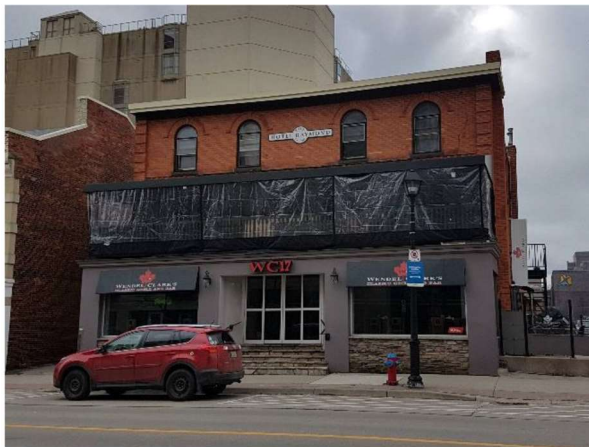
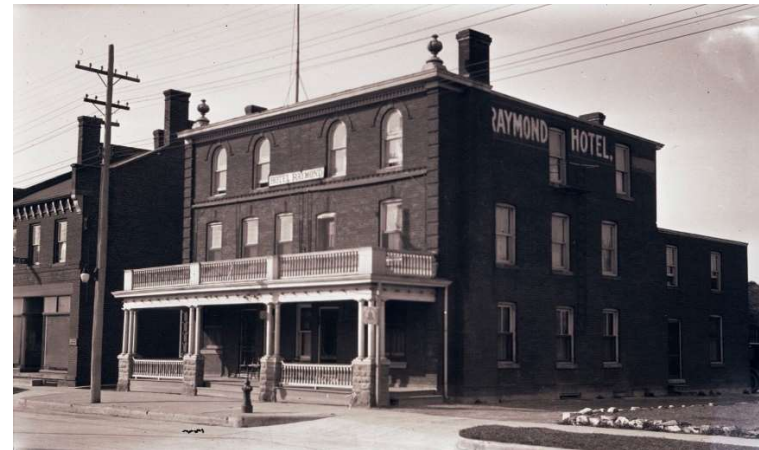
## 1. 380 Brant Street

Legal Description	PLAN 92 BLK Y LOT 7 PT LOT 6
Historic Land Use	Hotel ("Raymond Hotel")
Date of Construction	1860
Architectural Description	Mid 19 <sup>th</sup> C Italianate style commercial building Masonry construction, corner quoins, round-arched windows with keystones, segmental arched windows at second storey, masonry chimneys, cubic massing
Heritage Status	None
Assessment	(✓) Qualifies for Heritage Register

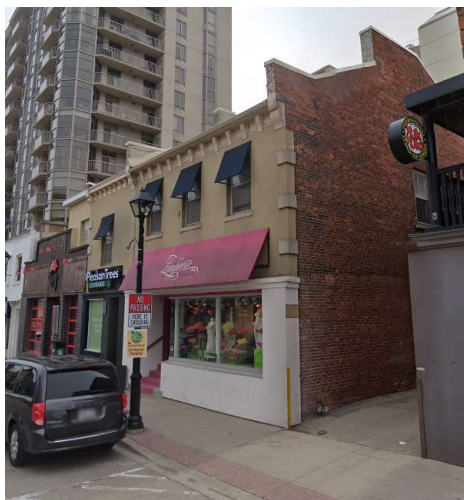
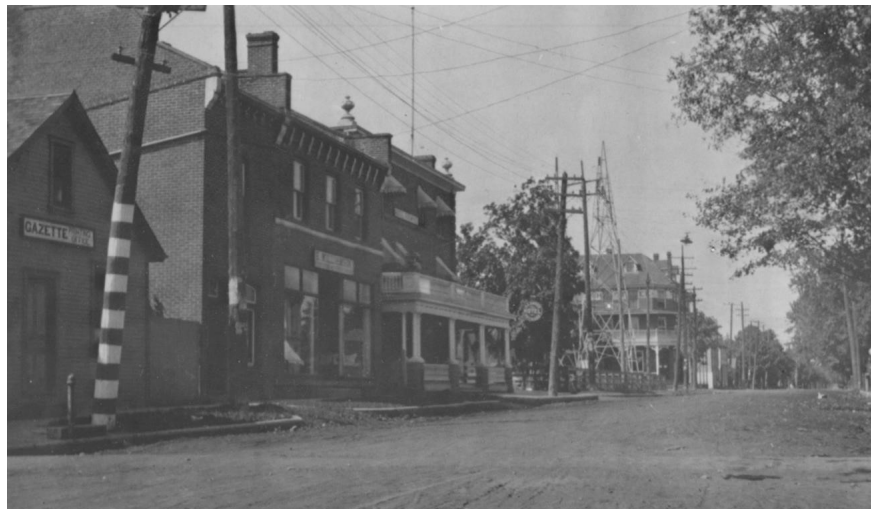
## 2. 372-374 Brant Street

<b>Legal Description</b>	PLAN 92 BLK Y PT LOTS 5,6
<b>Historic Land Use</b>	372- Undertaker, 374- Furniture Store
<b>Date of Construction</b>	Pre 1910
<b>Architectural Description</b>	<p>Late 18<sup>th</sup> century or early 20<sup>th</sup> century commercial building.</p> <p>Gable roof and massing, masonry sidewalls, demising wall, cornice and decorative brackets are original.</p> <p>The façade was originally exposed brick, but is now covered in stucco. The formerly symmetrical storefront has been reconfigured with the entrance relocated to one side.</p>
<b>Heritage Status</b>	None
<b>Assessment</b>	(✓) Qualifies for Heritage Register

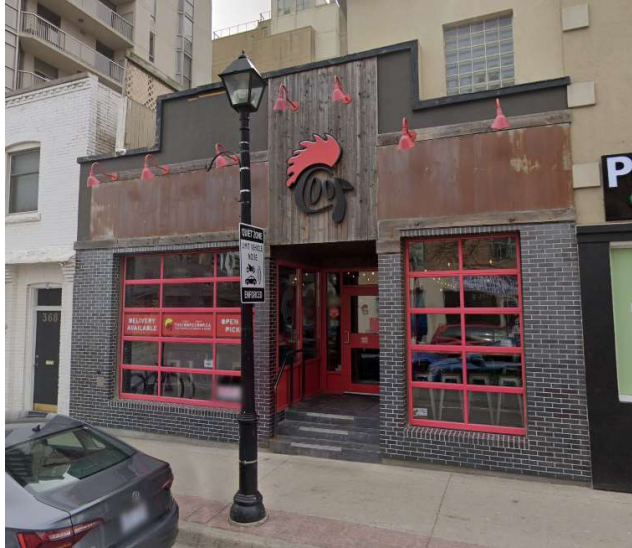
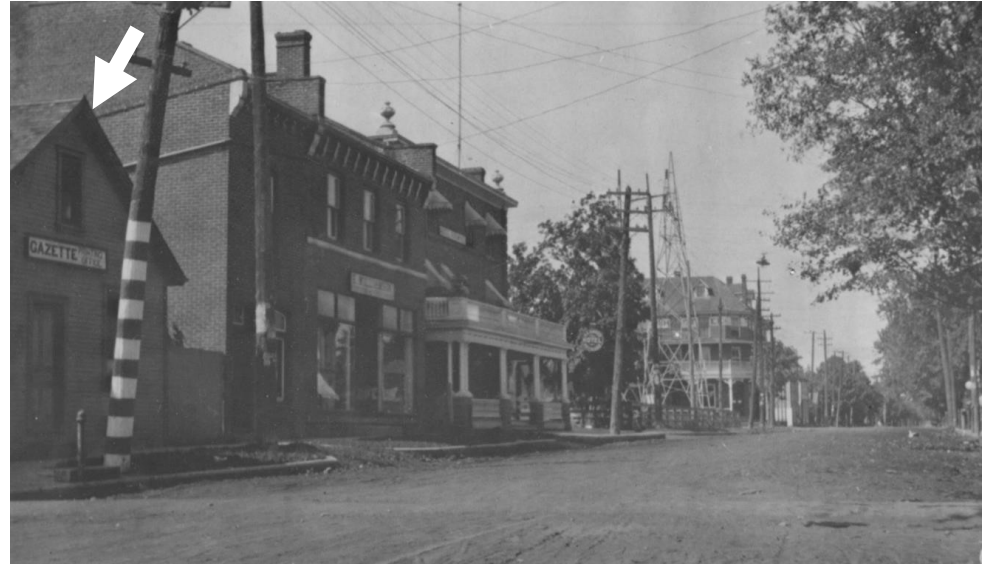
### 3. 370 Brant Street

Legal Description	PLAN 92 BLK Y PT LOT 4
Historic Land Use	Printing Office
Date of Construction	Post 1924
Architectural Description	1-storey brick commercial building, no distinguishing historic architectural features
Heritage Status	None
Assessment	(X) Not recommended for Heritage Register

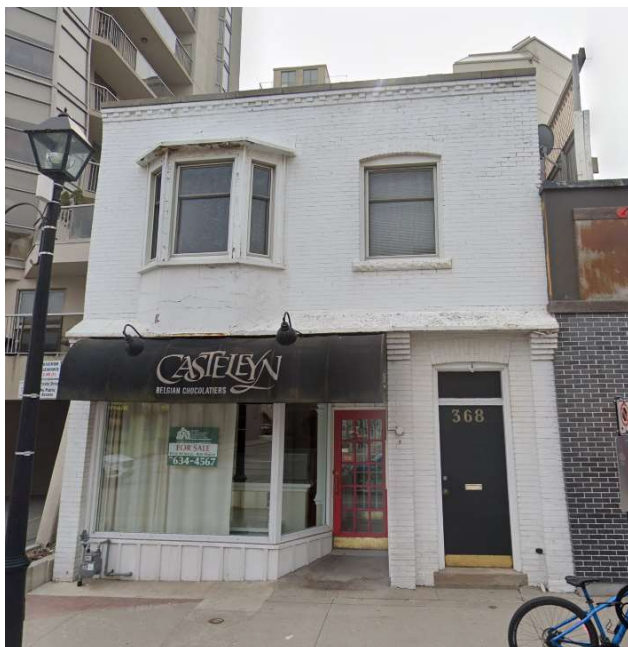
## 4. 368 Brant Street

<b>Legal Description</b>	PLAN 92 BLK Y PT LOTS 3,4
<b>Historic Land Use</b>	The Bell - Wiggins Boot and Shoe Store, The Parkin Barber Shop and Pool Hall
<b>Date of Construction</b>	1867
<b>Architectural Description</b>	Two-storey commercial building, dentilated cornice, segmental arched window and bay window at second storey, voussoirs above ground floor doorway, corbelled ground floor pilasters. Originally 1-storey, second storey added in 1902.
<b>Heritage Status</b>	Heritage Register, Non-designated
<b>Assessment</b>	(✓) Non Designated Heritage Register Property

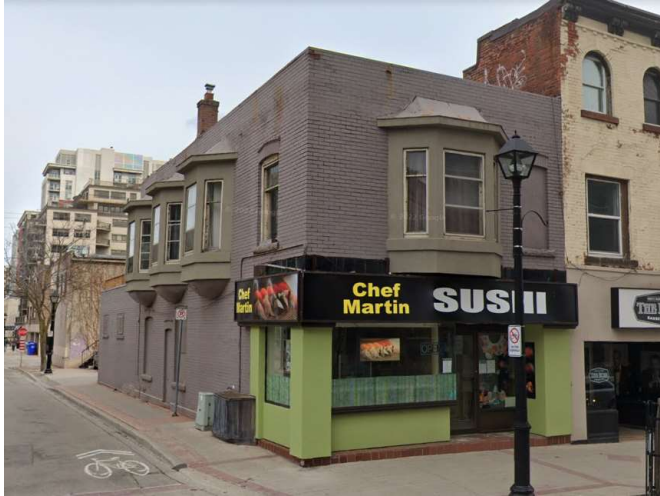
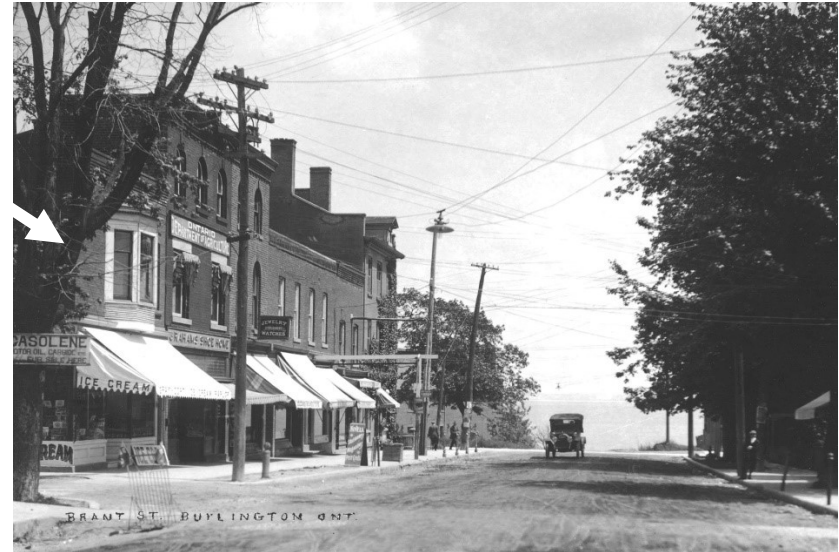
## 5. 361 Brant Street

<b>Legal Description</b>	PLAN 92 PT BLK M
<b>Historic Land Use</b>	The LePatourel Drug Store First Location
<b>Date of Construction</b>	1881
<b>Architectural Description</b>	Two-storey commercial building with oriel windows at the second storey and segmental arches over windows and entries at first and second storey. Ground floor reconfigured, upper storey oriel window details and wood construction now covered with stucco.
<b>Heritage Status</b>	Heritage Register, Non-designated
<b>Assessment</b>	(✓) Non Designated Heritage Register Property

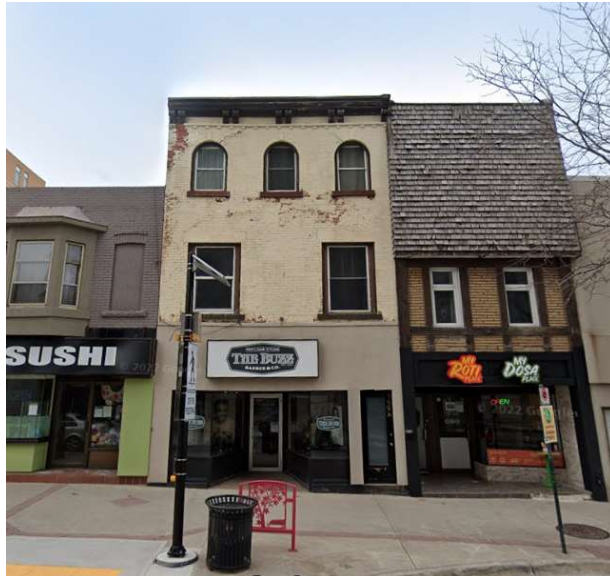
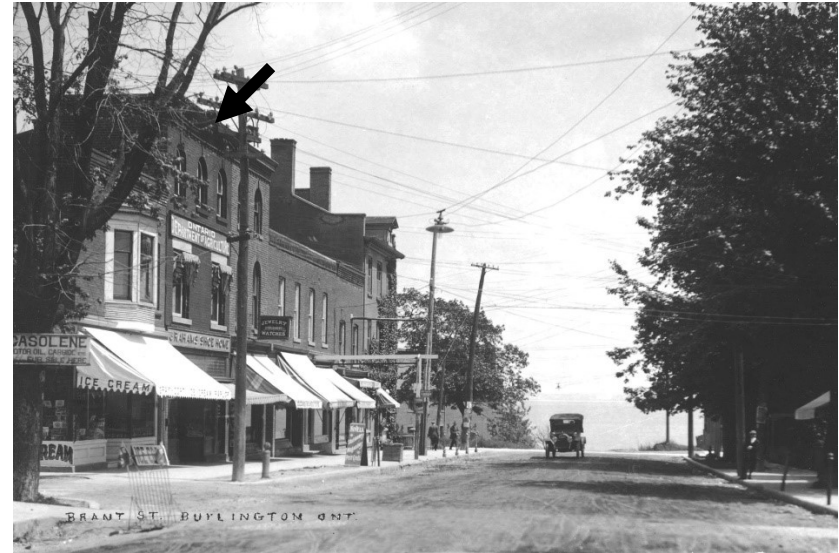
## 6. 359 Brant Street

<b>Legal Description</b>	PLAN 92 PT BLK M
<b>Historic Land Use</b>	Drugstore and Offices
<b>Date of Construction</b>	Pre 1910
<b>Architectural Description</b>	Three-storey commercial building with Italian renaissance design elements including round arched windows at third storey. Second storey originally had round arched windows. The arches and keystones of these windows are still visible in brickwork. The cornice with brackets is still intact along with the dentil course below the cornice brackets. The rectangular second storey windows are not original, but still over 100 years old. The storefront has been completely rebuilt and the transom window has been removed.
<b>Heritage Status</b>	None
<b>Assessment</b>	(✓) Qualifies for Heritage Register

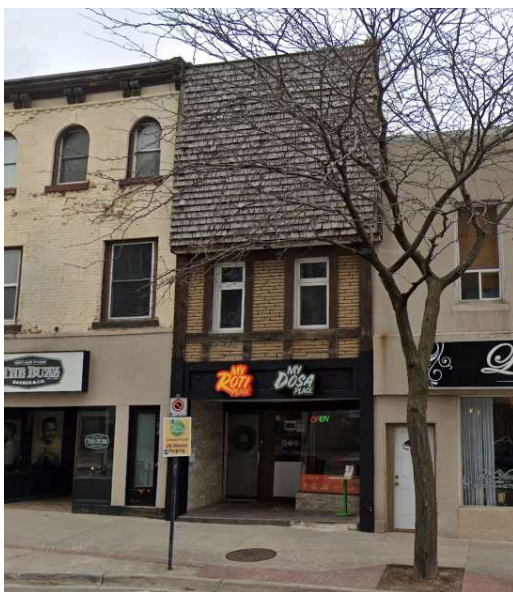
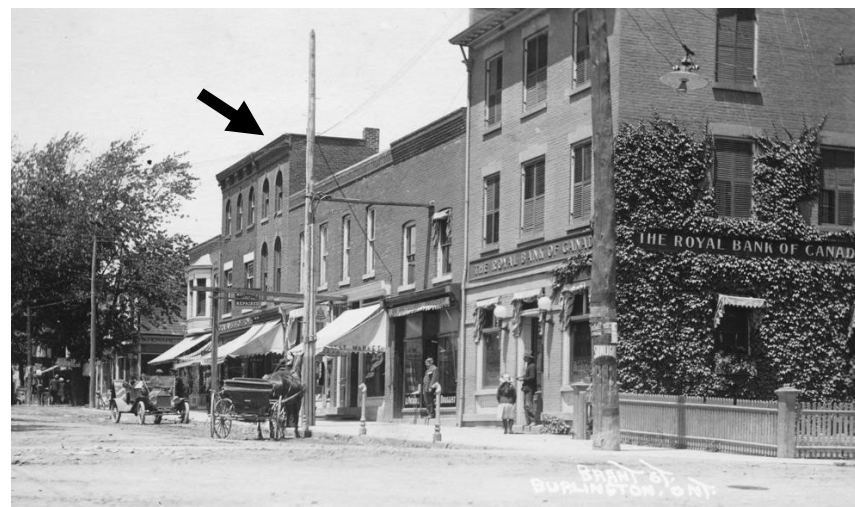
## 7. 357 Brant Street

Legal Description	PLAN 92 PT BLK M
Historic Land Use	Jeweler (see 1910 Fire Insurance Map)
Date of Construction	Pre 1910,
Architectural Description	Three-storey 1800s or early 1900s commercial building. Original form, scale and massing intact, but all façade details obscured. Ground floor remodeled, stone veneer placed over brick at 2 <sup>nd</sup> storey, wood shingle roof built over 3 <sup>rd</sup> storey. Some façade alterations may be removable or reversible, however significant rehabilitation is needed.
Heritage Status	None
Assessment	(X) Further study recommended

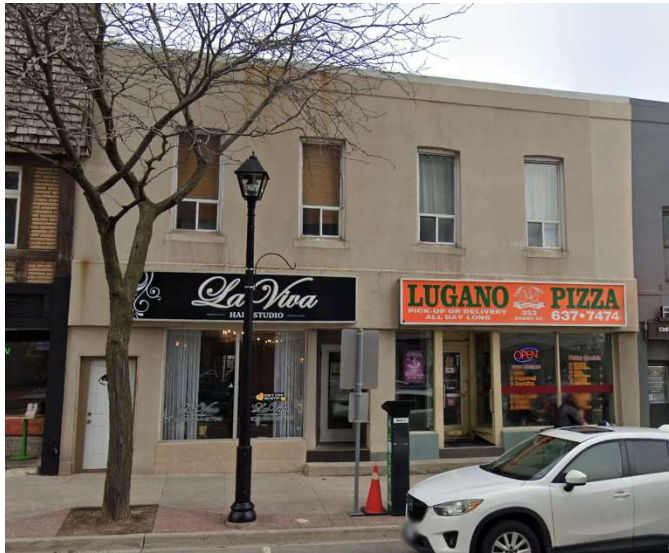
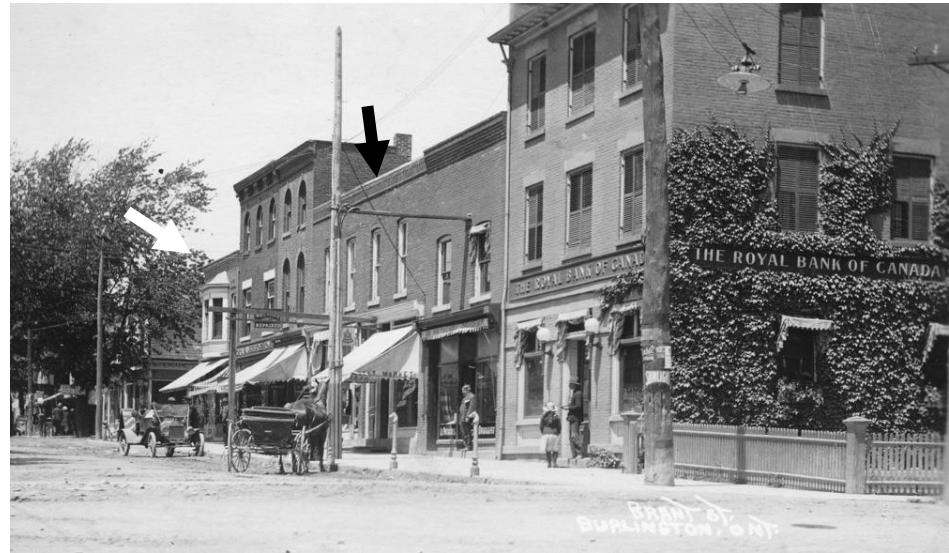
## 8. 353-355 Brant Street

Legal Description	PLAN 92 PT BLK M RP 20R8210 PARTS 1,3,4
Historic Land Use	Retail
Date of Construction	Pre 1910
Architectural Description	1800s or early 1900s two-storey brick commercial buildings. Upper storey window arrangement is original, although windows have been replaced. Segmental arched window openings are intact; however windows are aluminum replacements. Stone or concrete sills are still visible. Façade was formerly exposed brick and is now painted stucco. The original cornice is covered in stucco and the ground floor storefronts have been replaced. Original masonry side walls and structure may be intact.
Heritage Status	None
Assessment	(✓) Qualifies for Heritage Register

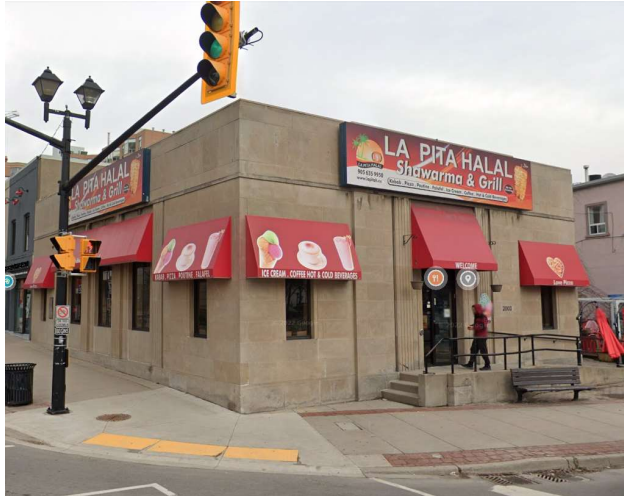
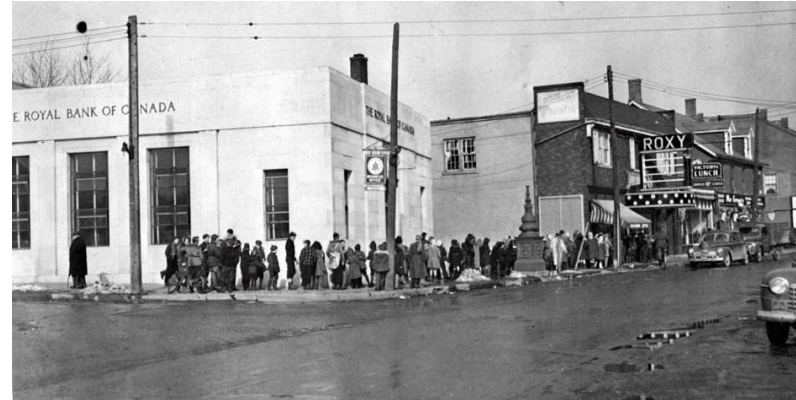
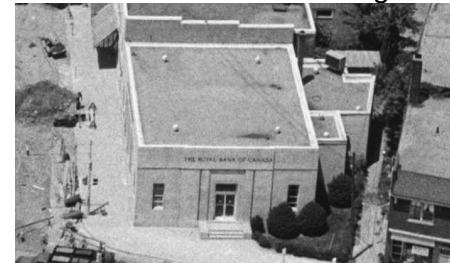
## 9. B) 2003 Lakeshore Road

<b>Legal Description</b>	PLAN 92 PT BLK M RP 20R10139 PARTS 1,4
<b>Historic Land Use</b>	Bank (RBC)
<b>Date of Construction</b>	Post 1940, likely 1950s
<b>Architectural Description</b>	Rare example of a transitional style "modernist" bank with minimalist classical references including "fluted" pilasters. The building has a simplified cornice, sandstone exterior and original fenestration. Signage and awnings obscure some details, but are removable. Style was characteristic of banks in the postwar decade as they sought to portray themselves as architecturally progressive but cautious in approach.
<b>Heritage Status</b>	None
<b>Assessment</b>	(✓) Qualifies for Heritage Register

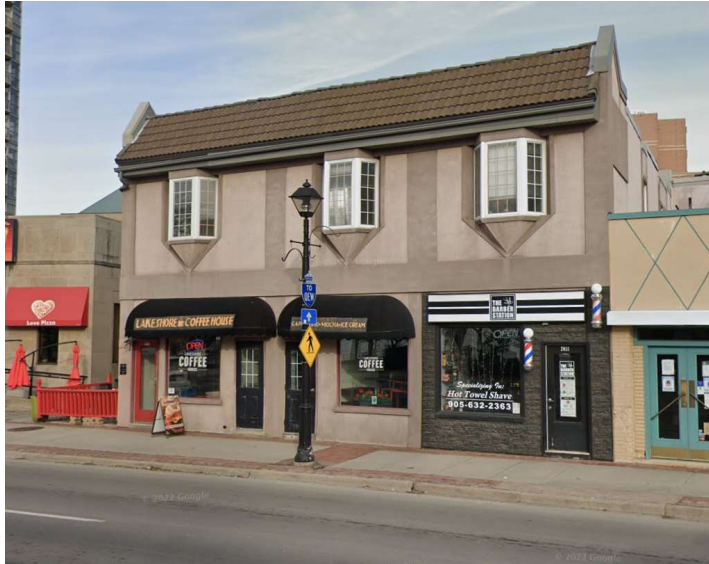
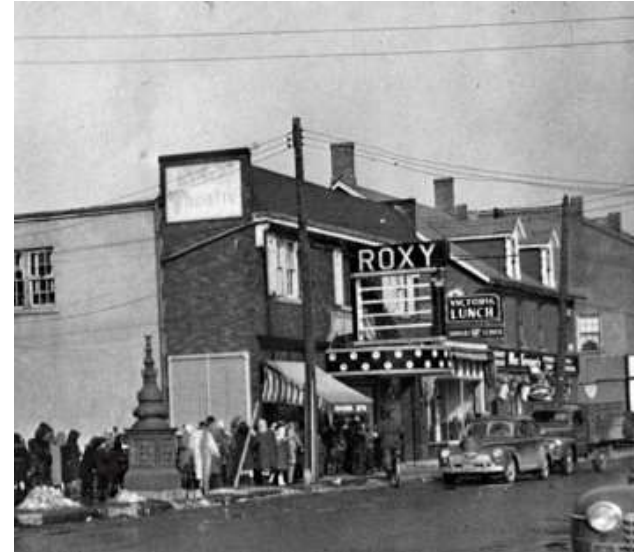
## 10. 2007-2011 Lakeshore Road

Legal description	PLAN 92 PT BLK M
Historic Land Use	Movie Theatre, Previously the property was occupied by a "Baby Clinic", which was demolished after 1924
Date of Construction	Unknown
Architectural Description	Two-storey former movie theatre building. Original windows replaced with bay windows, marquee removed, masonry covered with stucco and painted
Heritage Status	None
Assessment	(X) Further study recommended

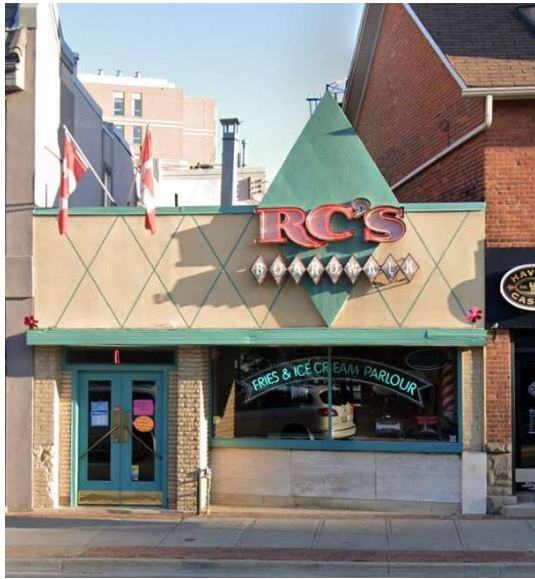
## 11. 2013 Lakeshore Road

Legal Description	PLAN 92 PT BLK M
Historic Land Use	N/A
Date of Construction	Unknown
Architectural Description	One-storey commercial building, undistinguished.
Heritage Status	None
Assessment	<b>(X) Not recommended for Heritage Register</b>

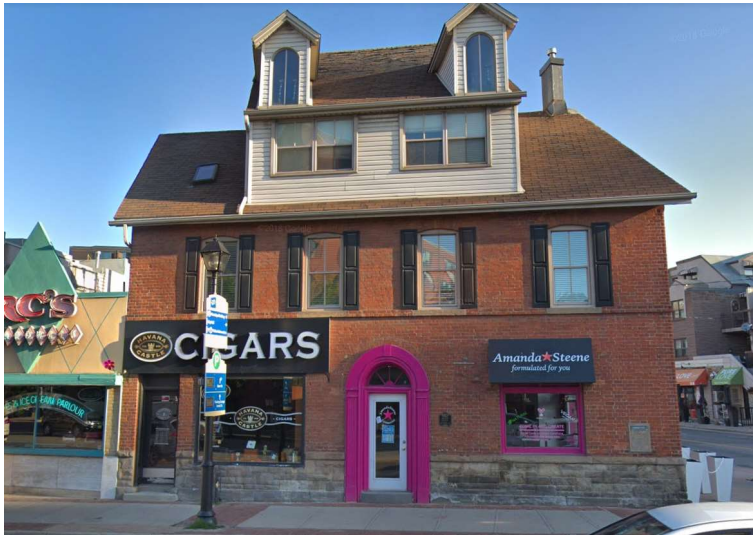
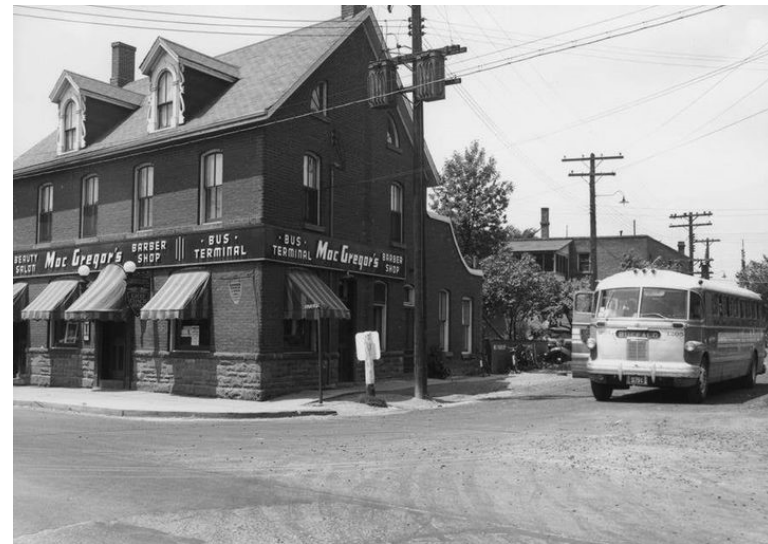
## 12. 2015-2017 Lakeshore Road

Legal Description	PLAN 92 PT BLK M
Historic Land Use	Bank (Bank of Hamilton)
Date of Construction	1881
Architectural Description	The "Shaver Building". Original two-and-a-half storey brick structure with Victorian gingerbread accents and arched windows.
Heritage Status	Heritage Register, Non-designated
Assessment	(✓) Non-Designated Heritage Register Property

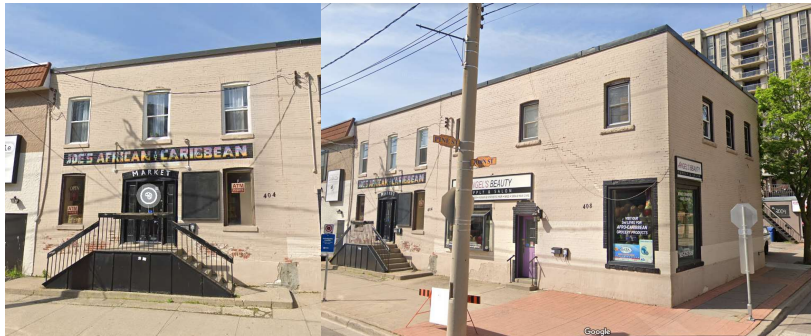
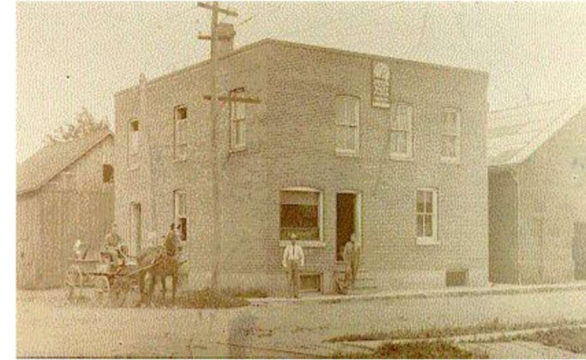
## 14. 404-408 John Street

<b>Legal Description</b>	PLAN 92 PT BLK M
<b>Historic Land Use</b>	404- Dwelling "2d" 408-Flour and Feed Mill
<b>Date of Construction</b>	404- Between 1910 and 1924 408- 1912
<b>Architectural Description</b>	404- Two storey masonry mixed-use building with symmetrical two-bay façade featuring segmental arched windows and rusticated stone or concrete sills. Centered and raised entry. 408- Two-storey brick manufacturing building. Segmental arched windows with rusticated stone or concrete sills at second storey. Ground floor has been altered. An entrance and window on the front elevation have been infilled.
<b>Heritage Status</b>	None
<b>Assessment</b>	(✓) Qualifies for Heritage Register
