Cultural Heritage Landscape #2- Locust Street

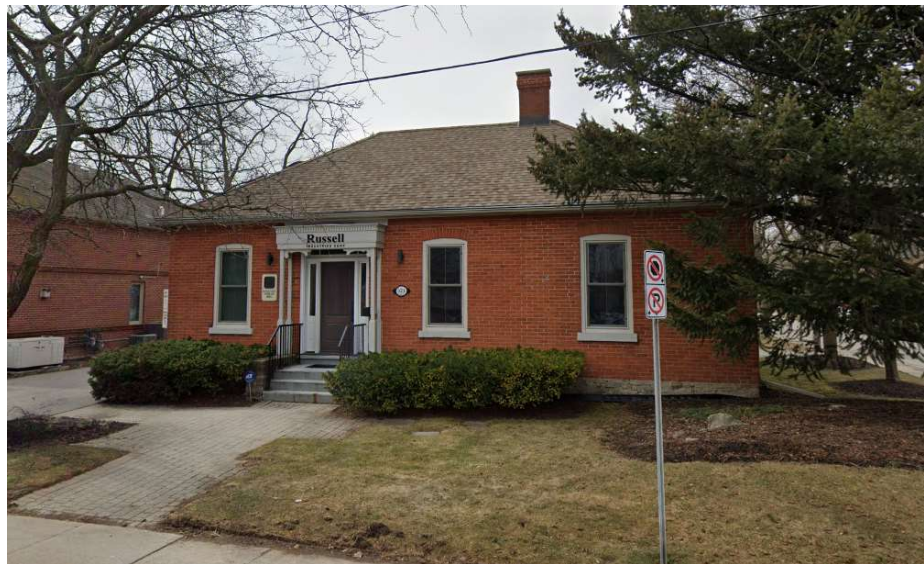
1. 524 Locust Street

Legal Description	PLAN 70 PT LOT 4
Historic Land Use	Residential (Dwelling)
Date of Construction	Pre 1910
Architectural Description	Victorian vernacular 1-storey dwelling with two-over-two windows, segmental arched windows, prominent sills, fieldstone foundation, entrance with sidelights.
Heritage Status	None
Assessment	(✓) Qualifies for Heritage Register

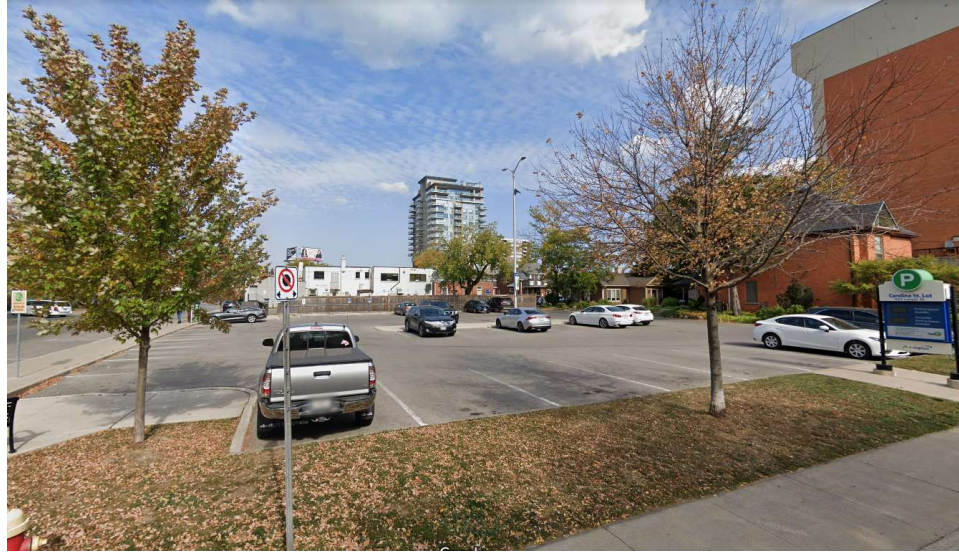
2. 523 Locust Street

Legal Description	PLAN 92 BLK V PT LOT 4
Historic Land Use	Residential (x2 Dwellings)
Date of Construction	N/A
Architectural Description	N/A
Heritage Status	None
Assessment	(X) Not recommended for Heritage Register

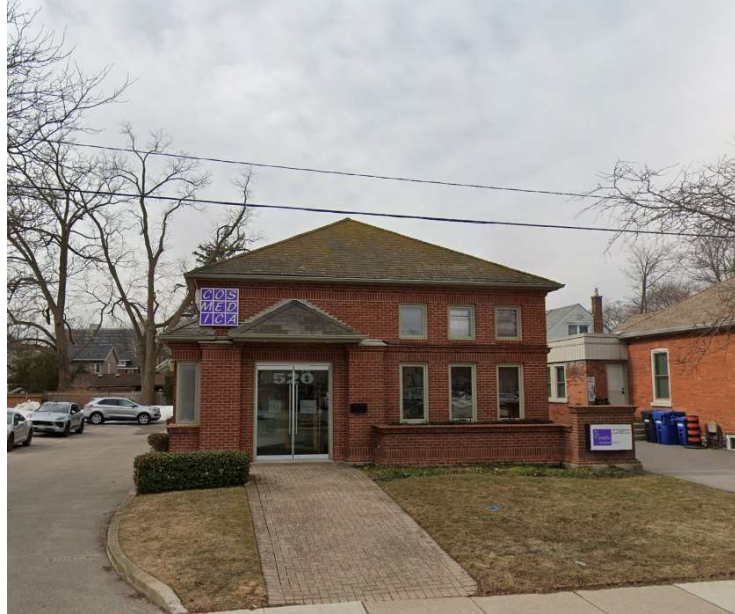
3. 520 Locust Street

Legal Description	PLAN 70 LOT 3
Historic Land Use	Residential
Date of Construction	Post 1924, relatively new building
Architectural Description	Relatively new two-storey commercial building.
Heritage Status	None
Assessment	(X) Not recommended for Heritage Register

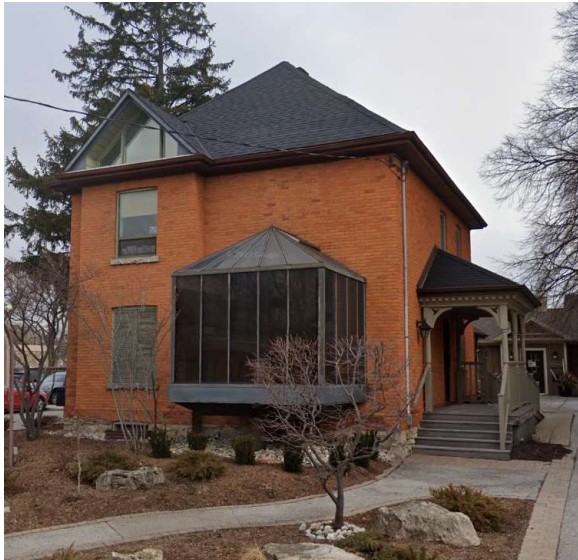
4. 513 Locust Street

1974 Image of rear of building

Legal Description	PLAN 92 BLK V PT LOT 2LOCUST
Historic Land Use	Residential
Date of Construction	1886
Architectural Description	Two-storey vernacular house with victorian/gothic porch details, a hipped roof, segmental arched ground floor windows, stone foundation. Rear covered porch was restored to a Victorian style porch.
Heritage Status	None
Assessment	(✓) Qualifies for Heritage Register

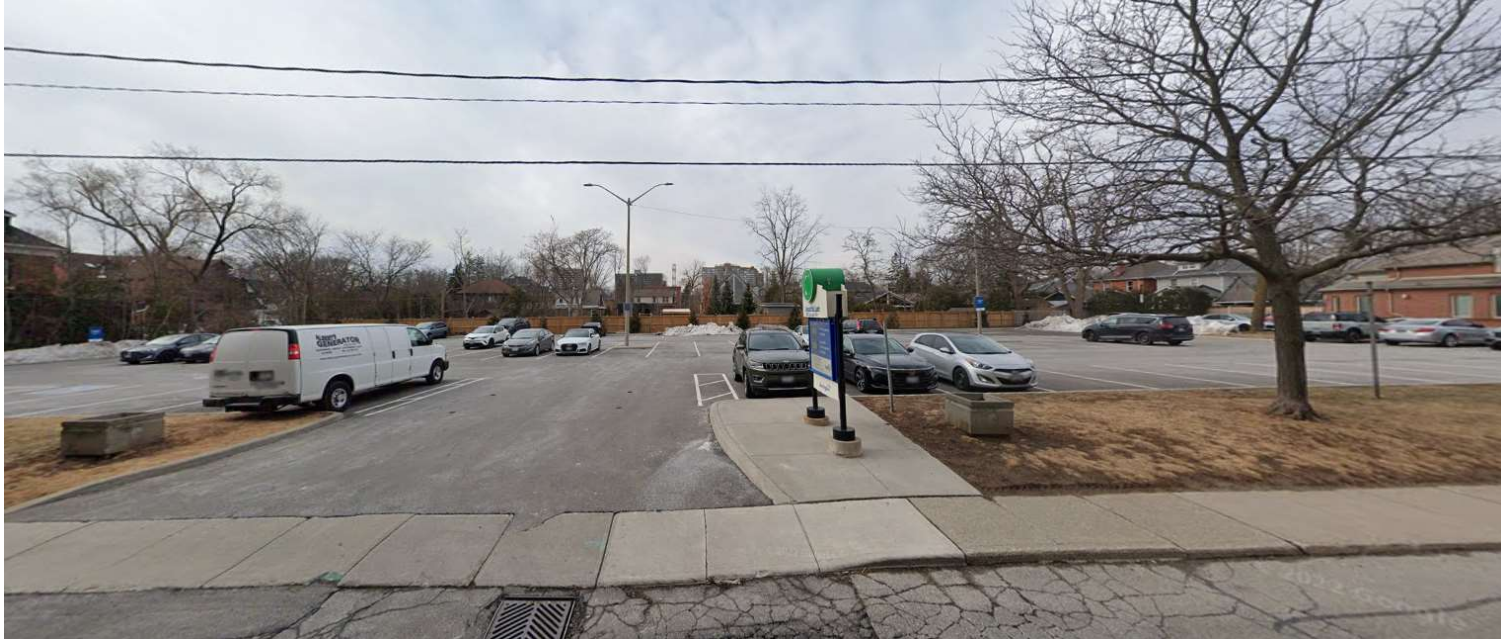
5. 500 Locust Street

Legal Description	PLAN 70 LOT 1 PLAN 74 PT LOT 50
Historic Land Use	Residential
Date of Construction	N/A
Architectural Description	N/A
Heritage Status	None
Assessment	(X) Not recommended for Heritage Register

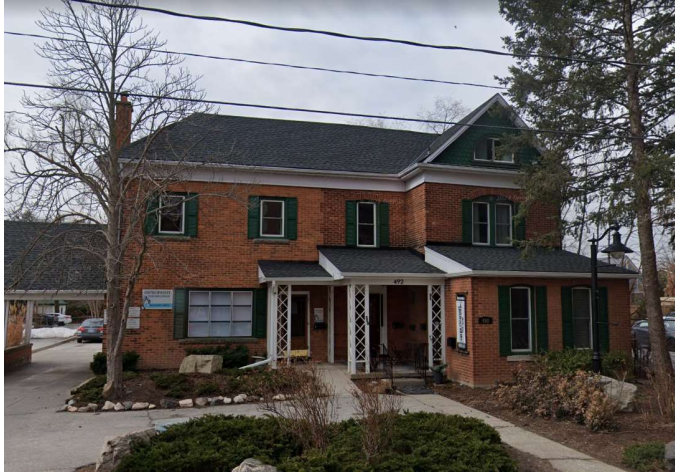
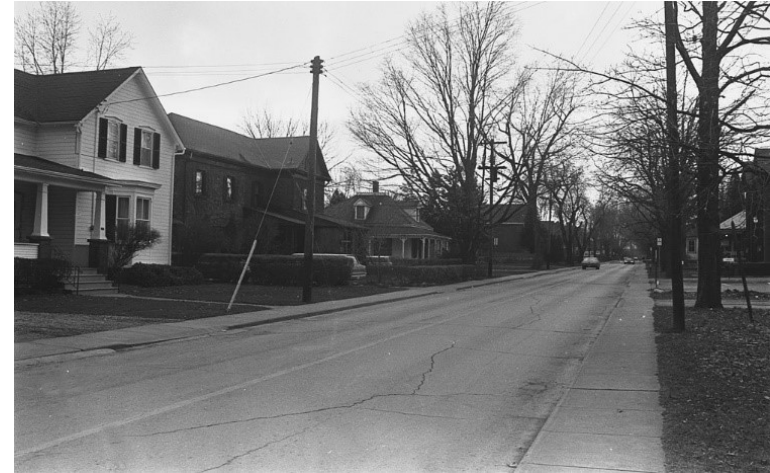
6. 492 Locust Street

1950s image of Locust Street- Vintage Burlington

Legal Description	PLAN 74 PT LOT 50
Historic Land Use	Residential (Dwelling)
Date of Construction	Pre 1910 (north half), 1924-195? (south half)
Architectural Description	Two-storey masonry house converted to commercial building. The north half displays some original features at the ground and second storey, however the portion of the façade beneath the front gable has been altered with a one-storey addition constructed onto the front. The south half is a later addition, using a slightly different colour brick and having different window proportions. The original detailing on the north half of the building includes round and segmental arched windows, fish-scale shingled gable with half round window opening.
Heritage Status	None
Assessment	(X) Further Study Recommended

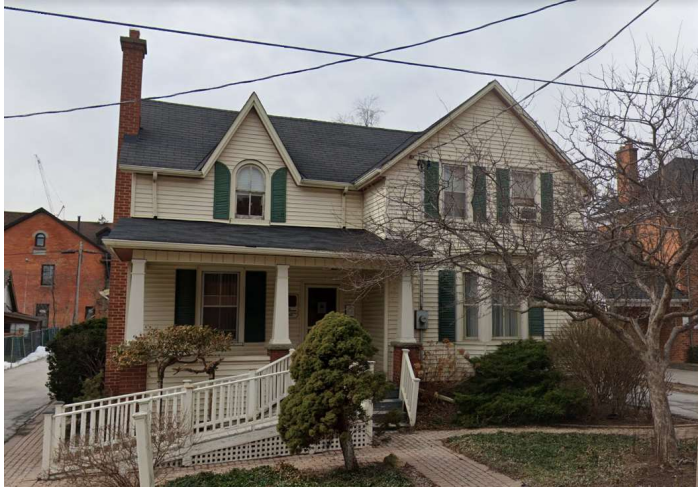
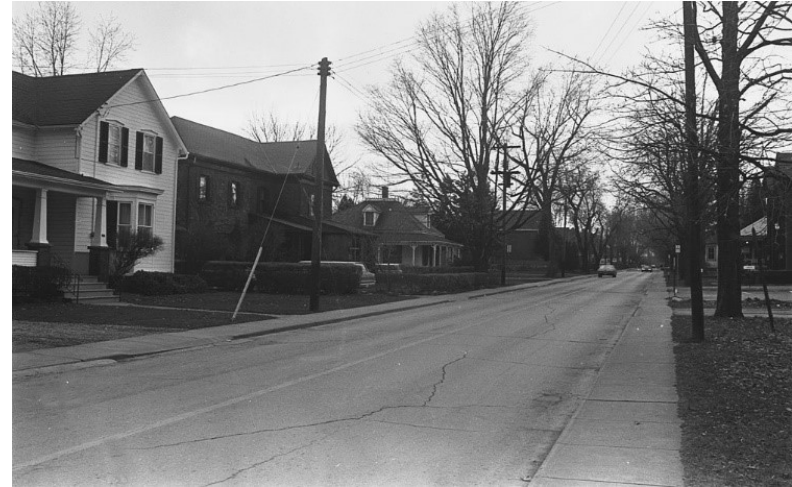
7. 488 Locust Street

1950s image of Locust Street- Vintage Burlington

Legal Description	PLAN 74 PT LOT 50
Historic Land Use	Residential (Dwelling)
Date of Construction	N/A
Architectural Description	Two-storey victorian vernacular house with a covered porch, bay window, round arched window in the second-storey gable and two-over-two sash windows.
Heritage Status	None
Assessment	(✓) Qualifies for Heritage Register

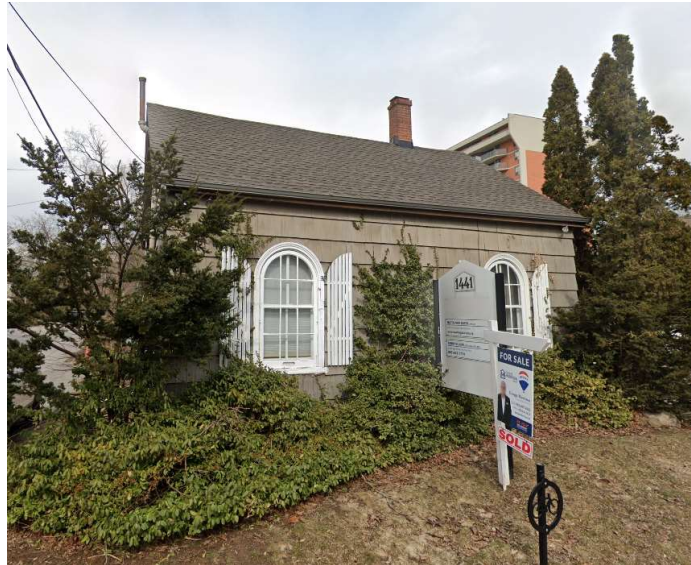
8. 1441 Ontario Street

Legal Description	PLAN 74 PT LOT 51
Historic Land Use	Residential (Dwelling)
Date of Construction	1830 (estimated)
Architectural Description	The William Hodgson - Sarah Oakley House. Vernacular loyalist cottage with 1-storey gable roof form and distinctive arched six-over-six sash windows on south and west elevations. The house has a rear 1-storey "kitchen tail". The exterior cladding does not appear original but may be possible to remove. "First constructed on the Brant Street site of the old town hall and library (which was built in 1906) and was moved to this lot in 1874 for William Hodgson. According to Stanley Blair, it was rebuilt by George Blair."- Building Stories
Heritage Status	Heritage Register, Non-designated
Assessment	(✓) Non Designated Heritage Register Property

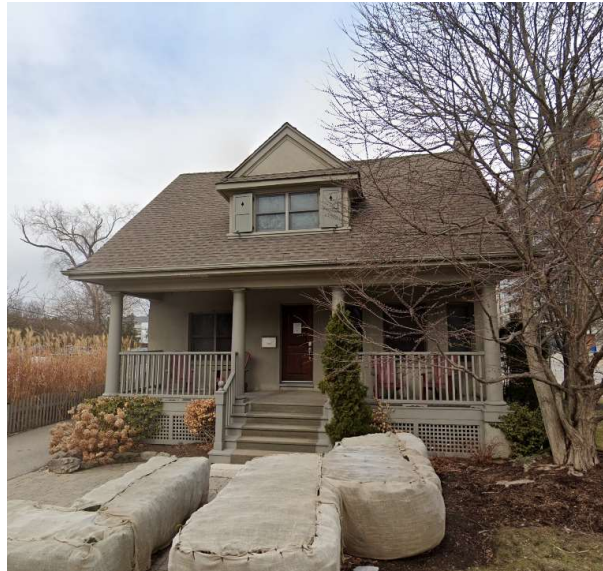
9. 1445 Ontario Street

Legal Description	PLAN 74 PT LOT 51
Historic Land Use	Residential (Dwelling)
Date of Construction	Between 1910-1924
Architectural Description	1.5-storey vernacular bungalow with covered porch supported with classical (Tuscan) columns. A half bay window on the east side of the front elevation introduces some asymmetry to the facade. Above the porch is a gabled dormer with double-hung one-over-one sash windows.
Heritage Status	None
Assessment	(✓) Qualifies for Heritage Register

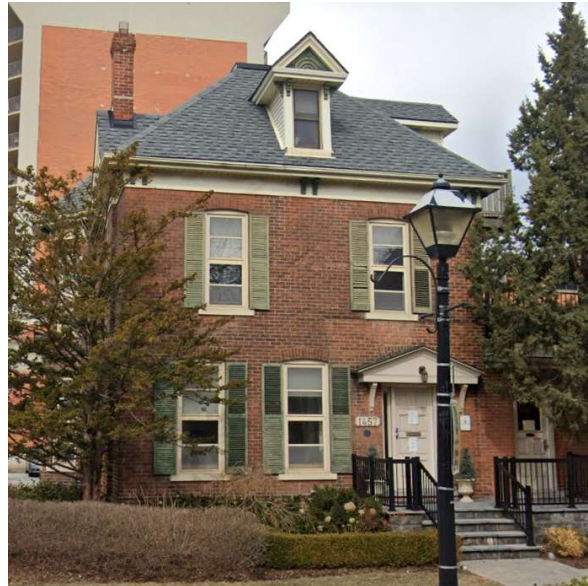
10. 1457 Ontario Street

Legal Description	PLAN 92 BLK W PTS 1,2 LOCUST
Historic Land Use	Residential (Dwelling)
Date of Construction	1875
Architectural Description	The Miller Bush House. 2-storey Victorian Vernacular building with masonry exterior, segmental arched windows, west facing hexagonal bay window
Heritage Status	Heritage Designated Property
Assessment	(✓) Heritage Designated

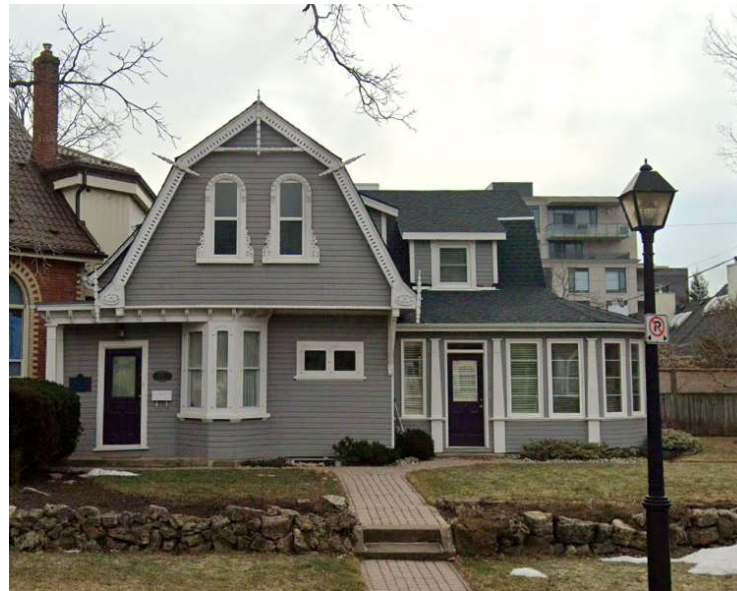
11. 1442 Ontario Street

Legal Description	PLAN 74 PT LOT 52
Historic Land Use	Residential (Dwelling)
Date of Construction	1888
Architectural Description	The James Cushie Bent House. Carpenter gothic style house of wood frame construction, with covered, curved and enclosed glassed-in porch, handmade and carved ornamentation for the windows, mouldings, soffits, gables and cornices. Decorative roof braces.
Heritage Status	Heritage Designated Property
Assessment	(✓) Heritage Designated

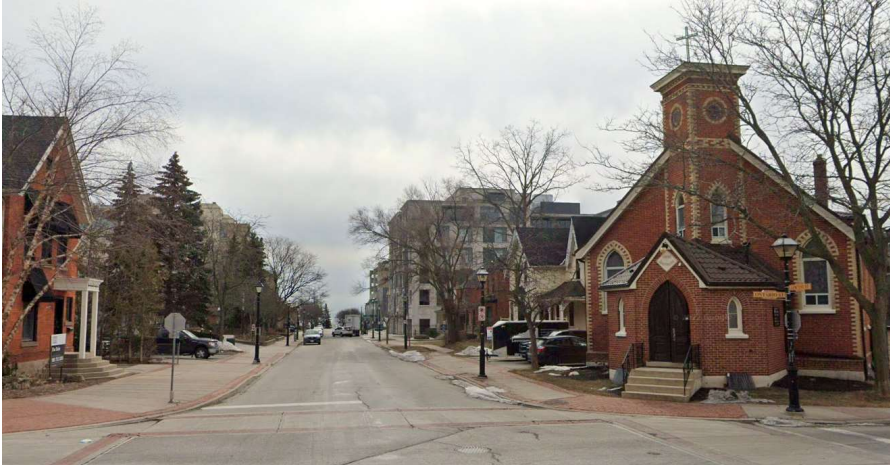
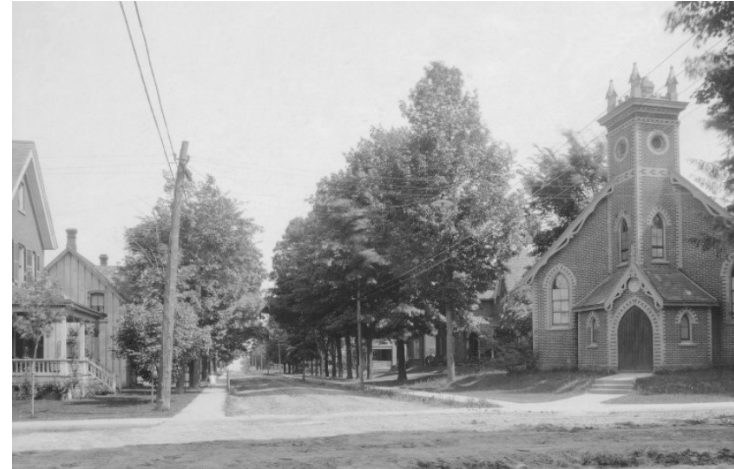
12. 472 Locust Street

1900 Print from Vintage Burlington North Shore Publishing

Legal Description	PLAN 74 PT LOT 52
Historic Land Use	Church
Date of Construction	N/A
Architectural Description	L'Eglise St Philippe Originally Calvary Baptist Church. Church structure with a combination of Gothic Revival and Italianate styles.
Heritage Status	Heritage Register, Non-designated
Assessment	(✓) Non Designated Heritage Register Property

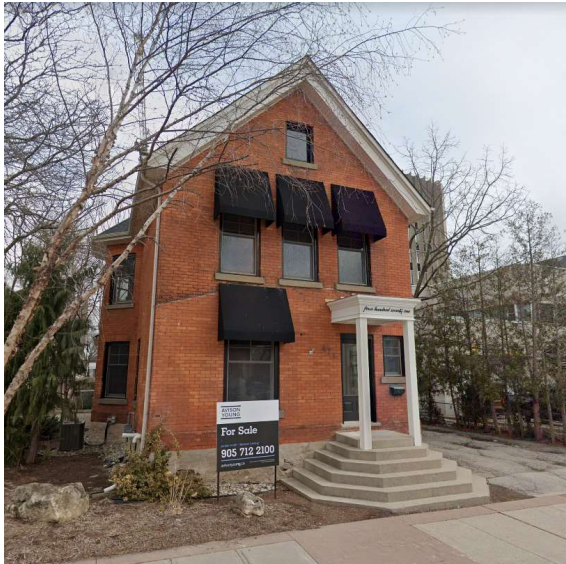
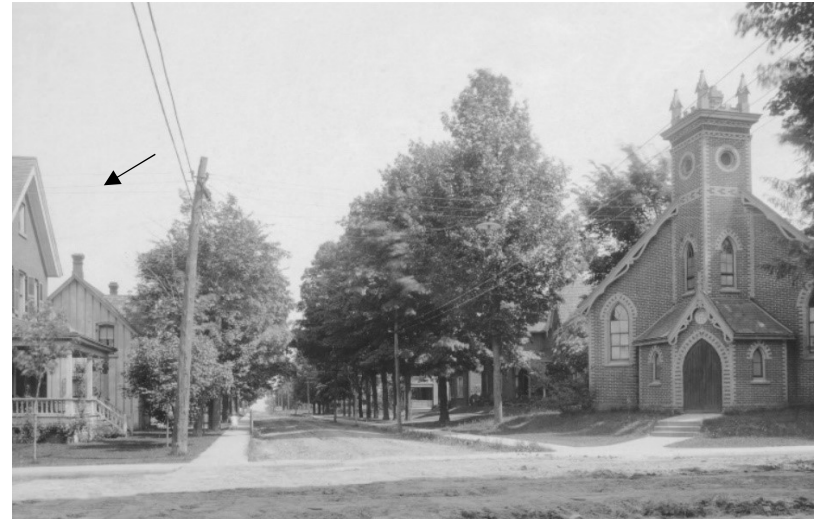
13. 471 Locust Street

1900 Print from Vintage Burlington North Shore Publishing

Legal Description	PLAN 92 BLK X PT LOT 1 RP 20R7438 PART 5
Historic Land Use	Dwelling
Date of Construction	1900
Architectural Description	The Atkinson - Peart House. Two-and-a-half storey brick structure dating back to 1900.
Heritage Status	Heritage Register, Non-designated
Assessment	(✓) Non Designated Heritage Register Property

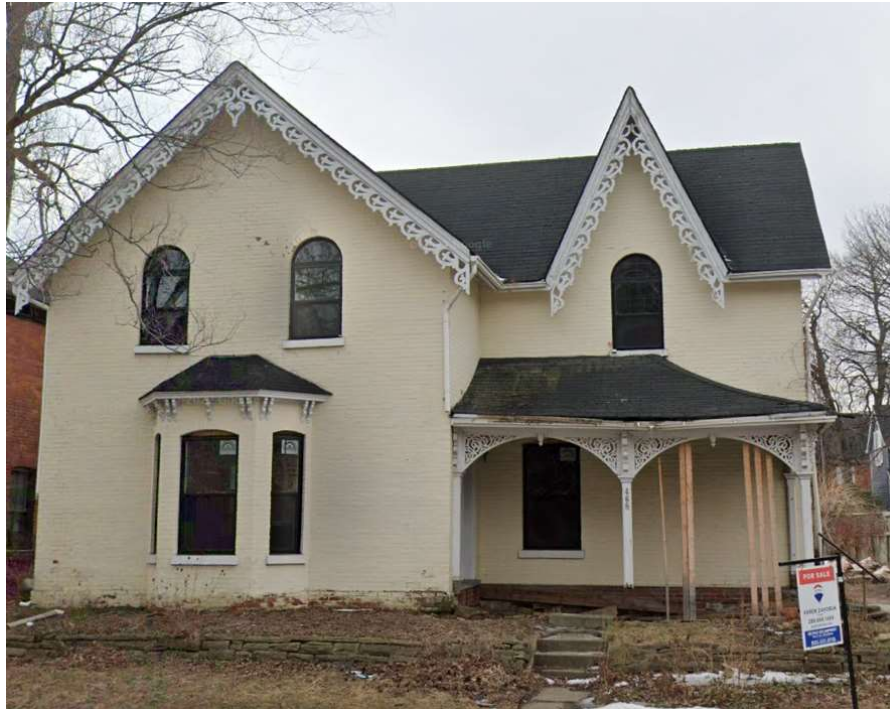
14. 468 Locust Street

Legal Description	PLAN 74 LOT 53
Historic Land Use	Dwelling
Date of Construction	1900
Architectural Description	The Robert Kentner House. Two storey brick structure in Gothic Revival style.
Heritage Status	Heritage Register, Non-designated
Assessment	(✓) Non Designated Heritage Register Property

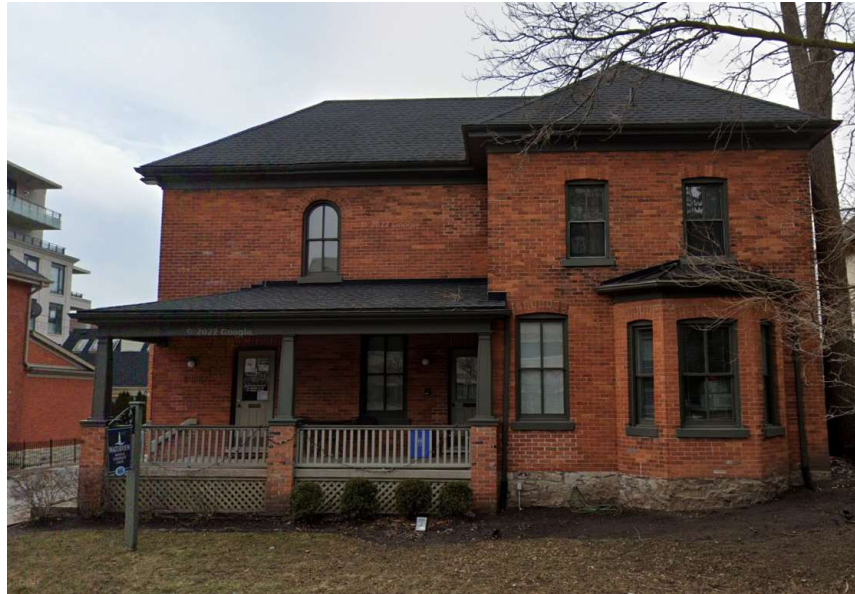
15. 462-464 Locust Street

Legal Description	PLAN 92 PT LOT 54
Historic Land Use	Dwelling
Date of Construction	1896
Architectural Description	The Richard Cole House. Early Victorian brick dwelling with later renovations from 1943.
Heritage Status	Heritage Designated Property
Assessment	(✓) Heritage Designated

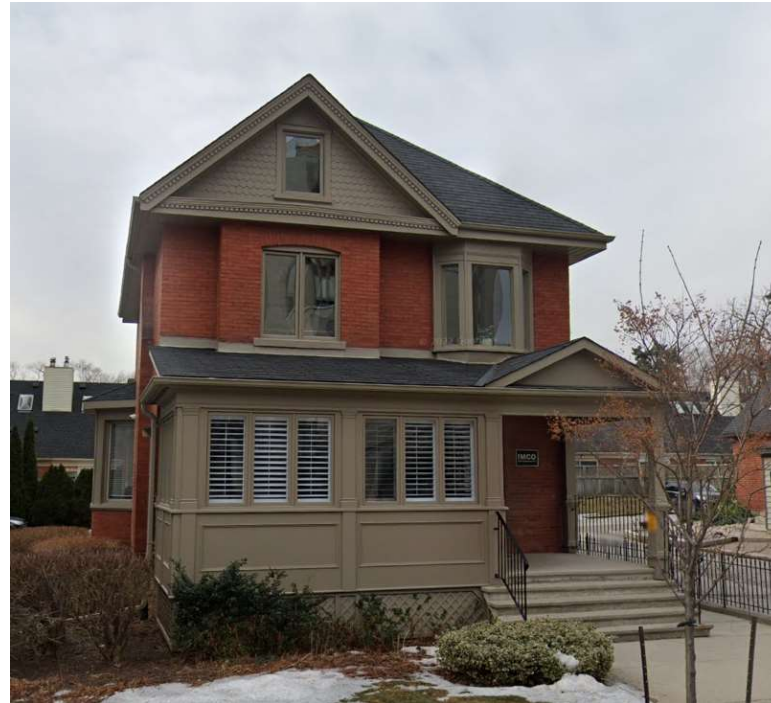
16. 458 Locust Street

Legal Description	PLAN 74 PT LOT 54 SAVE AND EXCEPT RP 20R7438 PART10
Historic Land Use	Dwelling
Date of Construction	Pre 1910
Architectural Description	Two-storey Queen Anne revival style house with fish scale shingles in gable and segmental arched window at second storey. Enclosed porch at ground storey is a later addition
Heritage Status	None
Assessment	(✓) Qualifies for Heritage Register

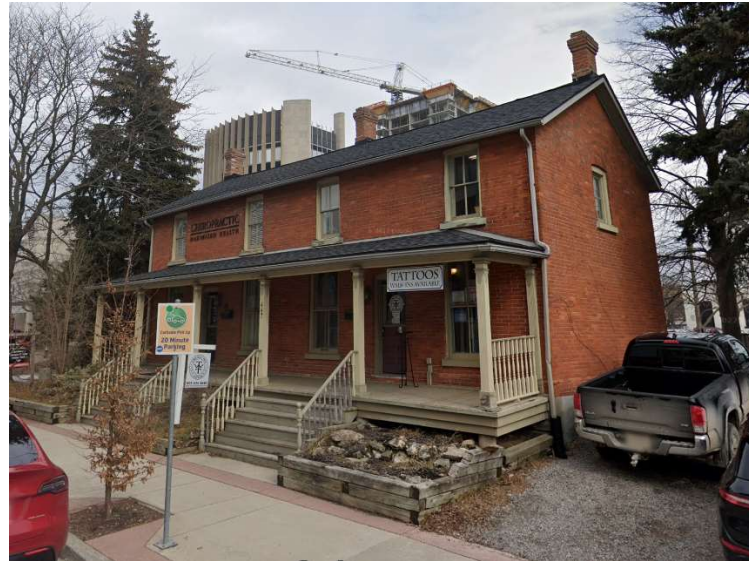
17. 447-449 Locust Street (Separate Properties)

Address	447- PLAN 92 BLK X PT LOT 8 RP 20R12790 PART 2 449- PLAN 92 BLK X PT LOT 8 RP 20R12790 PART 1
Historic Land Use	Semi-detached dwelling
Date of Construction	1867
Architectural Description	Built in 1867 for Norman Hamburg, a labourer, and his wife Sarah, and their family, this is a rare example of an historic semi-detached residence, and one of the few extant pre-Confederation structures in downtown Burlington. It is a “modest, but well constructed house...” “...unspoiled by modern alterations and retains its original windows, doors, wood trim, storm door and the original gallery verandah supported by square columns with decorative relief details”
Heritage Status	Heritage Designated
Assessment	(✓) Heritage Designated
