Cultural Heritage Landscape #1- Foot of Brant Street

Cultural Heritage Landscape #2- Locust Street

Cultural Heritage Landscape #4- Downtown East

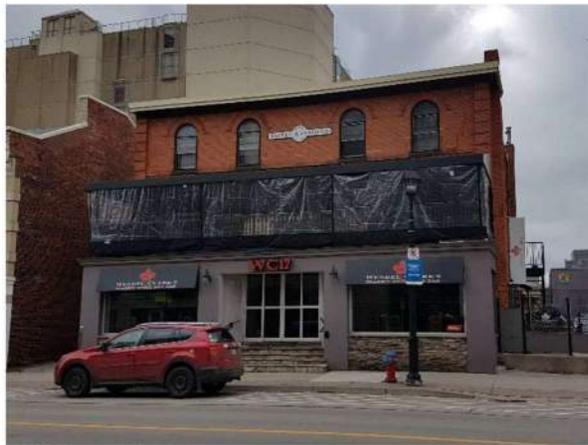
1. 380 Brant Street

Legal Description	PLAN 92 BLK Y LOT 7 PT LOT 6
Historic Land Use	Hotel ("Raymond Hotel")
Date of Construction	1860
Heritage Value or Interest	The property is believed to have historical value for its age and former hotel use, which has the potential to yield information about the Burlington community in the mid 19th century. Architectural merits include its Italianate details like corner quoins, round-arched windows with keystones, segmental arched windows at second storey, masonry chimneys and cubic massing. Contextual value as a landmark on the street. Alterations include removal and replacement of ground floor porch, new windows throughout.
Heritage Status	None
Assessment	(✓) Qualifies for Heritage Register

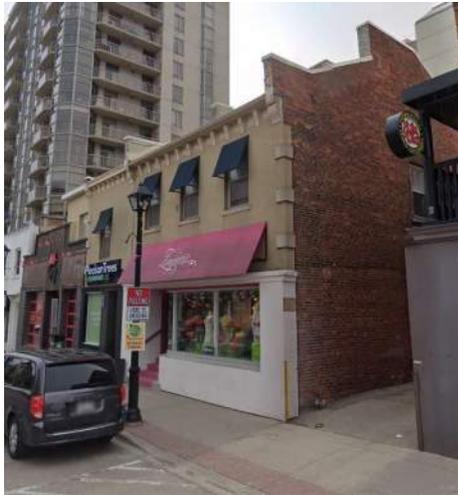
2. 372-374 Brant Street

Legal Description	PLAN 92 BLK Y PT LOTS 5,6
Historic Land Use	372- Undertaker, 374- Furniture Store
Date of Construction	Pre 1910
Heritage Value or Interest	Two-storey masonry clad commercial building. The property is believed to have historical value for its age and former uses as an undertaker and furniture store, which have the potential to yield information about the Burlington community pre 1910. The building is believed to have design value for its gable roof massing, masonry sidewalls, prominent demising wall, cornice and decorative brackets. Alterations include stucco covering the original masonry. The formerly symmetrical storefront has been reconfigured with the entrance relocated to one side.
Heritage Status	None
Assessment	(✓) Qualifies for Heritage Register

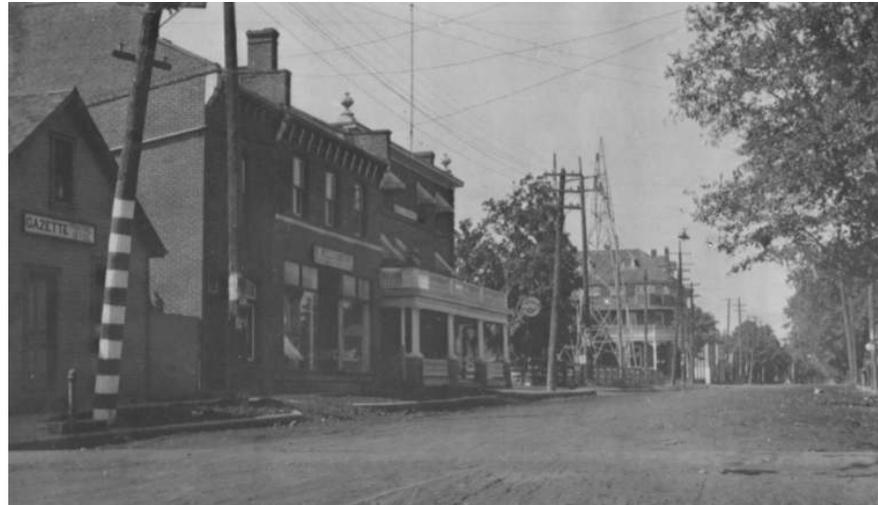
Undated photo of 370- 380 Brant Street with the Queens Hotel visible at top right. Photograph from The Prints of Burlington

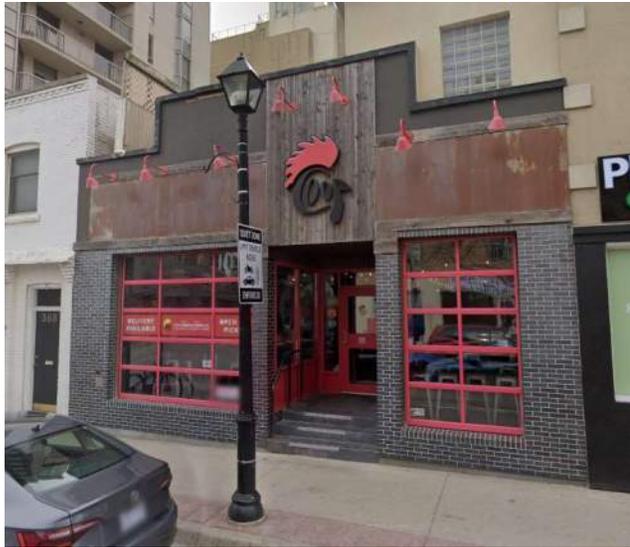
3. 370 Brant Street

Legal Description	PLAN 92 BLK Y PT LOT 4
Historic Land Use	Printing Office
Date of Construction	Post 1924
Heritage Value or Interest	Undetermined. 1-storey brick commercial building with no distinguishing historic architectural features
Heritage Status	None
Assessment	(X) Not recommended for Heritage Register

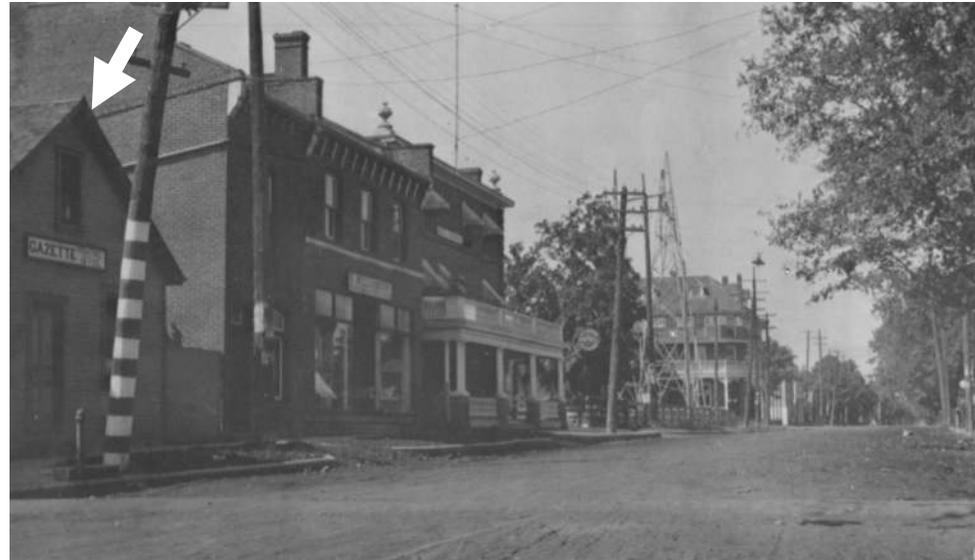
Undated photo of 370- 380 Brant Street with the Queens Hotel visible at top right. Photograph from The Prints of Burlington

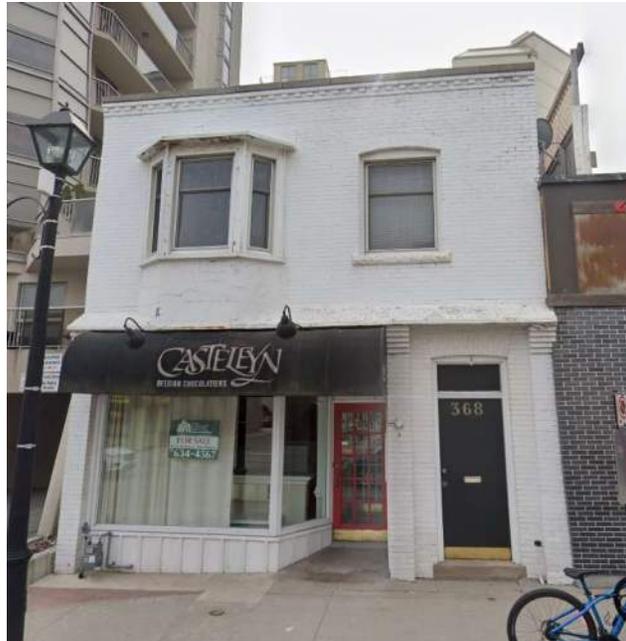
4. 368 Brant Street

Legal Description	PLAN 92 BLK Y PT LOTS 3,4
Historic Land Use	The Bell - Wiggins Boot and Shoe Store, The Parkin Barber Shop and Pool Hall
Date of Construction	1867
Heritage Value or Interest	Design and Historical Value. Two-storey commercial building, dentilated cornice, segmental arched window and bay window at second storey, voussoirs above ground floor doorway, corbelled ground floor pilasters. Originally 1-storey, second storey added in 1902.
Heritage Status	Heritage Register, Non-designated
Assessment	(✓) Non Designated Heritage Register Property

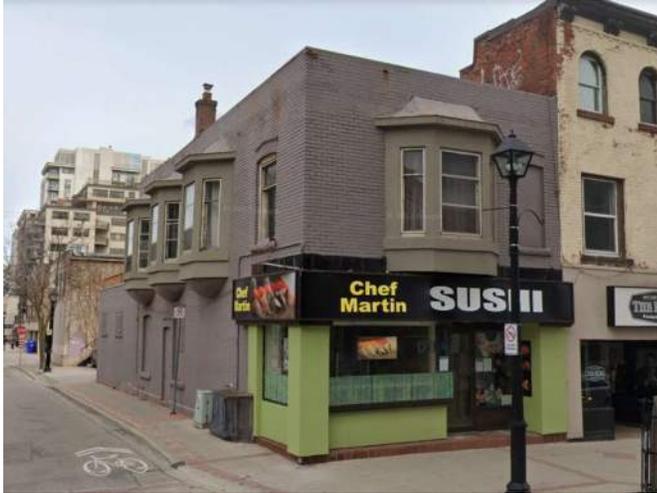
5. 361 Brant Street

Legal Description	PLAN 92 PT BLK M
Historic Land Use	The LePatourel Drug Store First Location
Date of Construction	1881
Heritage Value or Interest	Design and historical value. Two-storey commercial building with oriel windows at the second storey and segmental arches over windows and entries at first and second storey. Ground floor reconfigured, upper storey oriel window details and wood construction now covered with stucco.
Heritage Status	Heritage Register, Non-designated
Assessment	(✓) Non Designated Heritage Register Property

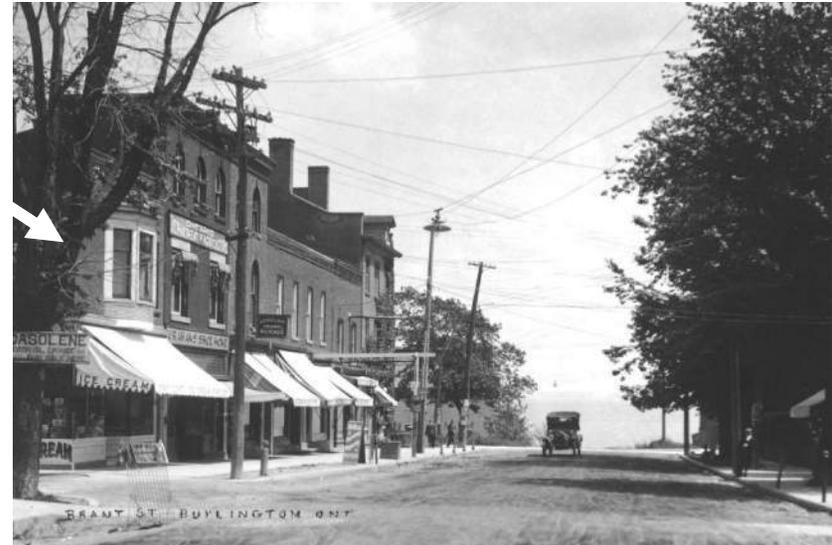
Early 1920s photo of lower Brant from 2019 Burlington Heritage Calendar

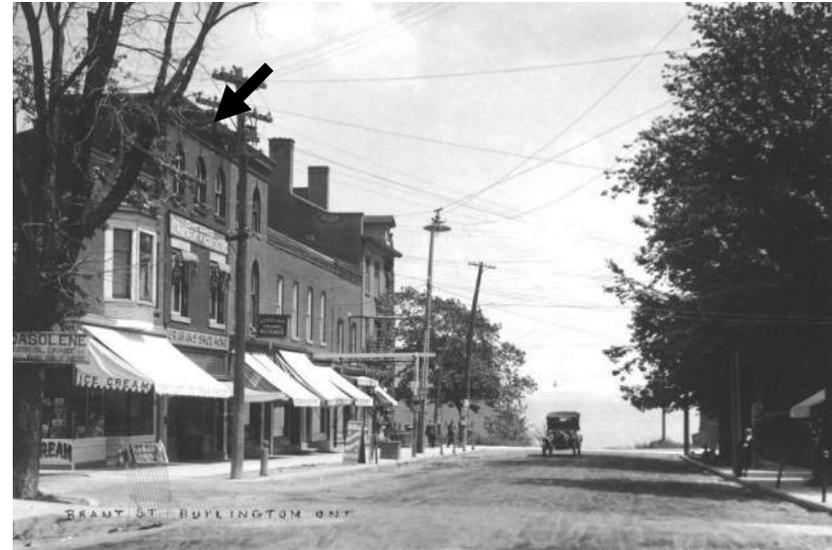
6. 359 Brant Street

Legal Description	PLAN 92 PT BLK M
Historic Land Use	Drugstore and Offices
Date of Construction	Pre 1910
Heritage Value or Interest	Three-storey commercial building believed to have historical value for its age and former use as an Ontario Department of Agriculture Office. The building is believed to have design value for its Italian renaissance elements including round arched windows at third storey. The building is believed to have design value for its Italian renaissance elements including round arched windows at third storey. The second storey originally had round arched windows and the arches and keystones of these windows are still visible in brickwork. The cornice with brackets is still intact along with the dentil course below the cornice brackets. Alterations include rectangular second storey window openings, replaced windows, painted brick and reconfigured storefront.
Heritage Status	None

Assessment	(✓) Qualifies for Heritage Register

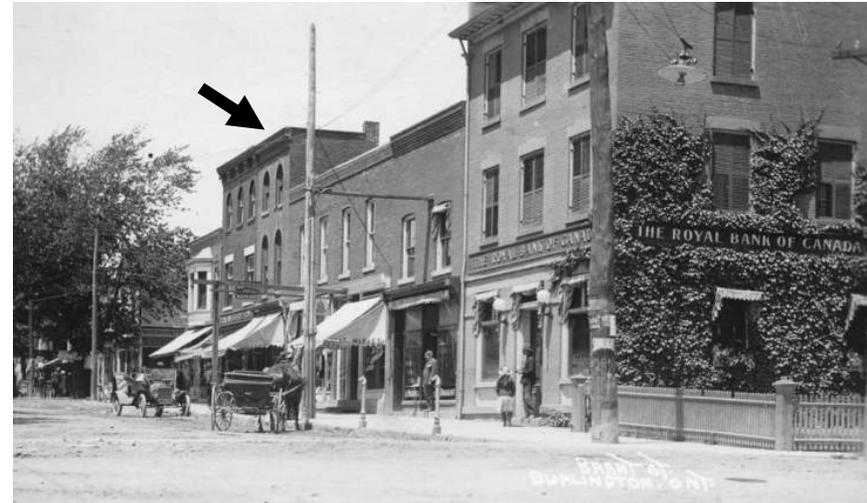
7. 357 Brant Street

1914 post card of Brant Street looking north from what was then Water Street. From "The Prints of Burlington."

Legal Description	PLAN 92 PT BLK M
Historic Land Use	Jeweler (see 1910 Fire Insurance Map)
Date of Construction	Pre 1910,
Heritage Value or Interest	Three-storey building believed to have historical potential for its age and former use as a mixed-use retail and residential building. The building may have architectural value if surface alterations and non-original cladding can be removed. Original form, scale and massing intact, but all façade details obscured. Ground floor remodeled, stone veneer placed over brick at 2 nd storey, wood shingle roof built over 3 rd storey.
Heritage Status	None
Assessment	(✓) Qualifies for Heritage Register (Heritage Burlington Advisory Committee recommendation)

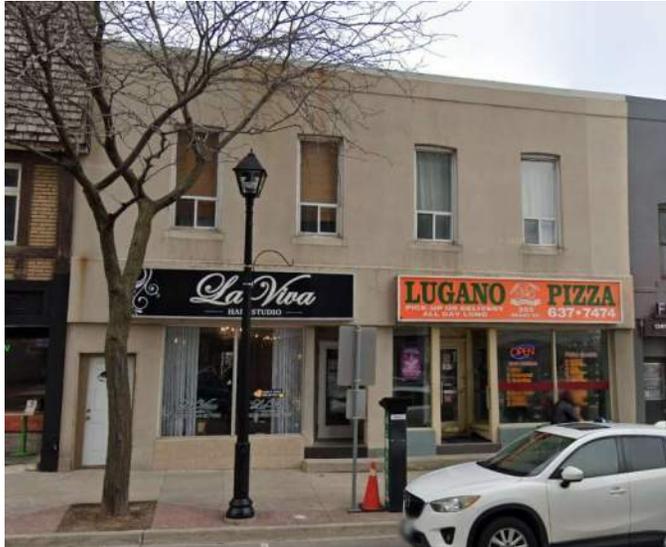
8. 353-355 Brant Street

Legal Description	PLAN 92 PT BLK M RP 20R8210 PARTS 1,3,4
Historic Land Use	Retail
Date of Construction	Pre 1910
Heritage Value or Interest	Two-storey building believed to have historical value for its age and former retail use. The building is believed to have architectural value for its original form, scale and massing and its arrangement of upper storey segmental arched windows with stone or concrete sills. Alterations include aluminum windows, painted stucco covering the original masonry and cornice. Ground floor storefronts have been replaced. Original masonry side walls and structure may be intact.
Heritage Status	None
Assessment	(✓) Qualifies for Heritage Register

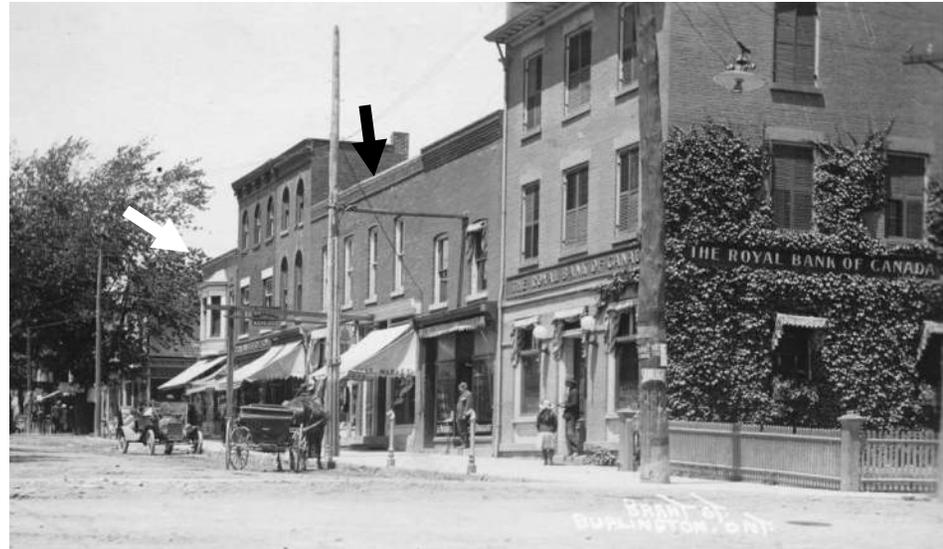
1914 post card of Brant Street looking north from what was then Water Street. From "The Prints of Burlington."

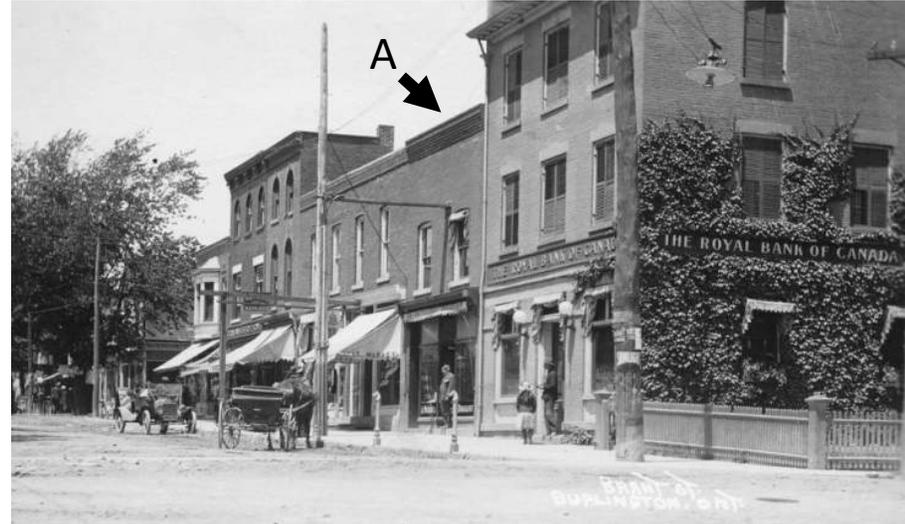
9. A) 2003 Lakeshore Road

1914 post card of Brant Street looking north from what was then Water Street. From "The Prints of Burlington".

Legal Description	PLAN 92 PT BLK M RP 20R10139 PARTS 1,4
Historic Land Use	Bell Telephone Exchange
Date of Construction	Pre 1910
Heritage Value or Interest	1800s or early 1900s two-storey commercial building believed to have historical value for its age and former use as the Bell Telephone Exchange. The building is believed to have architectural value for its original upper storey window arrangement and intact segmental arched windows with stone or concrete sills. Alterations include painted stucco over original masonry and a reconfigured storefront.
Heritage Status	None
Assessment	(✓) Qualifies for Heritage Register

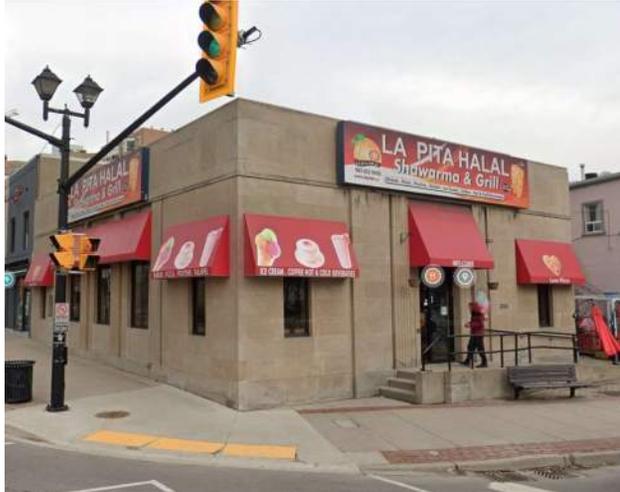
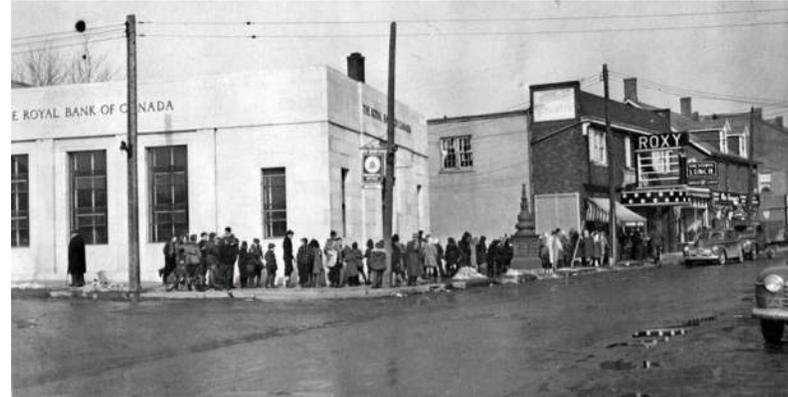
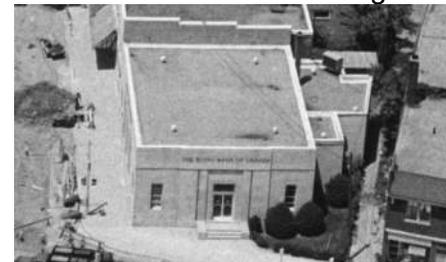
9. B) 2003 Lakeshore Road

Legal Description	PLAN 92 PT BLK M RP 20R10139 PARTS 1,4
Historic Land Use	Bank (RBC)
Date of Construction	Post 1940, likely 1950s
Heritage Value or Interest	Rare example of a transitional style "modernist" bank with minimalist classical references including "fluted" pilasters. The building has a simplified cornice, sandstone exterior and original fenestration. Signage and awnings obscure some details, but are removable. Style was characteristic of banks in the postwar decade as they sought to portray themselves as architecturally progressive but cautious in approach.
Heritage Status	None
Assessment	(✓) Qualifies for Heritage Register

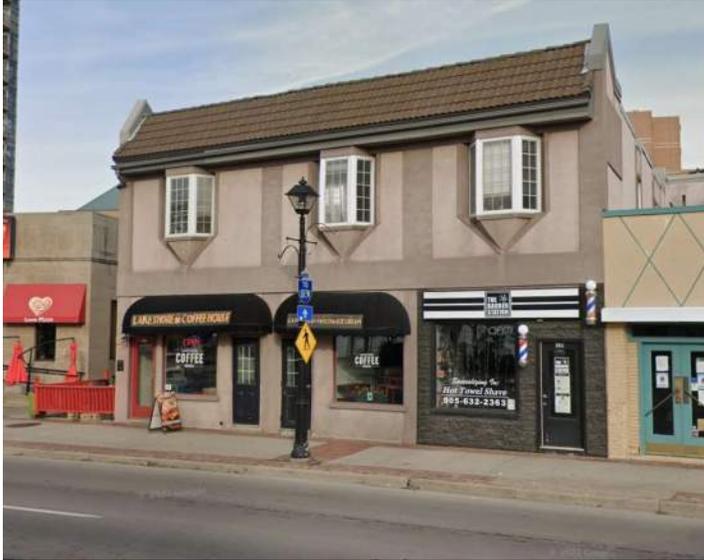
10. 2007-2011 Lakeshore Road

Legal description	PLAN 92 PT BLK M
Historic Land Use	Movie Theatre, Previously the property was occupied by a "Baby Clinic", which was demolished after 1924
Date of Construction	Post 1924
Heritage Value or Interest	Undetermined. Two-storey former movie theatre building. Original windows replaced with bay windows, marquee removed, masonry covered with stucco and painted
Heritage Status	None
Assessment	(X) Further study recommended

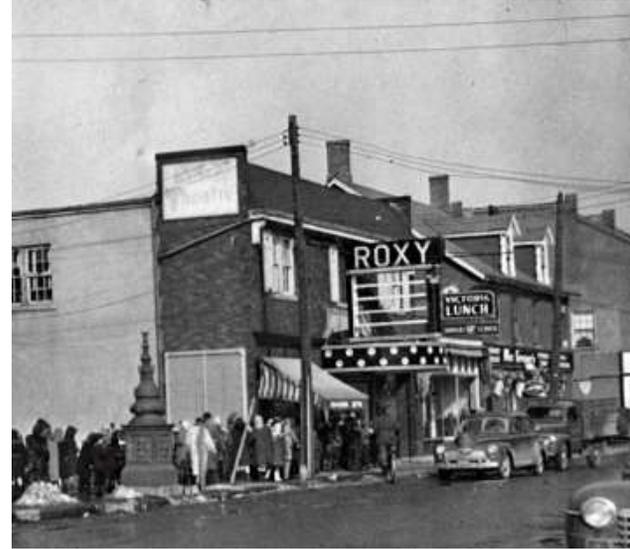
From "The Prints of Burlington"

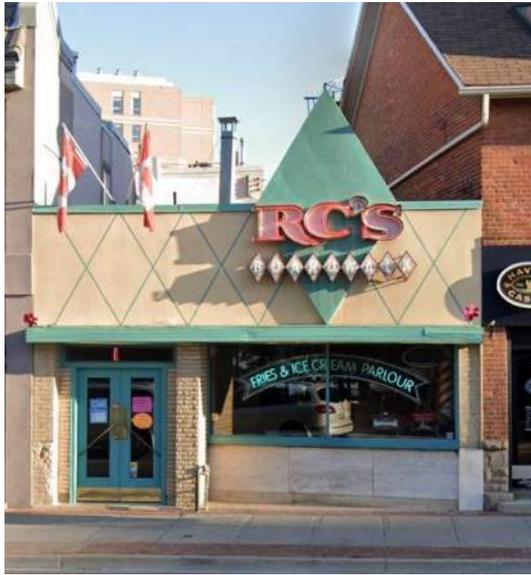
11. 2013 Lakeshore Road

Legal Description	PLAN 92 PT BLK M
Historic Land Use	N/A
Date of Construction	Post 1924
Heritage Value or Interest	Undetermined. Undistinguished one-storey commercial building.
Heritage Status	None
Assessment	(X) Not recommended for Heritage Register

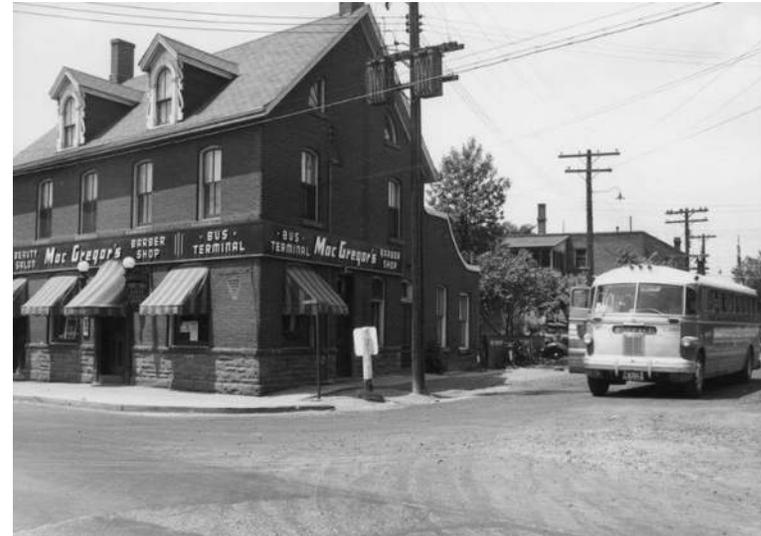
Legal Description	PLAN 92 PT BLK M
Historic Land Use	Bank (Bank of Hamilton)
Date of Construction	1881
Heritage Value or Interest	Historical and Architectural. The "Shaver Building". Original two-and-a-half storey brick structure with Victorian gingerbread accents and arched windows.
Heritage Status	Heritage Register, Non-designated
Assessment	(✓) Non-Designated Heritage Register Property

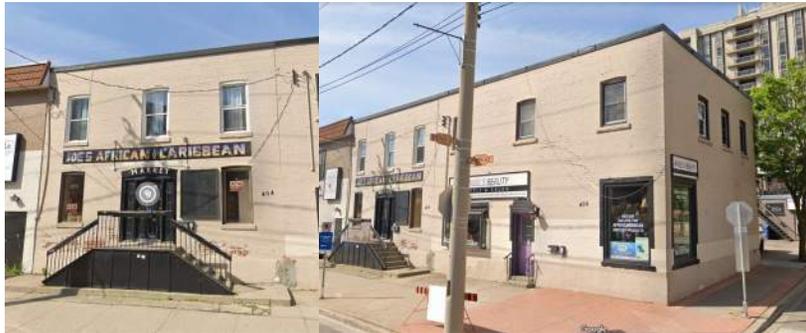
14. 404-408 John Street

Legal Description	PLAN 92 PT BLK M
Historic Land Use	404- Dwelling "2d" 408-Flour and Feed warehouse
Date of Construction	404- Between 1910 and 1924 408- 1912
Heritage Value or Interest	404- This two-storey masonry mixed-use building is believed to have historical value for its age and former use as an urban dwelling. It is believed to have design value for its symmetrical two-bay façade featuring segmental arched windows and rusticated stone or concrete sills. 408- Two-storey masonry building. Historical value for its former use as the Hannon Flour and Feed store. It is believed to have design value for its masonry exterior, utilitarian detailing and segmental arched windows with rusticated stone or concrete sills at second storey..
Heritage Status	None
Assessment	(✓) Qualifies for Heritage Register

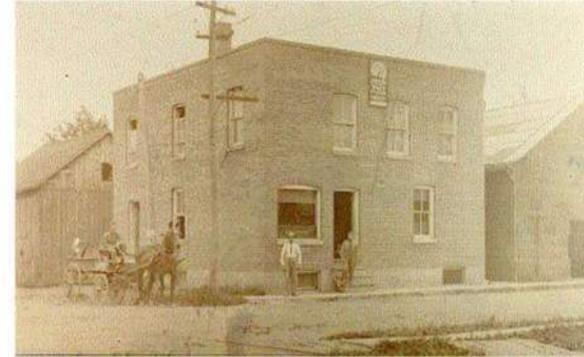
William Isaac Hannon standing in front of his store, Hannon Flour and Feed, at the southwest corner of Pine and John Streets, ca 1912 (Source: Burlington Historical Society)

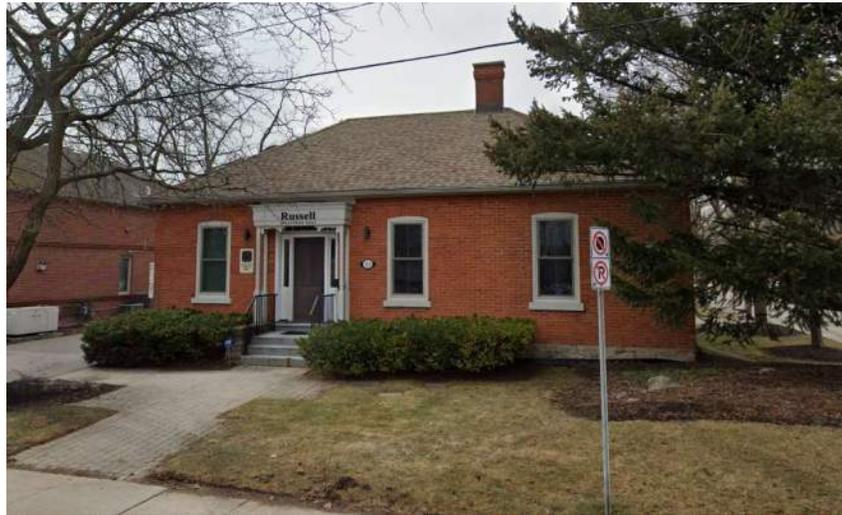
1. 524 Locust Street

Legal Description	PLAN 70 PT LOT 4
Historic Land Use	Residential (Dwelling)
Date of Construction	Pre 1910
Heritage Value or Interest	1-storey house form building believed to have historical value for its age and potential to yield information about Burlington's residential neighbourhoods before 1910. It is believed to have design value for its Victorian vernacular details including two-over-two windows, segmental arched windows, prominent sills, fieldstone foundation and entrance with sidelights.
Heritage Status	None
Assessment	(✓) Qualifies for Heritage Register

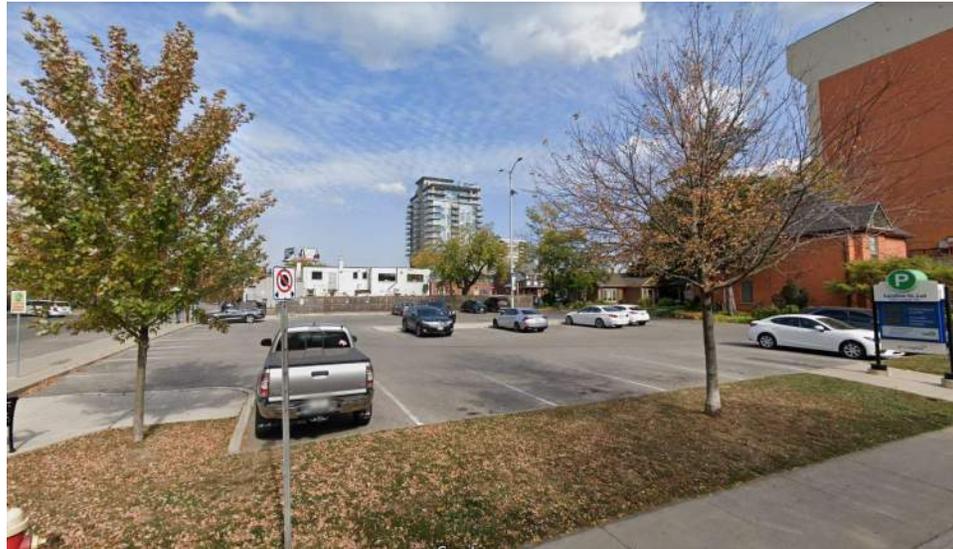
2. 523 Locust Street

Legal Description	PLAN 92 BLK V PT LOT 4
Historic Land Use	Residential (x2 Dwellings)
Date of Construction	N/A
Heritage Value or Interest	None. Vacant lot with no historical features.
Heritage Status	None
Assessment	(X) Not recommended for Heritage Register

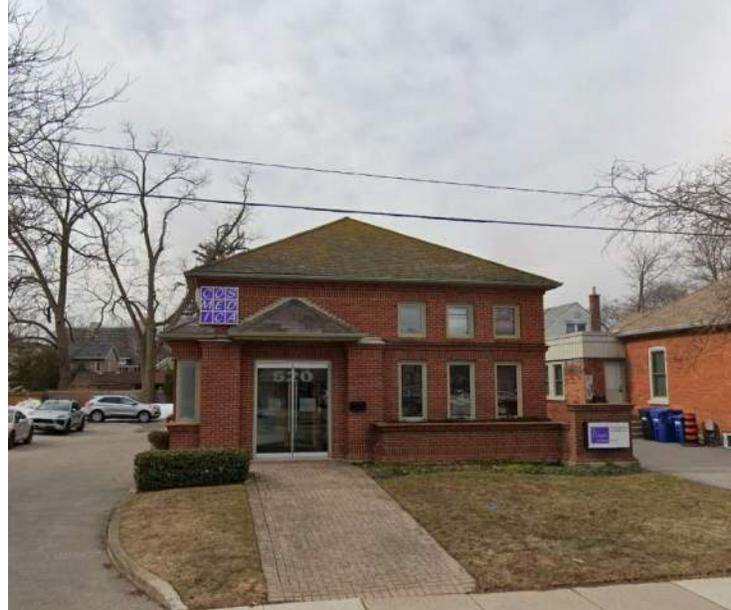
3. 520 Locust Street

Legal Description	PLAN 70 LOT 3
Historic Land Use	Residential
Date of Construction	Post 1924, relatively new building
Heritage Value or Interest	None. Relatively new two-storey commercial building.
Heritage Status	None
Assessment	(X) Not recommended for Heritage Register

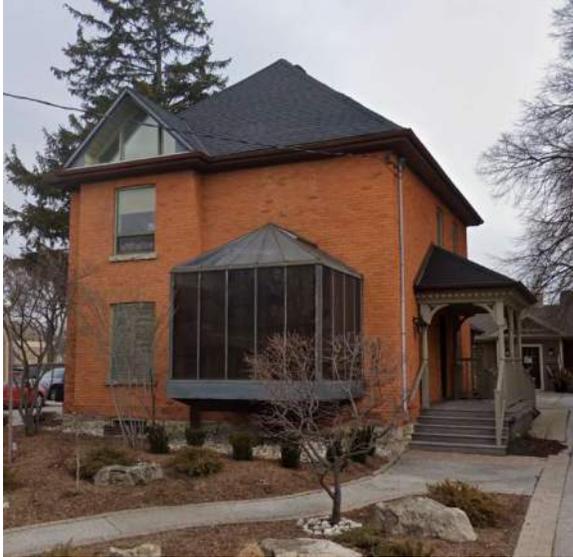
4. 513 Locust Street

Legal Description	PLAN 92 BLK V PT LOT 2LOCUST
Historic Land Use	Residential
Date of Construction	1886
Heritage Value or Interest	This two-storey vernacular house is believed to have historical value for its potential to yield information about Burlington's residential neighbourhoods in the late 1800s. It is believed to have design value for its victorian/gothic porch details, hipped roof, segmental arched ground floor windows and stone foundation. Alterations include the modern box window at the front and the restoration of a Victorian style porch to the rear elevation.
Heritage Status	None
Assessment	(✓) Qualifies for Heritage Register

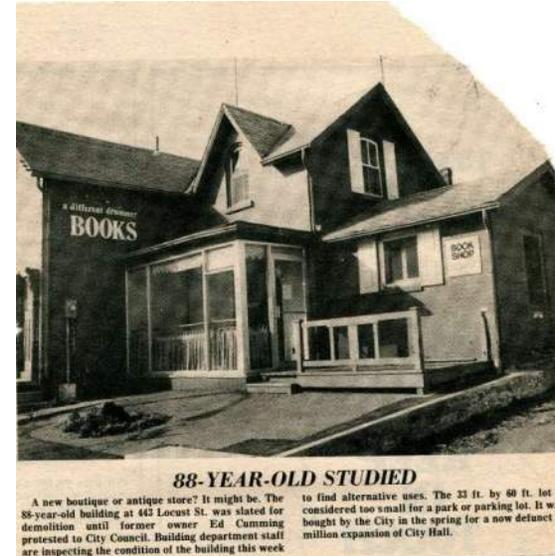
1974 Image of rear of building

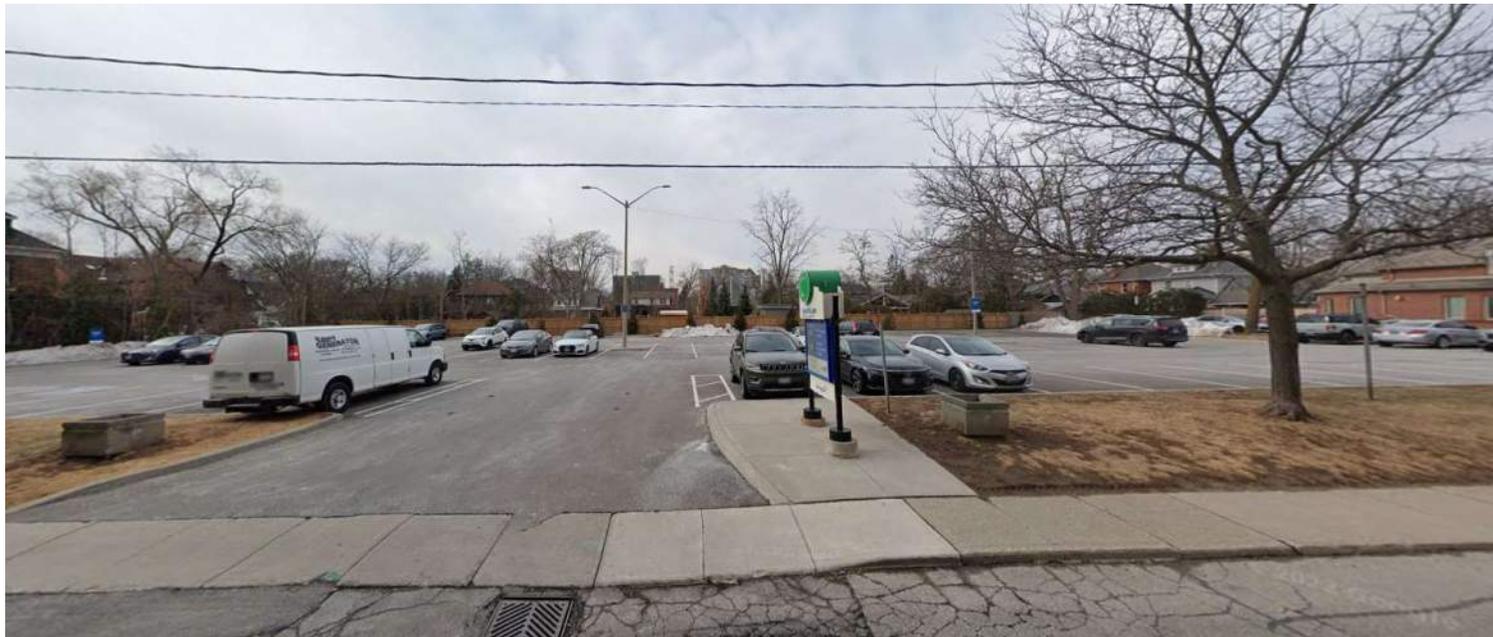
5. 500 Locust Street

Legal Description	PLAN 70 LOT 1 PLAN 74 PT LOT 50
Historic Land Use	Residential
Date of Construction	N/A
Heritage Value or Interest	None, no historical features on the property.
Heritage Status	None
Assessment	(X) Not recommended for Heritage Register

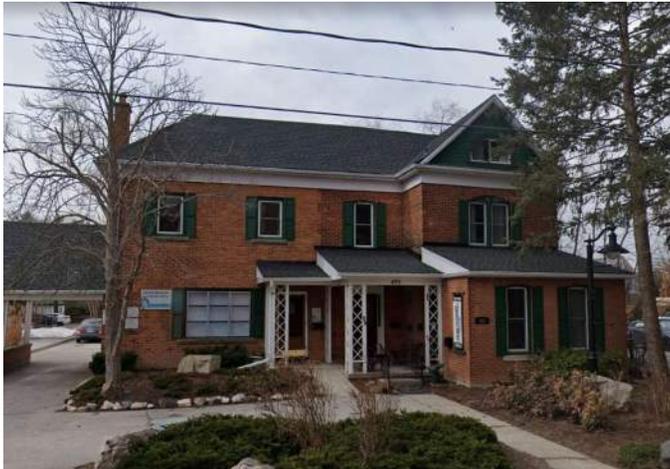
6. 492 Locust Street

Legal Description	PLAN 74 PT LOT 50
Historic Land Use	Residential (Dwelling)
Date of Construction	Pre 1910 (north half), 1924-195? (south half)
Heritage Value or Interest	North half built before 1910, south half built between 1924 and 1950s. HBAC recommends this property for inclusion on the Heritage Register for its design value, present in original features at the ground and second storey. The original detailing on the north half of the building includes round and segmental arched windows and fish-scale shingled gable with half round window opening. HBAC also believes the property has historical value for its significant age and mixed-use function. Alterations to the building include the south half of the building, which is a later addition and uses a slightly different colour brick and different window proportions.
Heritage Status	None
Assessment	(✓) Recommended by Heritage Burlington Advisory Committee for Heritage Register

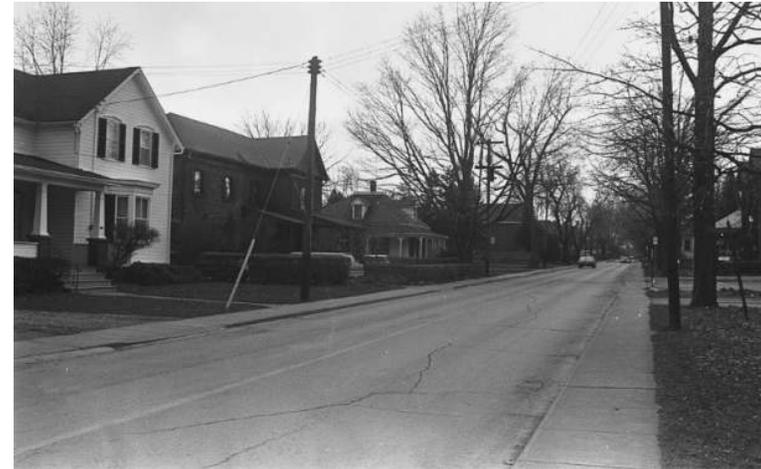
1950s image of Locust Street- Vintage Burlington

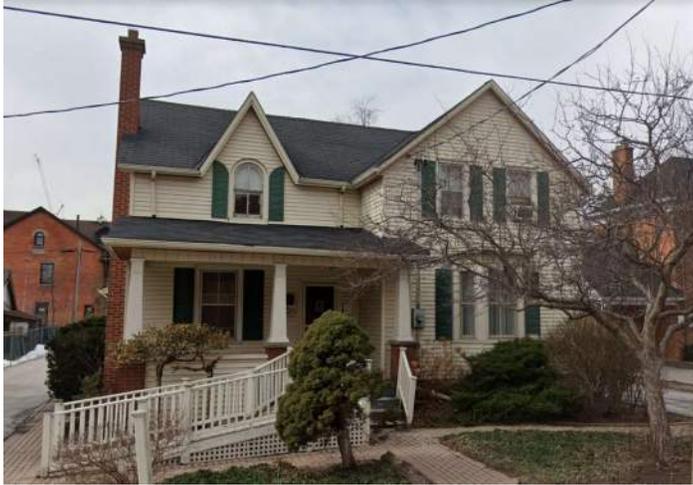
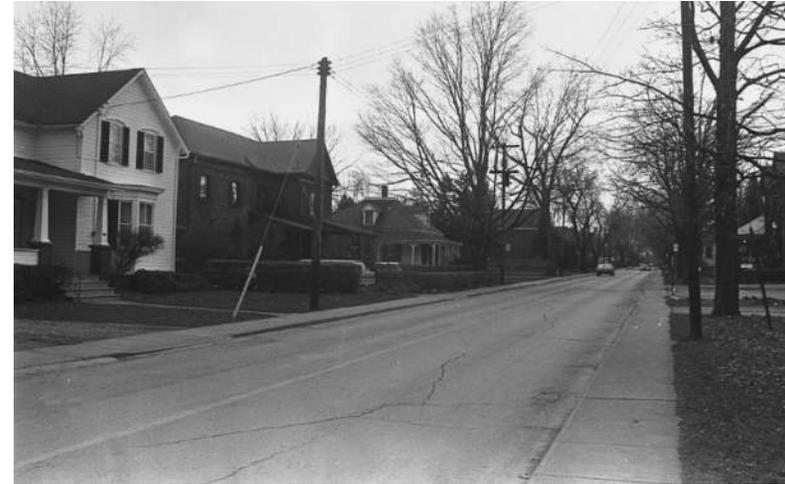
7. 488 Locust Street

Legal Description	PLAN 74 PT LOT 50
Historic Land Use	Residential (Dwelling)
Date of Construction	Pre 1910
Heritage Value or Interest	This property is believed to have historical value for its significant age and potential to yield information about Burlington's residential neighbourhoods before 1910. It is also believed to have architectural value for its Victorian vernacular features including a covered porch, bay window, round arched window in the second-storey gable and two-over-two sash windows.
Heritage Status	None
Assessment	(✓) Qualifies for Heritage Register

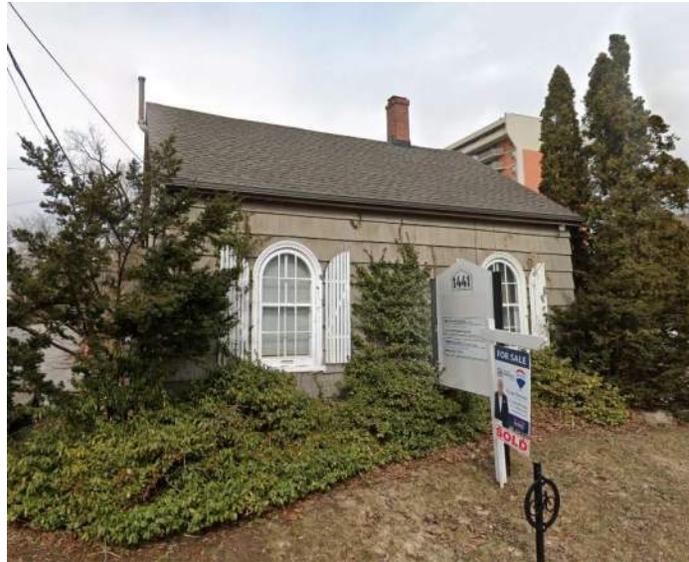
8. 1441 Ontario Street

Legal Description	PLAN 74 PT LOT 51
Historic Land Use	Residential (Dwelling)
Date of Construction	1830 (estimated)
Heritage Value or Interest	The William Hodgson - Sarah Oakley House. Vernacular loyalist cottage with 1-storey gable roof form and distinctive arched six-over-six sash windows on south and west elevations. The house has a rear 1-storey "kitchen tail". The exterior cladding does not appear original but may be possible to remove. "First constructed on the Brant Street site of the old town hall and library (which was built in 1906) and was moved to this lot in 1874 for William Hodgson. According to Stanley Blair, it was rebuilt by George Blair."- Building Stories
Heritage Status	Heritage Register, Non-designated
Assessment	(✓) Non Designated Heritage Register Property

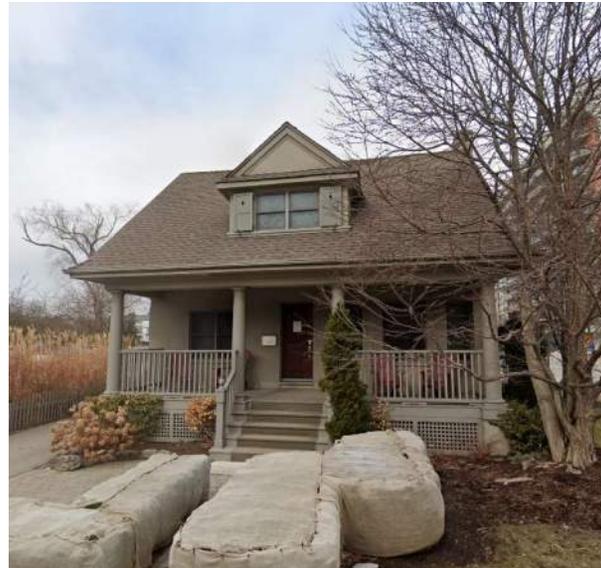
9. 1445 Ontario Street

Legal Description	PLAN 74 PT LOT 51
Historic Land Use	Residential (Dwelling)
Date of Construction	Between 1910-1924
Heritage Value or Interest	This property is believed to have historical value for its potential to yield information about Burlington's residential neighbourhoods in the early 20 th century. It is believed to have architectural value as a 1.5-storey vernacular bungalow with covered porch supported with classical (Tuscan) columns. A half bay window on the east side of the front elevation introduces some asymmetry to the facade. Above the porch is a gabled dormer with double-hung one-over-one sash windows.
Heritage Status	None
Assessment	(✓) Qualifies for Heritage Register

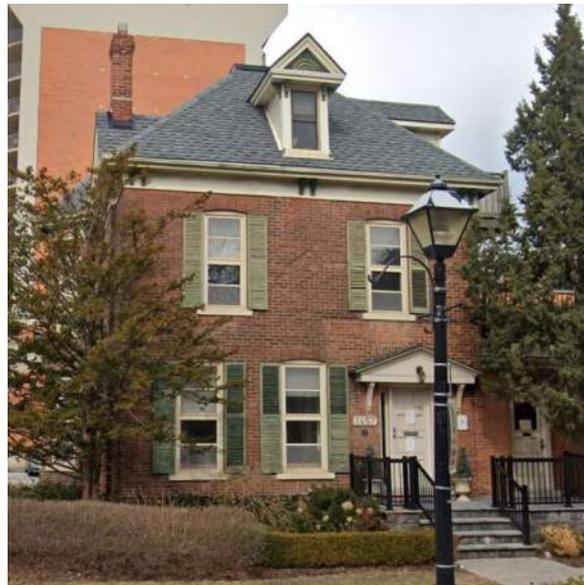
10. 1457 Ontario Street

Legal Description	PLAN 92 BLK W PTS 1,2 LOCUST
Historic Land Use	Residential (Dwelling)
Date of Construction	1875
Heritage Value or Interest	Historical and architectural. The Miller Bush House. 2-storey Victorian Vernacular building with masonry exterior, segmental arched windows, west facing hexagonal bay window
Heritage Status	Heritage Designated Property
Assessment	(✓) Heritage Designated

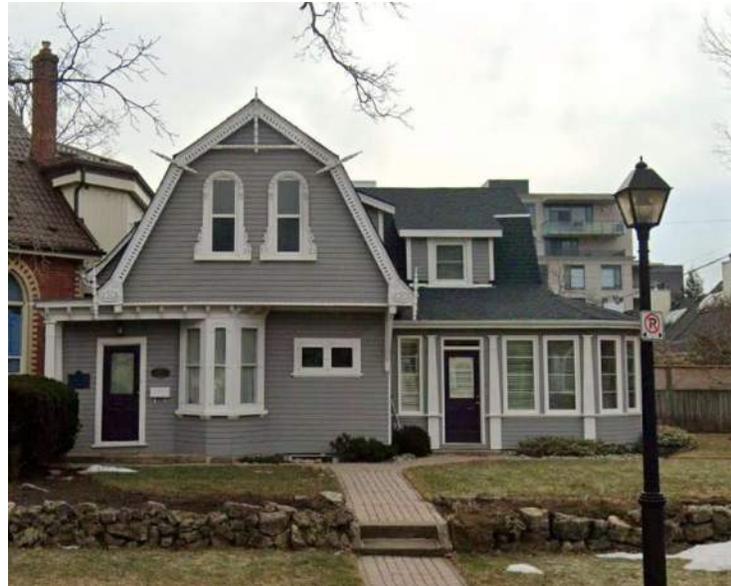
11. 1442 Ontario Street

Legal Description	PLAN 74 PT LOT 52
Historic Land Use	Residential (Dwelling) The James Cushie Bent House.
Date of Construction	1888
Heritage Value or Interest	Architectural value. Carpenter gothic style house of wood frame construction, with covered, curved and enclosed glassed-in porch, handmade and carved ornamentation for the windows, mouldings, soffits, gables and cornices. Decorative roof braces.
Heritage Status	Heritage Designated Property
Assessment	(✓) Heritage Designated

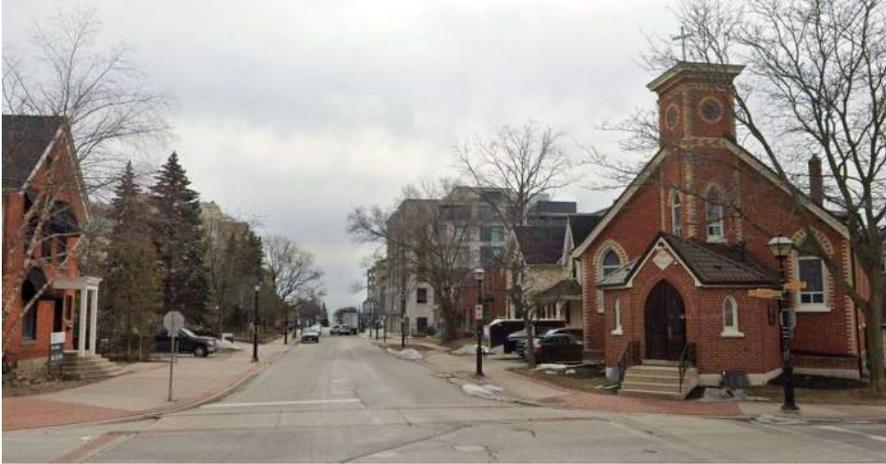
12. 472 Locust Street

Legal Description	PLAN 74 PT LOT 52
Historic Land Use	Church ("L'Eglise St Philippe")
Date of Construction	N/A
Heritage Value or Interest	Architectural and historical/associative value. Originally Calvary Baptist Church. Church structure with a combination of Gothic Revival and Italianate styles.
Heritage Status	Heritage Register, Non-designated
Assessment	(✓) Non Designated Heritage Register Property

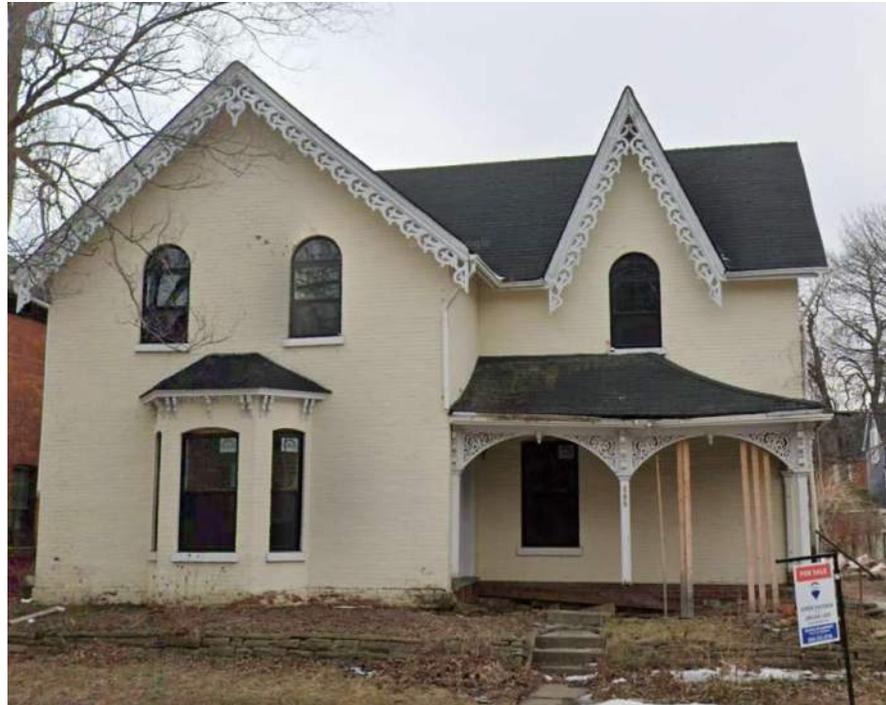
14. 468 Locust Street

Legal Description	PLAN 74 LOT 53
Historic Land Use	Dwelling ("The Robert Kentner House")
Date of Construction	1900
Heritage Value or Interest	Architectural value. Two storey brick structure in Gothic Revival style.
Heritage Status	Heritage Register, Non-designated
Assessment	(✓) Non Designated Heritage Register Property

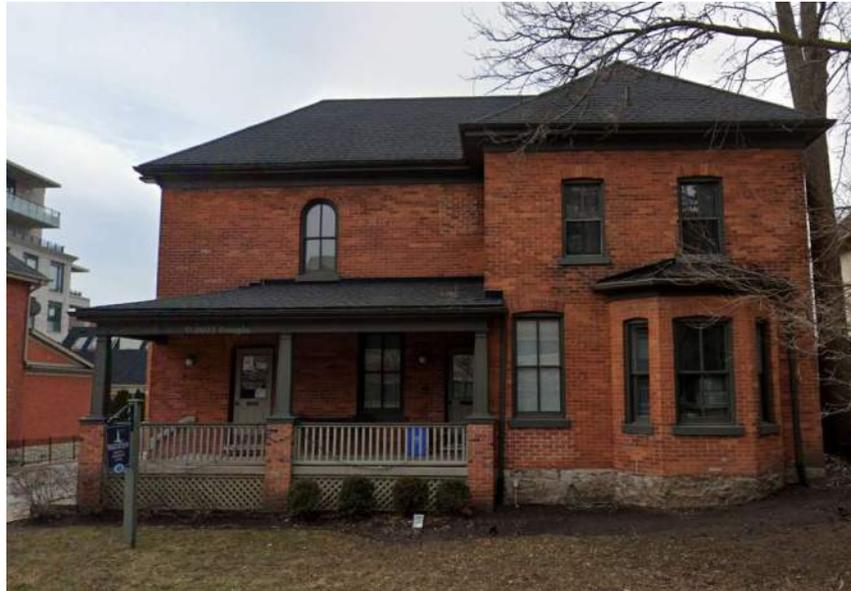
15. 462-464 Locust Street

Legal Description	PLAN 92 PT LOT 54
Historic Land Use	Dwelling (The "Richard Cole House")
Date of Construction	1896
Heritage Value or Interest	Architectural and historical/associative. Early Victorian brick dwelling with later renovations from 1943.
Heritage Status	Heritage Designated Property
Assessment	(✓) Heritage Designated

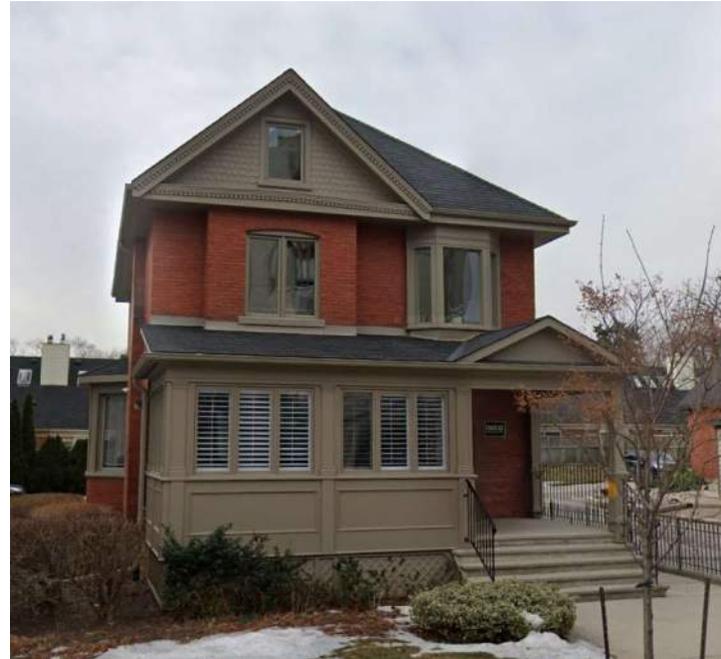
16. 458 Locust Street

Legal Description	PLAN 74 PT LOT 54 SAVE AND EXCEPT RP 20R7438 PART10
Historic Land Use	Dwelling
Date of Construction	Pre 1910
Heritage Value or Interest	This two-storey masonry dwelling is believed to have architectural value for its Queen Anne revival style details including fish scale shingles in gable and segmental arched window at second storey. is believed to have historical value for its potential to yield information about Burlington's residential neighbourhoods before 1910. Alterations include the enclosed the porch at ground storey.
Heritage Status	None
Assessment	(✓) Qualifies for Heritage Register

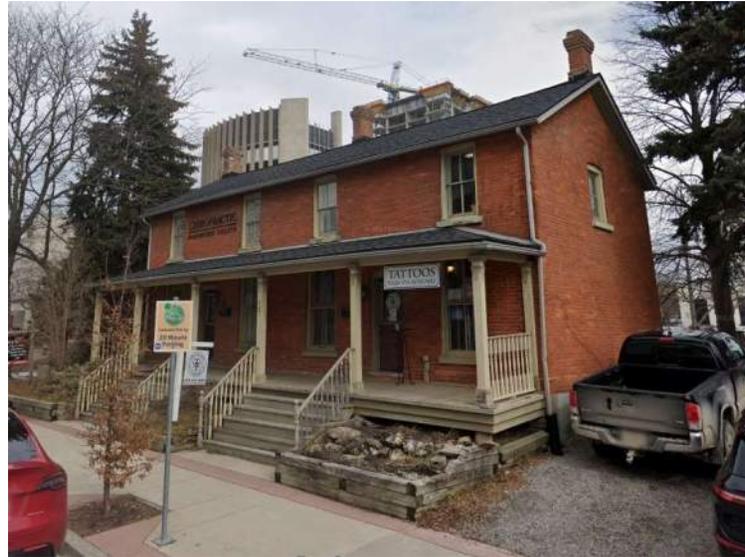
17. 447-449 Locust Street (Separate Properties)

Address	447- PLAN 92 BLK X PT LOT 8 RP 20R12790 PART 2 449- PLAN 92 BLK X PT LOT 8 RP 20R12790 PART 1
Historic Land Use	Semi-detached dwelling
Date of Construction	1867
Heritage Value or Interest	Built in 1867 for Norman Hamburg, a labourer, and his wife Sarah, and their family, this is a rare example of an historic semi-detached residence, and one of the few extant pre-Confederation structures in downtown Burlington. It is a “modest, but well-constructed house...” “...unspoiled by modern alterations and retains its original windows, doors, wood trim, storm door and the original gallery verandah supported by square columns with decorative relief details”
Heritage Status	Heritage Designated
Assessment	(✓) Heritage Designated

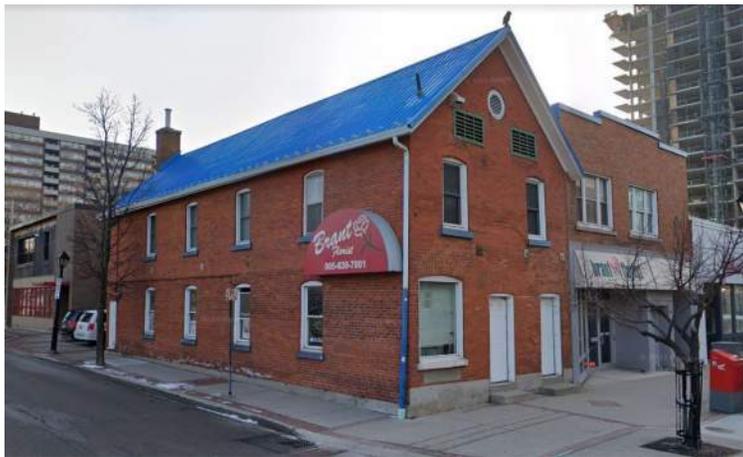
1. 459-463 Brant Street

Legal Description	PLAN 92 BLK E PT LOT 1
Historic Land Use	Offices and Masonic Lodge
Date of Construction	Corner portion- Pre 1910, South portion- Post 1924
Heritage Value or Interest	Architectural and historical value. Two storey masonry commercial building with gable roof. The building features segmental arched windows at the first and second storey. The south portion of the building facing Brant Street is a much later addition with newer brick and mortar in better condition.
Heritage Status	Heritage Register, Non-designated
Assessment	(✓) Non Designated Heritage Register Property
