Cultural Heritage Landscape #1- Foot of Brant Street

Cultural Heritage Landscape #2- Locust Street

Cultural Heritage Landscape #4- Downtown East

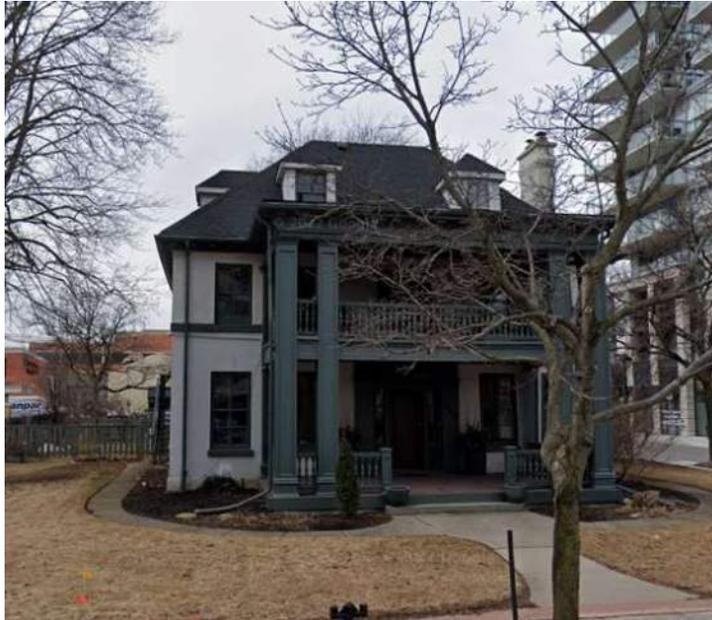
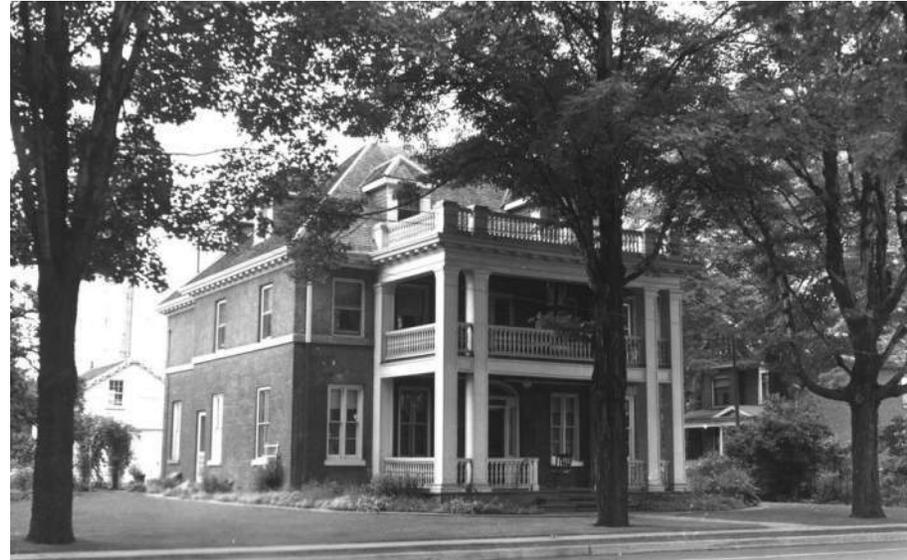
3. 490 Elizabeth Street / 2042 Maria Street

Undated Historic Photo of 490 Elizabeth/ 2042 Maria Street from Vintage Burlington

Legal Description	PLAN 92 BLK F PT LOTS 1,2
Historic Land Use	Residential (Dwelling) The Laing - Fisher House Shanston Hall (aka 490 Elizabeth St).
Date of Construction	1855
Heritage Value or Interest	Mid-Victorian Neo-Classic solid brick structure with Edwardian rear additions and second and third storey
Heritage Status	Heritage Register, Non-designated
Assessment	(✓) Non Designated Heritage Register Property

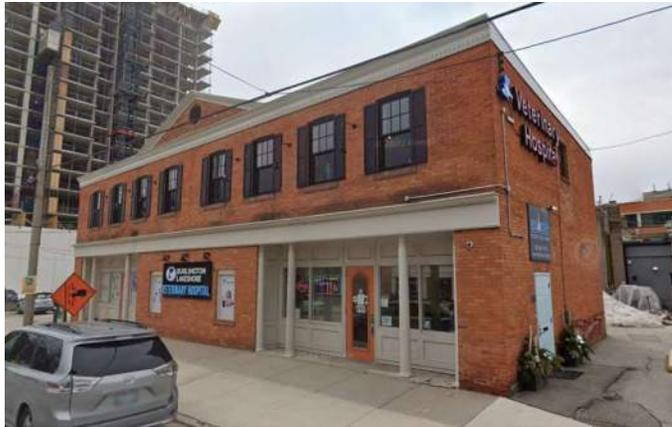
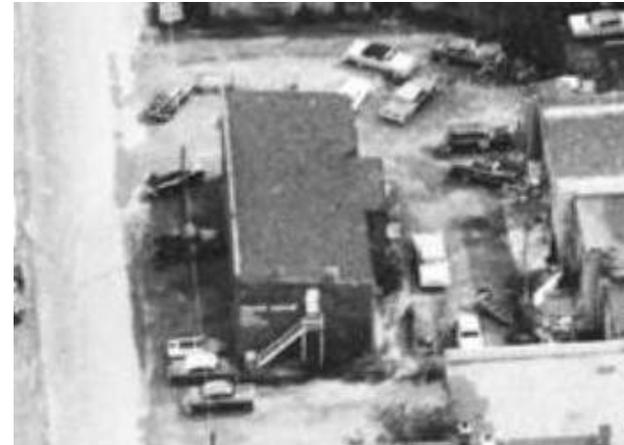
4. 482 John Street

Legal Description	PLAN 92 BLK E PT LOTS 2 TO 4
Historic Land Use	Electric Power & Light (the "The Burlington Electric Company")
Date of Construction	1910-1924
Heritage Value or Interest	Two storey masonry industrial building with segmental arched windows and brick sills at second storey. The roofline features a dentilated cornice and pediment, however the pediment may be a later addition. The ground floor configuration and storefronts is likely not original. Masonry exterior of the building is largely intact.
Heritage Status	Heritage Register, Non-designated
Assessment	(✓) Non Designated Heritage Register Property

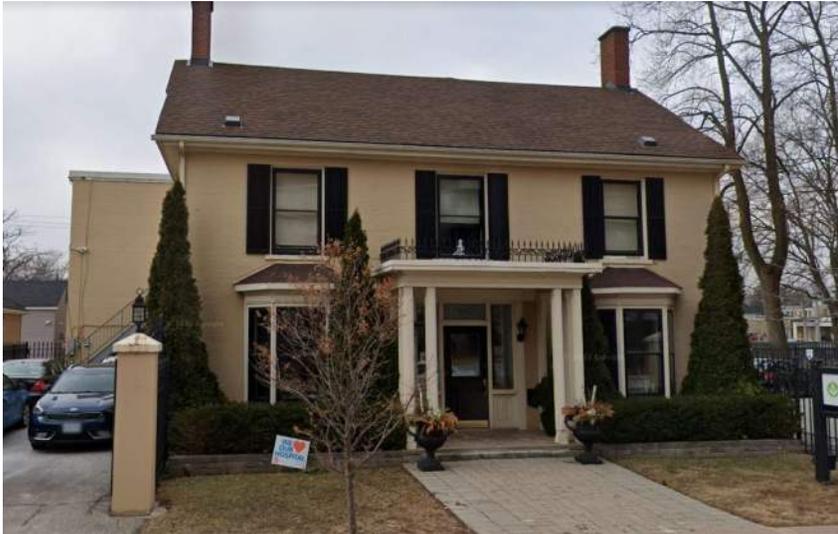
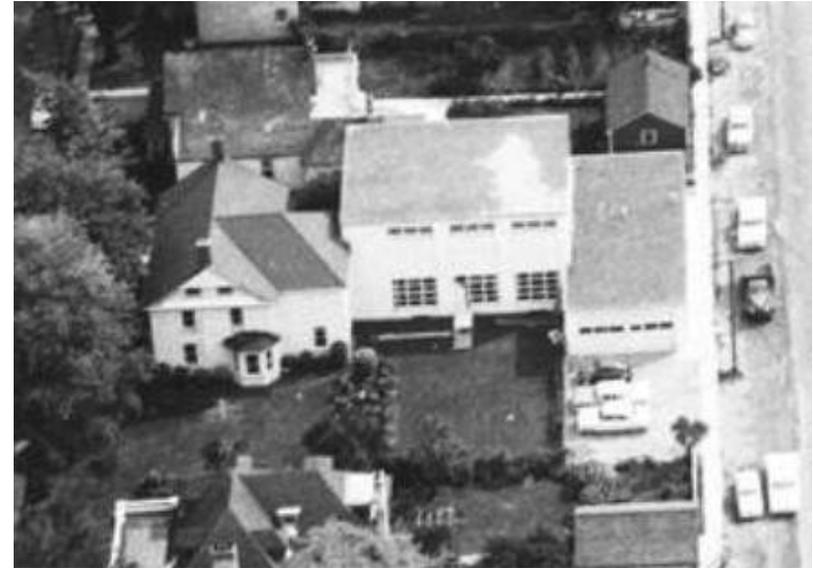
5. 482 Elizabeth Street

Legal Description	PLAN 92 BLK F LOT 3 PT LOT 2
Historic Land Use	Residential (dwelling) The Laing - Speers House and former Burlington Public Library.
Date of Construction	1873
Heritage Value or Interest	Two-storey three-bay brick structure in Neo-Classical style.
Heritage Status	Heritage Register, Non-designated
Assessment	(✓) Non-Designated Heritage Register Property

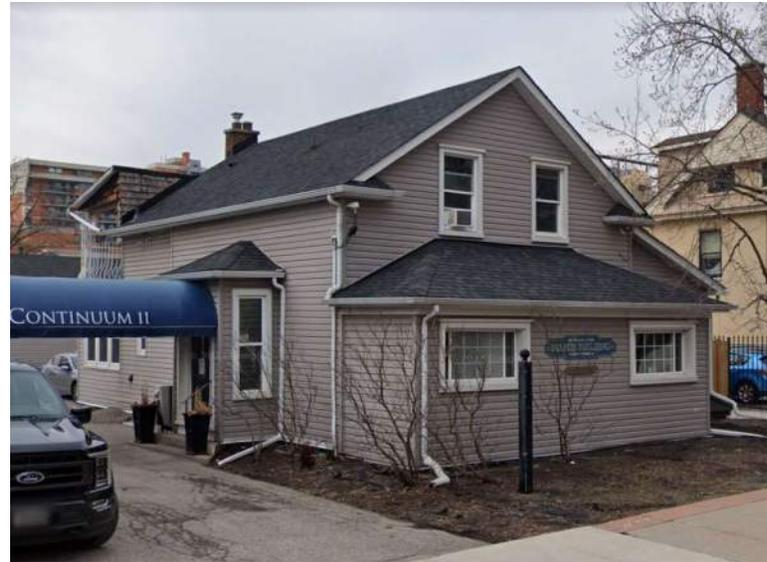
6. 478 Elizabeth Street

Legal Description	PLAN 92 BLK F LOT 4
Historic Land Use	Residential (dwelling)
Date of Construction	Pre 1910
Heritage Value or Interest	Potential heritage value compromised by extensive alterations. Two storey gable roof dwelling with multiple additions and alterations obscuring original character. Second storey window openings in gable may be original.
Heritage Status	None
Assessment	(X) Not recommended for Heritage Register

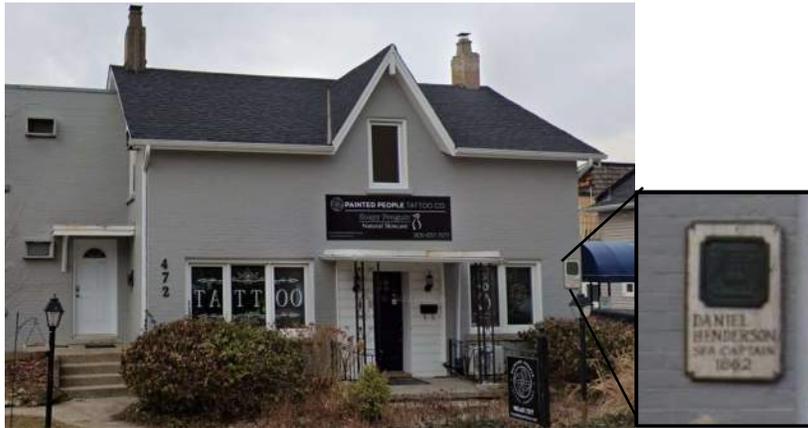
7. 472 Elizabeth Street

Legal Description	PLAN 92 BLK F LOT 5
Historic Land Use	Residential (dwelling)
Date of Construction	1862(?) (According to Plaque)
Heritage Value or Interest	Some potential historical and design value, however extent of alterations means it requires further study. Two storey masonry house with peaked dormer centred over the main entrance. The house is designed in the Gothic vernacular style, popular between 1850 and 1880. Alterations to the house include painted brick, replaced windows, south addition. The ground floor window openings may not be original. In 1915, the house featured a full width covered porch with a sheet metal roof
Heritage Status	None
Assessment	(X) Further Study Recommended

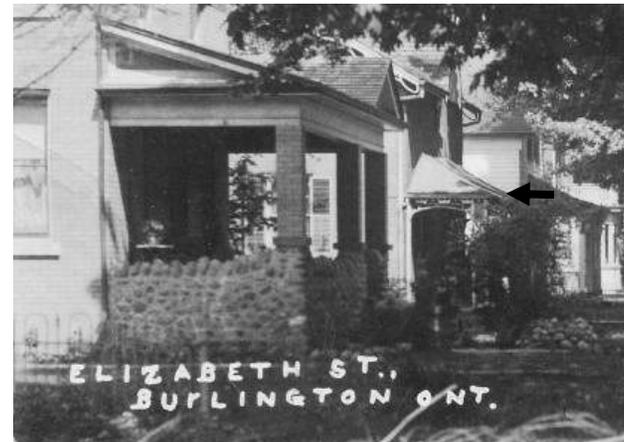
Cropped 1915 Photo of Elizabeth Street looking North towards Caroline

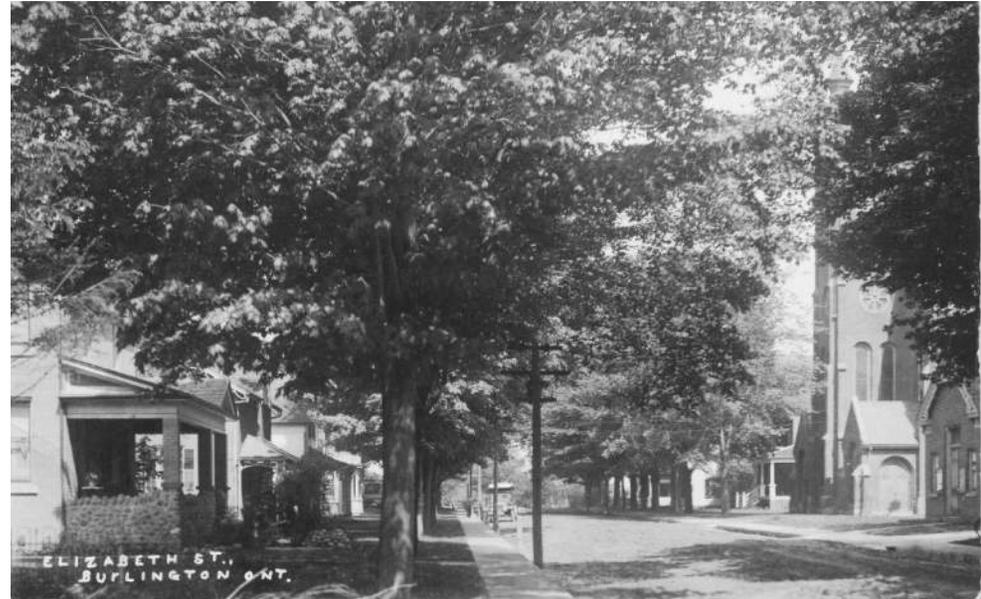
8. 468 Elizabeth Street

1915 Photo of Elizabeth Street looking North towards Caroline

Legal Description	PLAN 92 BLK F PT LOT 6
Historic Land Use	Residential (dwelling)
Date of Construction	Pre 1910
Heritage Value or Interest	This two storey masonry building has historical value for its age and potential to yield information about Burlington residential areas before 1910. It is believed to have design value for its vernacular homestead and craftsman details. The house is two bays wide, with entrance positioned at the side of the ground floor. The full width veranda with craftsman style stone base is original. Two-over-two sash windows feature segmental arches.
Heritage Status	None
Assessment	(✓) Qualifies for Heritage Register

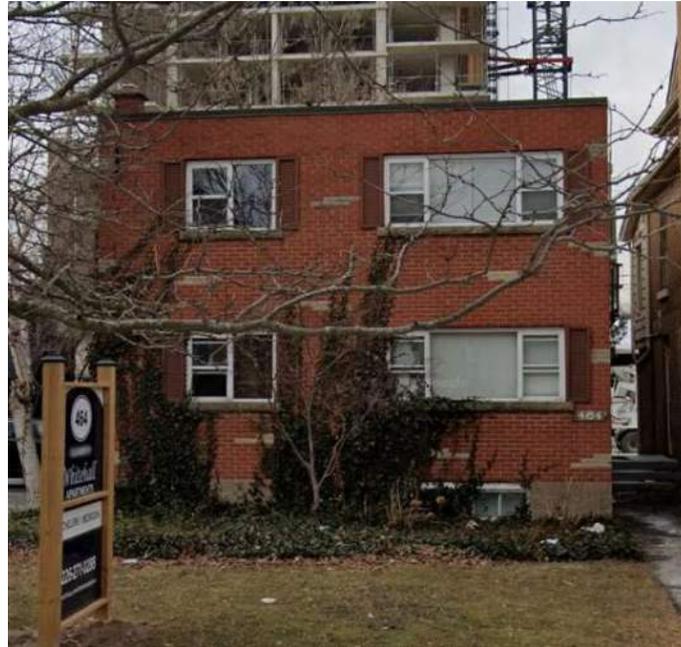
9. 464 Elizabeth Street

Legal Description	PLAN 92 BLK F PT LOTS 6,7
Historic Land Use	Residential (dwelling)
Date of Construction	Post 1924
Heritage Value or Interest	The Heritage Burlington Advisory Committee believes this building has potential design value as a transitional style building blending elements of architectural modernism such as long horizontal windows and traditional elements like protruding window sills.
Heritage Status	None
Assessment	(X) Further Study Recommended

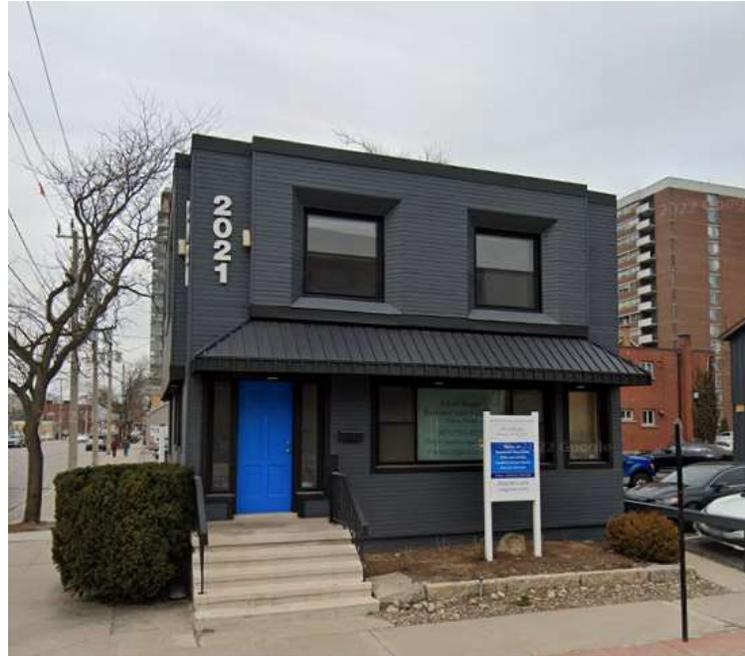
10. 2021 James Street

Legal Description	PLAN 92 BLK F PT LOT 7
Historic Land Use	1924- Empty Lot
Date of Construction	?
Heritage Value or Interest	Two storey commercial building with contemporary exterior cladding and details. Original masonry likely survives underneath.
Heritage Status	None
Assessment	(X) Further Study Recommended

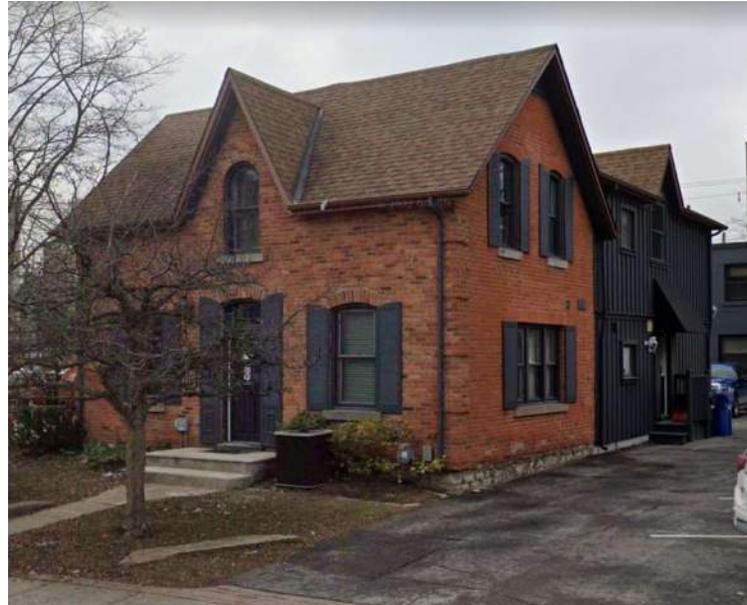
11. 458 Elizabeth Street

Legal Description	PLAN 92 BLK F PT LOT 7
Historic Land Use	Residential (dwelling) "The John Taylor House"
Date of Construction	1876
Heritage Value or Interest	Historical and design value. This two-storey gothic vernacular house is clad in polychromatic brick. The peaked dormer in the roof features a round arched window. Other windows and entrance feature segmental arches with voussoirs. The front façade is accented with brick corner quoins at the edges.
Heritage Status	Heritage Register, Non-designated
Assessment	(✓) Non-Designated Heritage Register Property

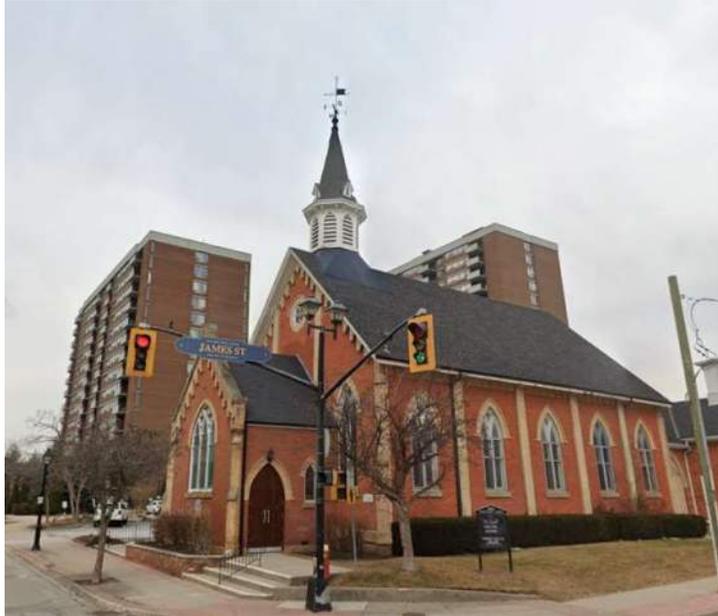
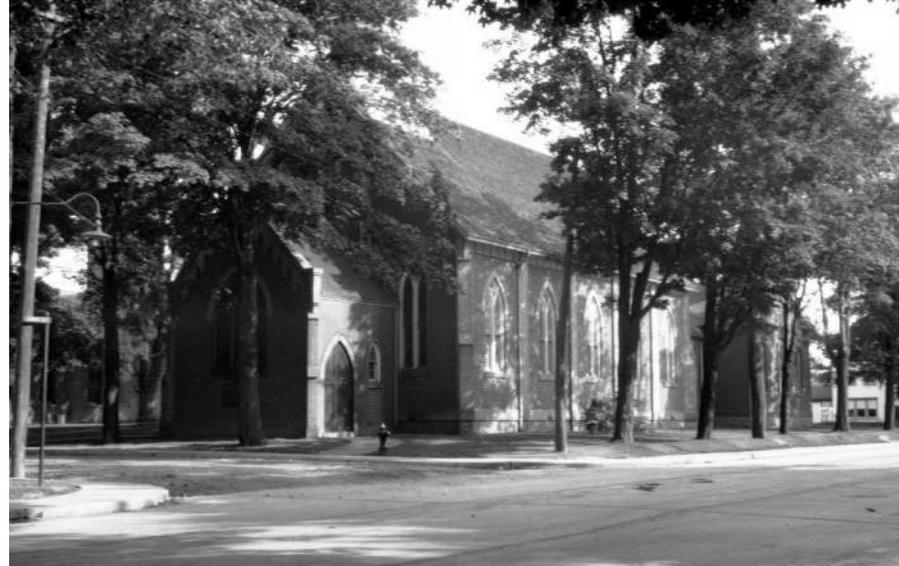
12. 461 Elizabeth Street

Knox Presbyterian Church, Oct 27 1930 The Evening Review. F.H. Leslie

Legal Description	PLAN 92 BLK G PT LOTS 6,7
Historic Land Use	Place of Worship (Church) Knox Presbyterian Church
Date of Construction	1877
Heritage Value or Interest	Historical, design and contextual value. Gothic revival style church constructed of red and buff brick on land donated to the church in 1845. The main gable and entry gable feature buff corbelled brick and buttresses at the corners. The rich detailing with arched windows and doors and a steeple at the front of the building make this a neighbourhood landmark.
Heritage Status	Heritage Register, Non-designated
Assessment	(✓) Non-Designated Heritage Register Property

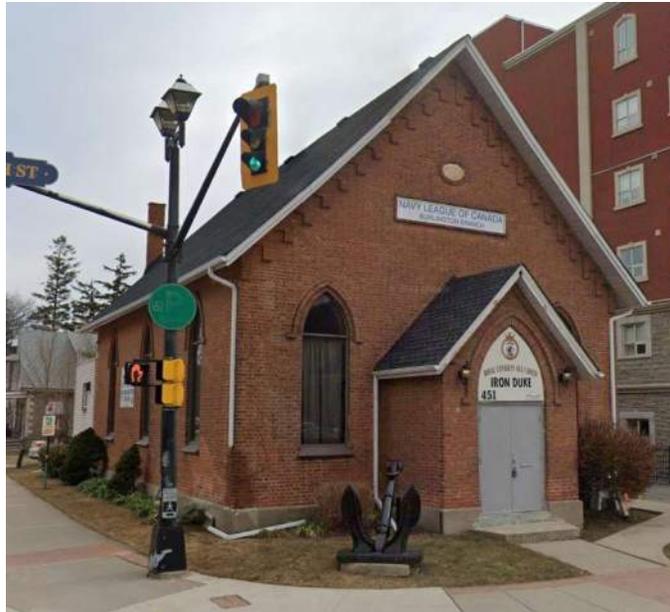
13. 451 Elizabeth Street

Legal Description	PLAN 92 BLK K PT LOT 1
Historic Land Use	Institutional (Sunday School) The Former Methodist Episcopal Church, later the Iron Duke.
Date of Construction	1868
Heritage Value or Interest	Historical, design and contextual value. First Methodist Church in the Village of Burlington. Gothic Revival vernacular brick structure
Heritage Status	Heritage Register, Non-designated
Assessment	(✓) Non Designated Heritage Register Property

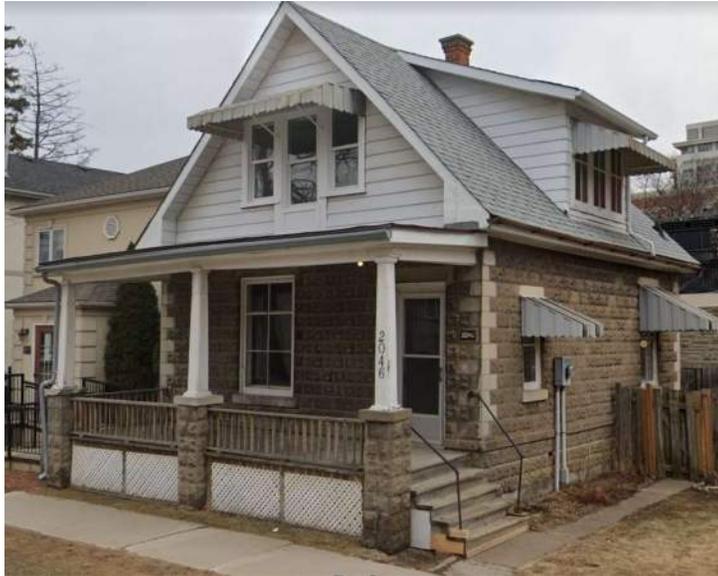
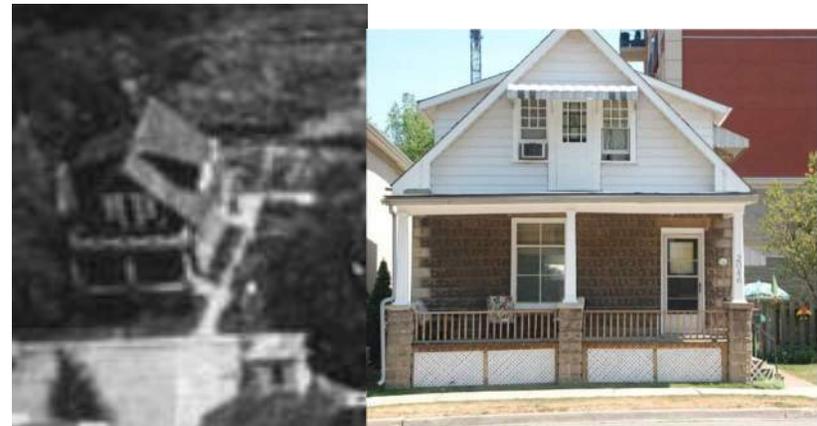
14. 2046 James Street

Crop from 1960 Aerial Photo & 2012 Photo

Legal Description	PLAN 92 BLK K PT LOT 1
Historic Land Use	Residential (dwelling)
Date of Construction	Between 1910-1924
Heritage Value or Interest	Undetermined heritage value. Basic vernacular homestead with square headed windows and distinctive shed dormers with three-part windows. Full width front verandah with simple square columns. The top of the gable and the sides of the dormers have been re-clad in aluminum or plastic siding.
Heritage Status	None
Assessment	(X) Further Study Recommended

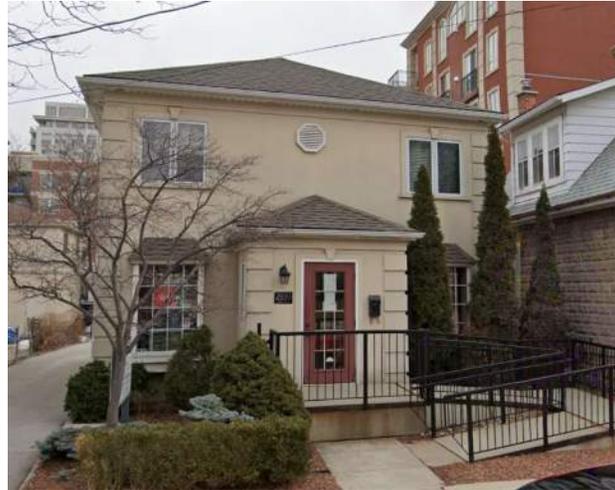
15. 2050 James Street

Legal Description	PLAN 92 BLK K PT LOTS 15,16
Historic Land Use	Empty lot
Date of Construction	Unknown, post 1924
Heritage Value or Interest	None. Modern neo traditional, hipped roof office building. Mix of imitation historic building features with no unifying style.
Heritage Status	None
Assessment	(X) Not recommended for Heritage Register

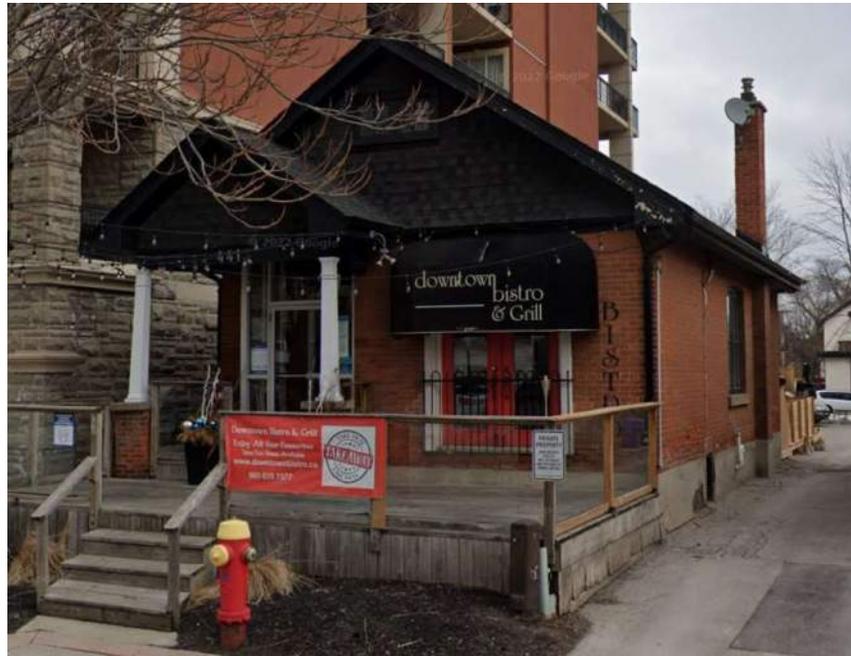
16. 441 Elizabeth Street

Legal Description	PLAN 92 BLK K PT LOT 3
Historic Land Use	Empty lot
Date of Construction	Unknown, post 1924
Heritage Value or Interest	Believed to have some historical and design value. Basic vernacular homestead with heavily altered façade with minimal distinguishing historic features. Segmental arched window visible on side elevation
Heritage Status	None
Assessment	(✓) Heritage Burlington Advisory Committee recommends for inclusion on Register

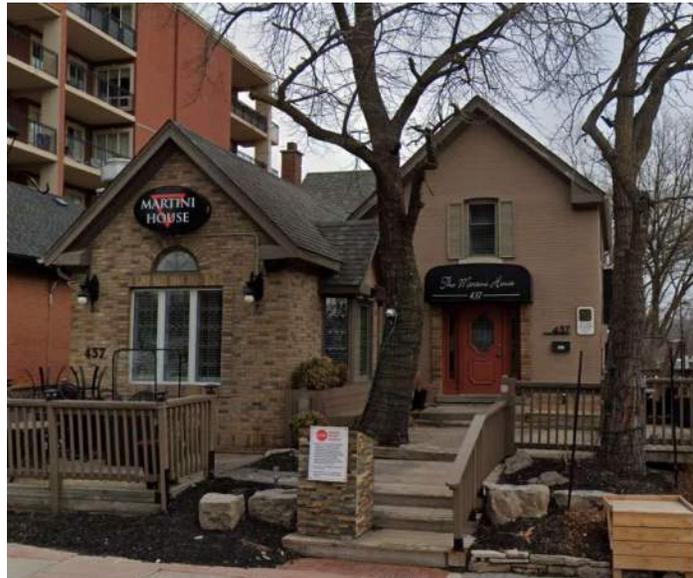
17. 437 Elizabeth Street

Legal Description	PLAN 92 BLK K PT LOT 3
Historic Land Use	Residential (Dwelling)
Date of Construction	Pre 1910 (south portion)
Heritage Value or Interest	The original portions of this two storey masonry house are believed to have design value for their vernacular homestead details such as segmental arched windows and projecting sills. The house has been significantly altered with a large addition built onto the north side. The main entrance has been altered and enlarged. All windows replaced.
Heritage Status	None
Assessment	(✓) Heritage Burlington Advisory Committee recommends for inclusion on Register

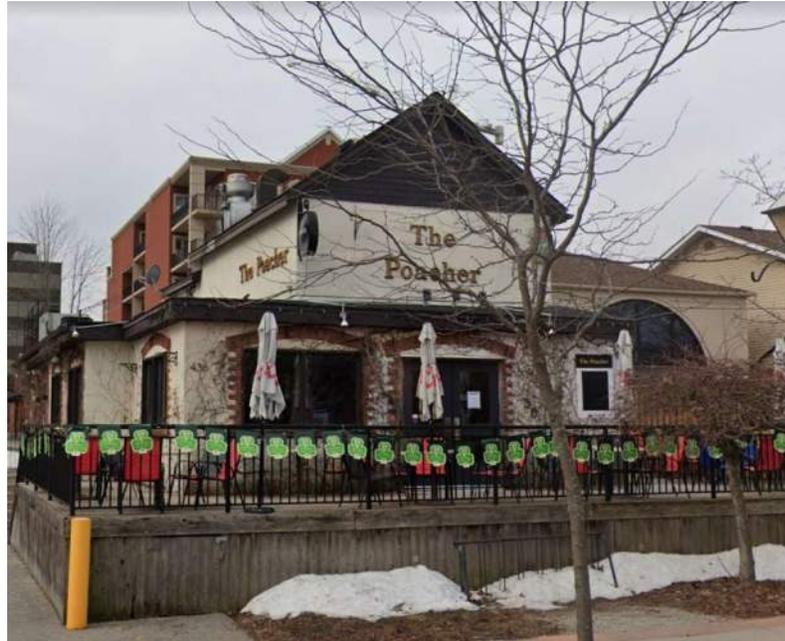
18. 436 Pearl Street

Legal Description	PLAN 92 BLK K LOT 14
Historic Land Use	Residential (Dwelling)
Date of Construction	Pre 1910 (Middle gable roof portion)
Heritage Value or Interest	This building is believed to have some potential historical value due to its local reputation and conversion from a two-storey gable roof house to a popular restaurant. Extensively altered with ground storey additions. Second storey has been re-clad and no window openings remain.
Heritage Status	None
Assessment	(✓) Heritage Burlington Advisory Committee recommends for inclusion on Register

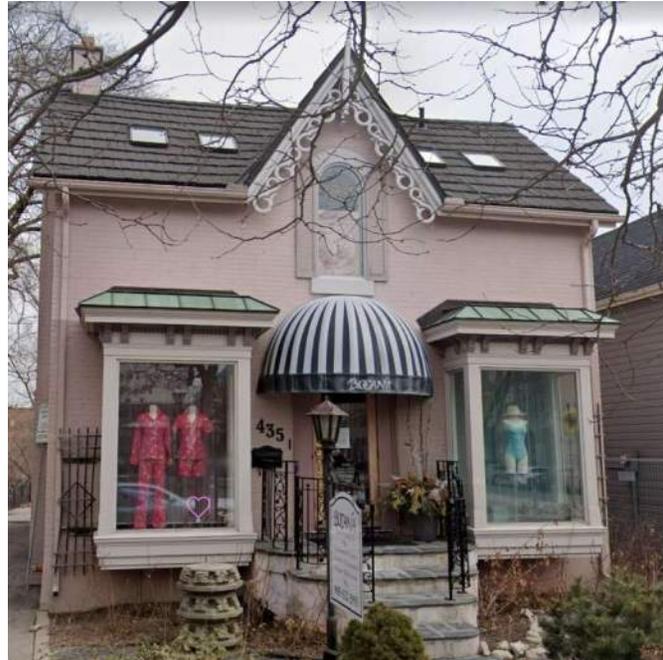
19. 435 Pearl Street

Legal Description	PLAN 92 BLK L PT LOT 3
Historic Land Use	Residential (Dwelling)
Date of Construction	Mid-late 1800s
Heritage Value or Interest	This two-storey house is believed to have design value for its gothic vernacular detailing including gingerbread trim accenting a peaked dormer in the roof. The dormer features a round arched window centred over the main entry. Front box bay windows are likely not original.
Heritage Status	None
Assessment	(✓) Qualifies for Heritage Register

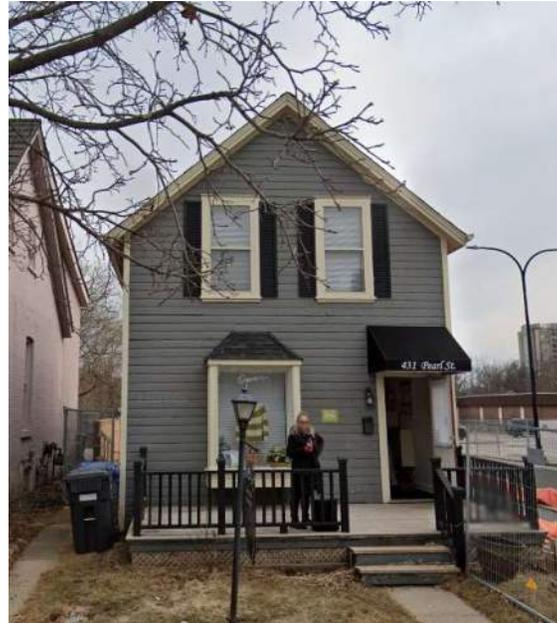
20. 431 Pearl Street

Legal Description	PLAN 92 BLK L PT LOTS 3,4 ,13 AND 14 AND RP 20R12443 PART 1 RP 20R21723 PARTS 1 TO 4, 17 TO 22
Historic Land Use	Residential (Dwelling)
Date of Construction	Pre 1910
Heritage Value or Interest	This two-storey wood frame house is believed to have design value for its vernacular homestead details including an asymmetrical façade and square headed, one-over-one sash windows.
Heritage Status	None
Assessment	(✓) Qualifies for Heritage Register

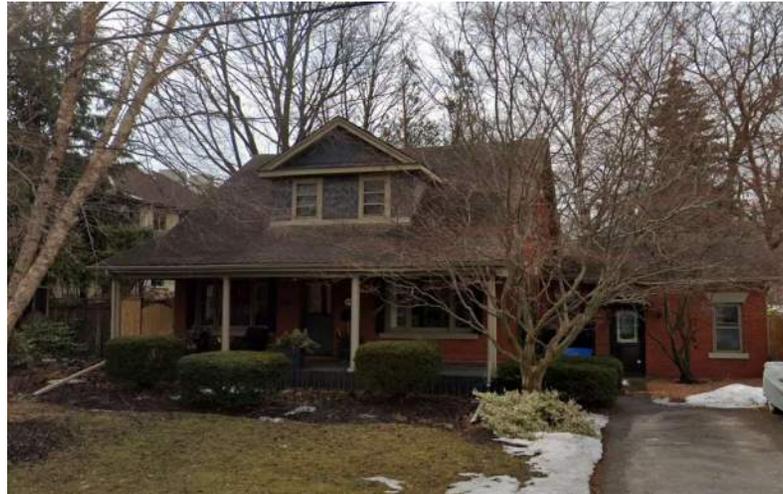
1. 436 Burlington Avenue

Legal Description	PLAN 74 PT LOT 20 RP 20R5459 PART 1
Historic Land Use	Residential
Date of Construction	1914
Architectural Description	The Toronto and Niagara Power Company Office and House. Craftsman-inspired building. The building is a one and a half storey bungalow with a red brick main floor and a low-sloped end gable roof with wooden fish scale shingles and full front verandah. The front elevation's prominent dormer window has a pedimented roof, double hung windows and wooden fish-scale shingles. The front verandah is supported by slim "Tuscan style columns". The front façade has two grouped windows flanking the front entrance (one wide and two narrow).
Heritage Status	Heritage designated
Assessment	(✓) Designated Heritage Property

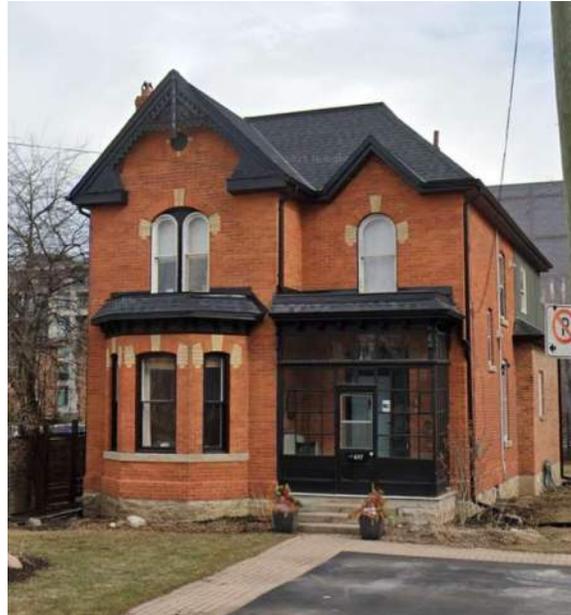
2. 437 Burlington Avenue

Legal Description	PLAN 74 PT LOT 21
Historic Land Use	Residential
Date of Construction	Pre 1924, likely 1850-1870
Architectural Description	Two-and-a-half storey Italianate style masonry dwelling. Red brick with buff brick accents around the window arches resembling a hood mould with a keystone. Full arched windows at second storey with segmental arched windows at the ground-storey. The house features carved Victorian style trim in the main gable and decorative brackets accenting the eaves of the half bay window and porch at the ground storey.
Heritage Status	None
Assessment	(✓) Qualifies for Heritage Register

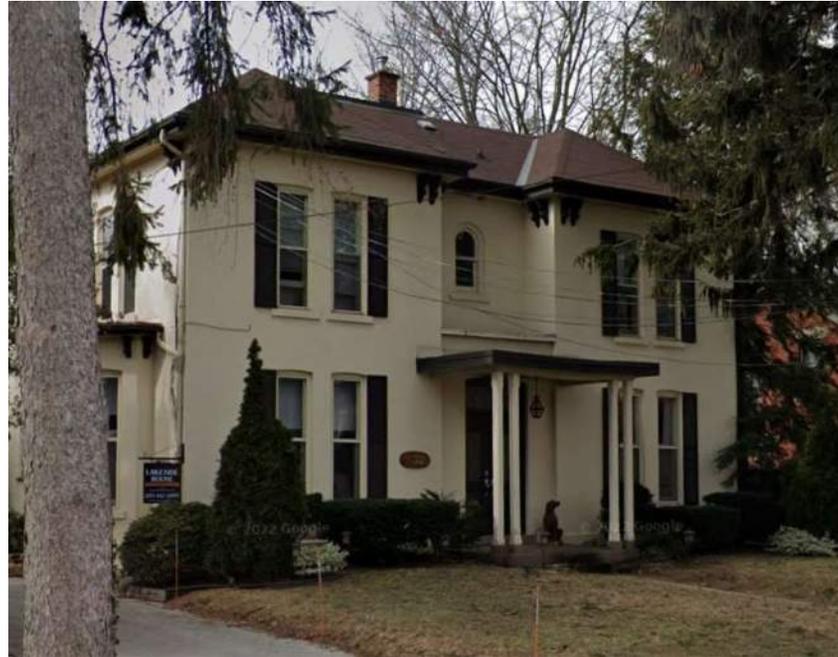
Legal Description	PLAN 74 LOT 17
Historic Land Use	Residential
Date of Construction	1885
Architectural Description	The Stuart Greer House. Itanianate style two-storey masonry house with a symmetrical facade featuring paired segmental arched windows and paired brackets along the eaves. The façade has been painted.
Heritage Status	Heritage Register, Non-designated
Assessment	(✓) Non Designated Heritage Register Property

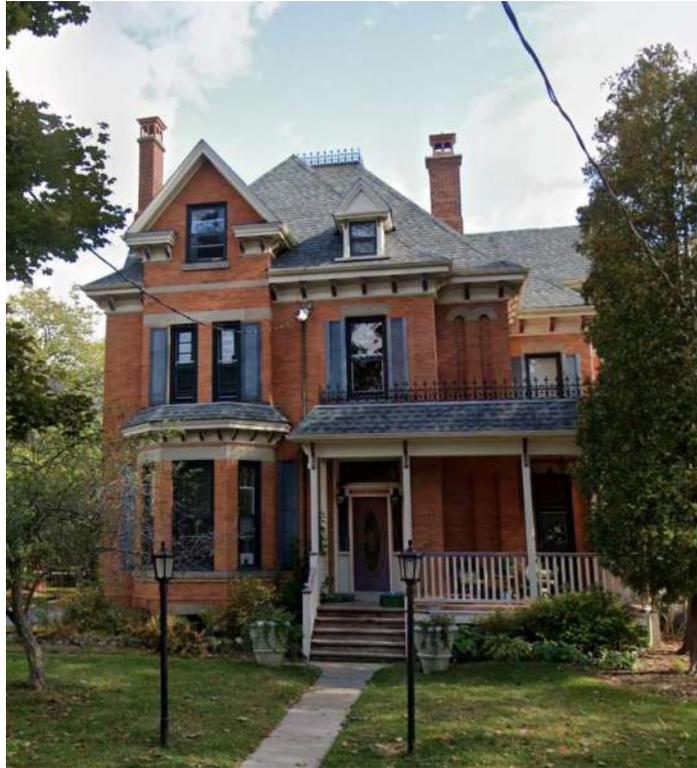
Legal Description	PLAN 74 LOT 16
Historic Land Use	Residential
Date of Construction	1887
Architectural Description	The Stuart Greer House. Two-and-a-half storey brick structure in Queen Anne Revival style. Three original standing gas lamps
Heritage Status	Heritage Register, Non-designated
Assessment	(✓) Non Designated Heritage Register Property

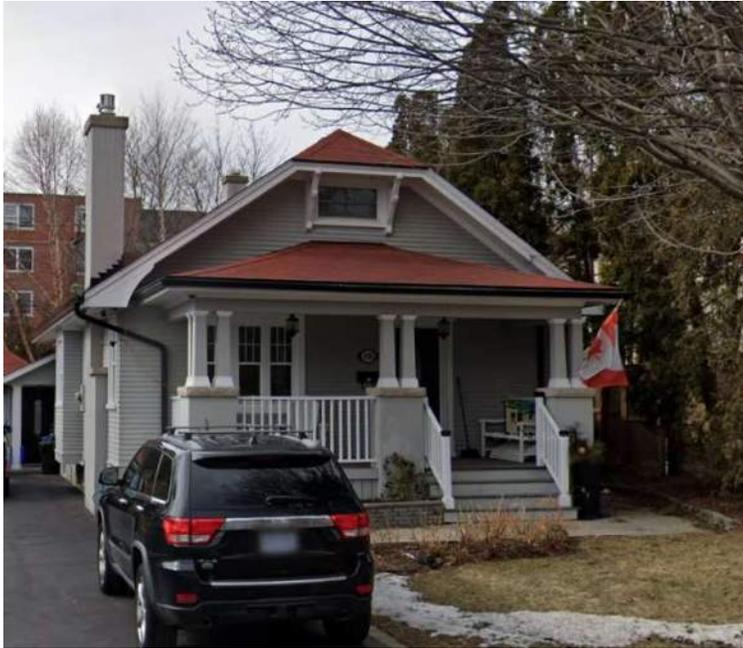
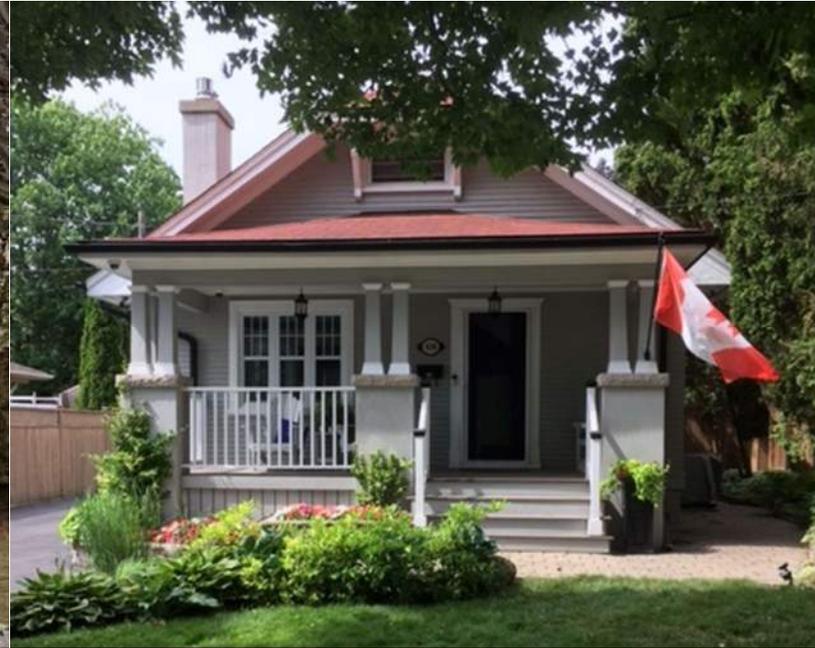
Legal Description	PLAN 74 PT LOT 14
Historic Land Use	Residential
Date of Construction	Pre 1924
Architectural Description	1.5 storey craftsman bungalow characterized by a broad verandah with grouped square columns and masonry pedestals. To the left of the doorway are three six-over-one sash windows. The house also has a distinctive jerkinhead roof with knee brackets.
Heritage Status	None
Assessment	(✓) Qualifies for Heritage Register

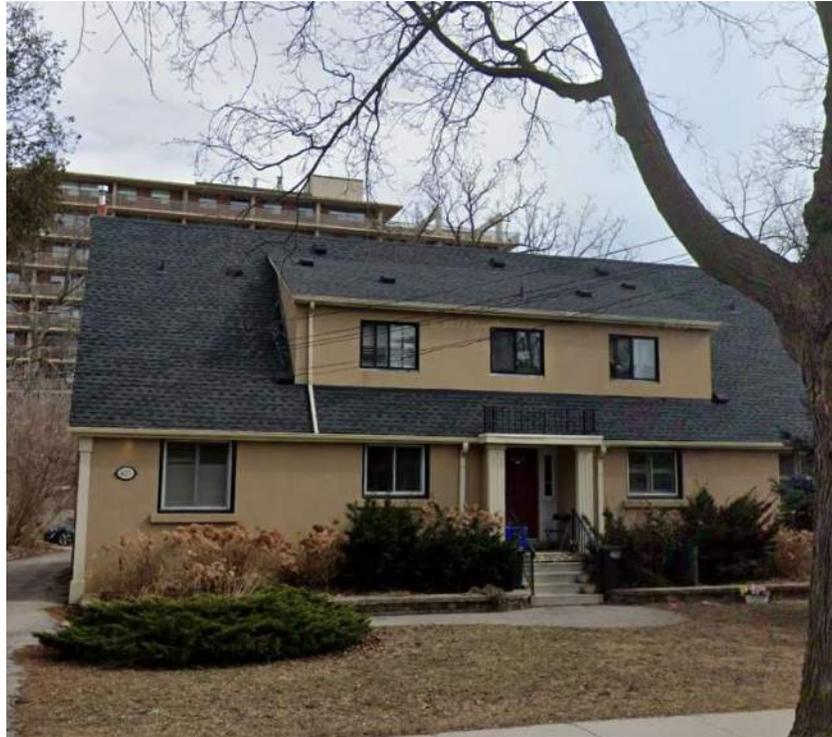
Legal Description	PLAN 74 LOT 15
Historic Land Use	Empty Lot
Date of Construction	Post 1924
Architectural Description	1.5 storey multi-unit residential building. Symmetrical façade, no distinguishing historic features.
Heritage Status	None
Assessment	(X) Not recommended for Heritage Register

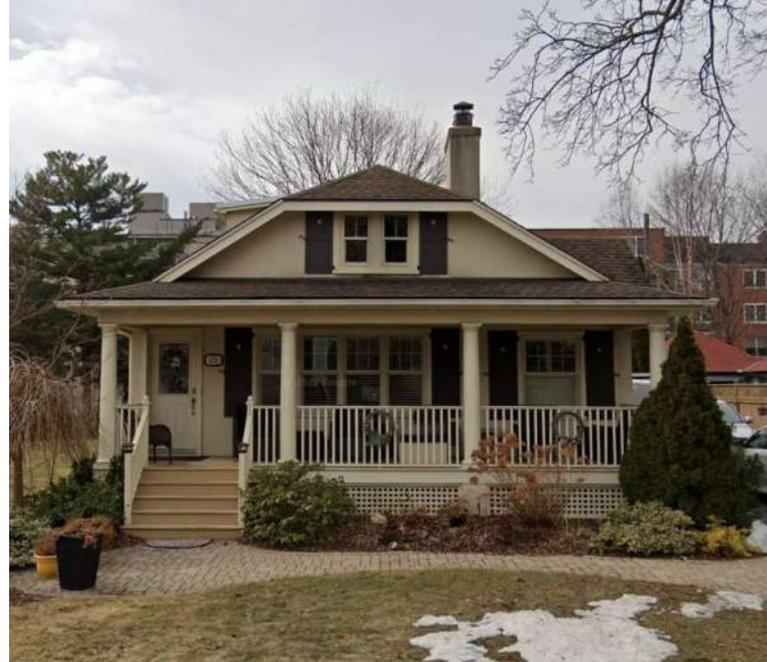
Legal Description	PLAN 74 PT LOTS 13,14
Historic Land Use	Empty Lot
Date of Construction	Post 1924, but likely constructed during the 1920s
Architectural Description	1.5 storey craftsman bungalow characterized by a full width verandah with Tuscan columns. Asymmetrical façade with doorway to one side of a set of four six-over-one windows. The house also has a distinctive jerkinhead roof.
Heritage Status	None
Assessment	(✓) Qualifies for Heritage Register

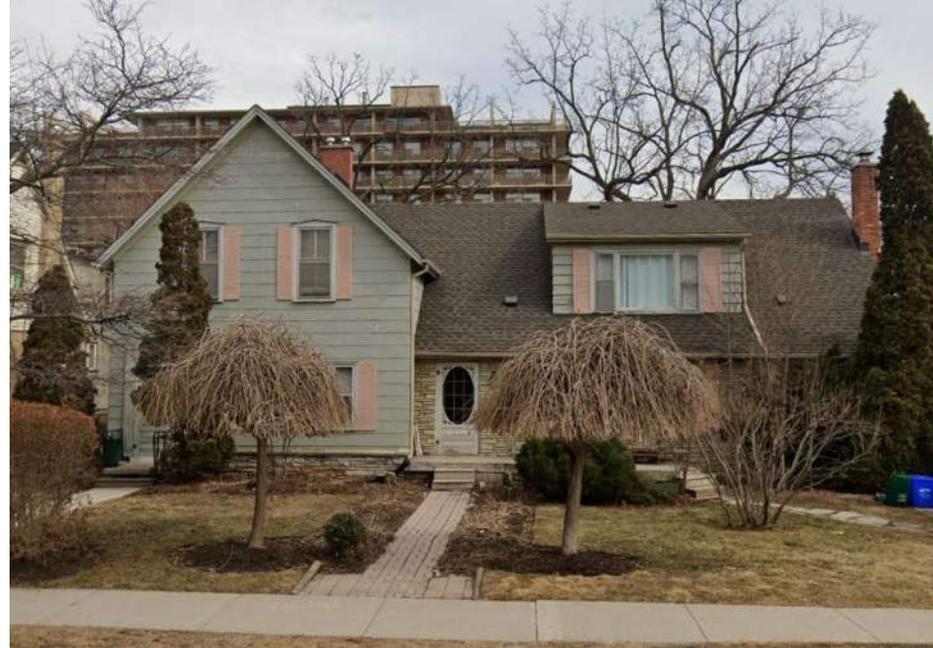
Legal Description	PLAN 74 LOT 12 PT LOT 9
Historic Land Use	Empty Lot
Date of Construction	Pre 1924
Architectural Description	The Buntion - Knife - Flock House. Oldest house on Burlington Avenue. Two-storey front-gabled frame structure clad with vertical board-and-batten siding.
Heritage Status	Heritage Register, Non-designated
Assessment	(✓) Non Designated Heritage Register Property

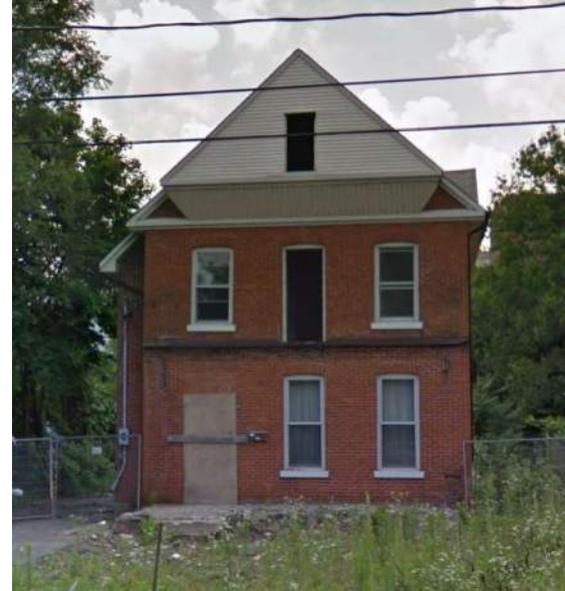
2020 Image

Legal Description	PLAN 74 PT LOT 13
Historic Land Use	Residential
Date of Construction	Pre 1924
Architectural Description	N/A
Heritage Status	None
Assessment	(X) Not eligible for Heritage Register

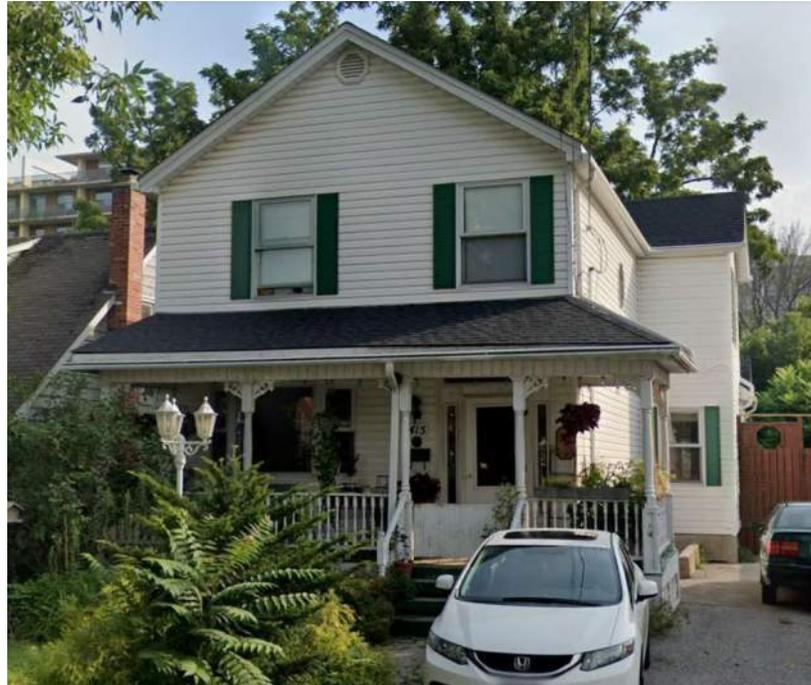
Legal Description	PLAN 74 PT LOTS 6,7
Historic Land Use	Residential
Date of Construction	1895
Architectural Description	The George and Josephine Noyes House.
Heritage Status	Heritage Register, Designated
Assessment	(✓) Designated Heritage Property

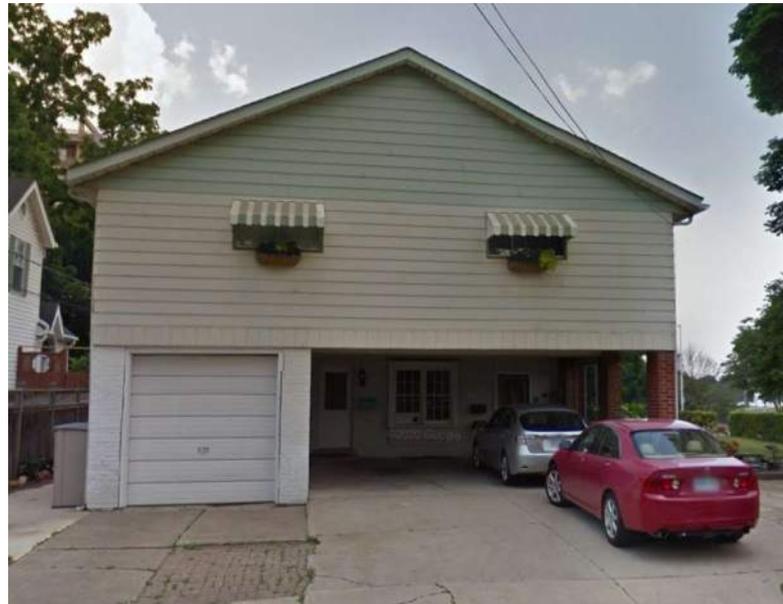
Legal Description	PLAN 74 PT LOTS 6,7
Historic Land Use	Empty lot
Date of Construction	Unknown
Architectural Description	Unexceptional two-storey residential building.
Heritage Status	None
Assessment	(X) Not recommended for Heritage Register

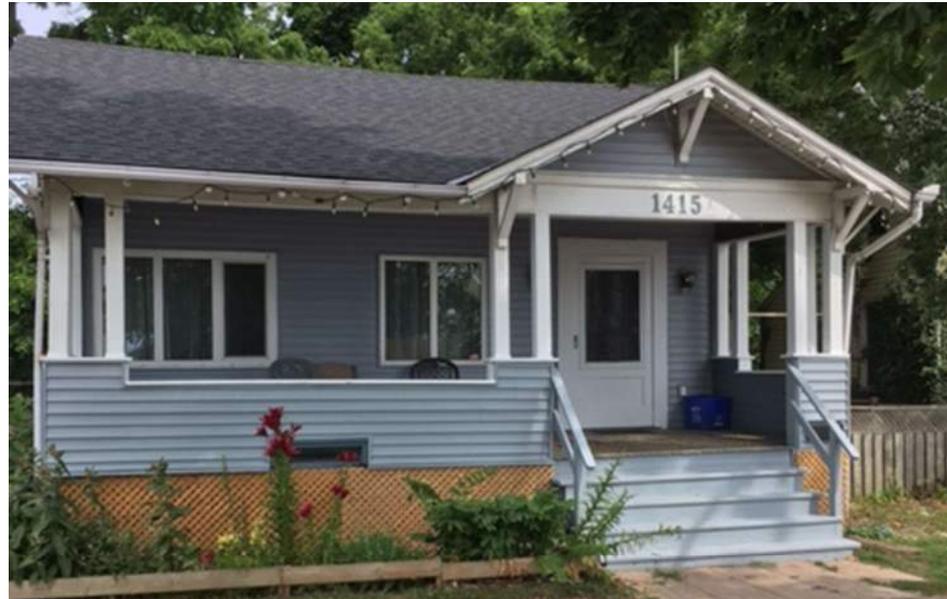
Legal Description	PLAN 74 PT LOT 8
Historic Land Use	Residential
Date of Construction	Pre 1924
Architectural Description	Simple one-and-a-half storey craftsman bungalow with full width porch featuring simplified square posts. The main entry is accentuated by a gable with knee brackets. Horizontal wood cladding is a typical craftsman style feature. All windows on front façade have been replaced.
Heritage Status	None
Assessment	(✓) Qualifies for Heritage Register

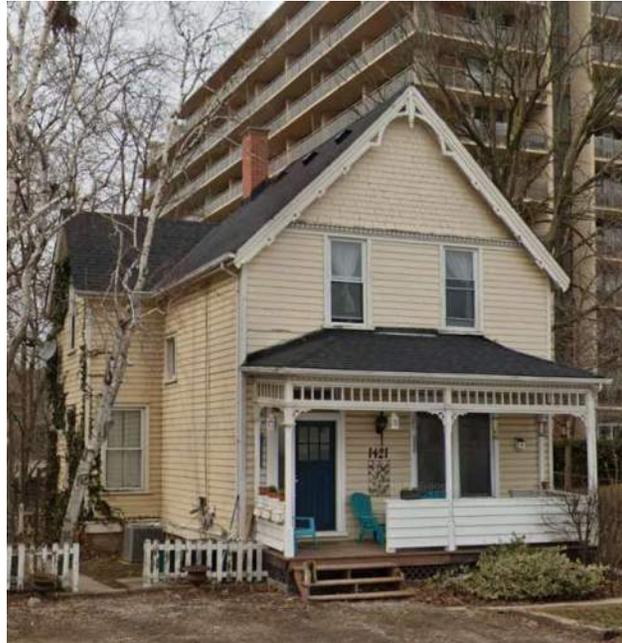
13. 1421 Lakeshore Road

Legal Description	PLAN 74 PT LOTS 9,10
Historic Land Use	Residential
Date of Construction	1894
Architectural Description	Two-storey front-gable frame structure with front verandah and gingerbread bargeboard.
Heritage Status	Heritage Register, Non-designated
Assessment	(✓) Non Designated Heritage Register Property
