# Cultural Heritage Landscape #1- Foot of Brant Street

# Cultural Heritage Landscape #2- Locust Street

# Cultural Heritage Landscape #4- Downtown East

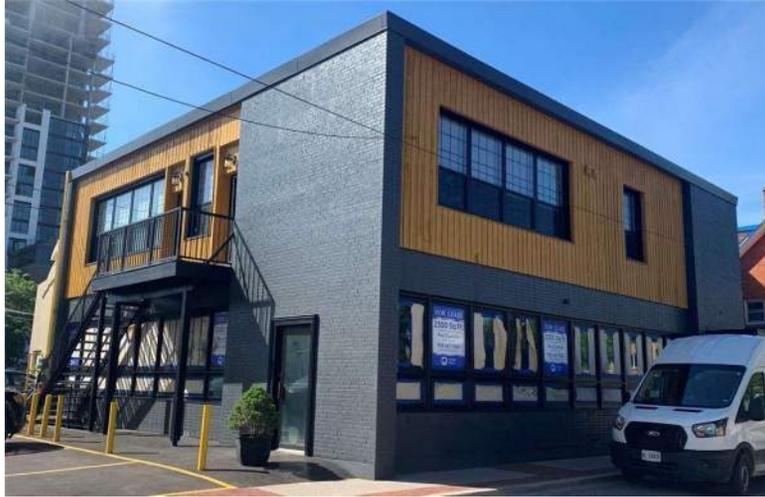
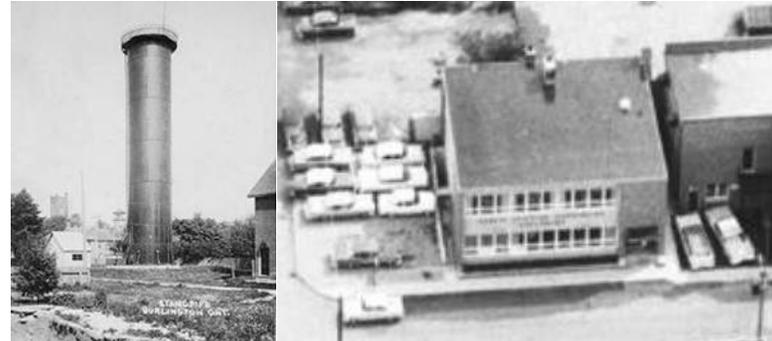
## 2. 2010 Maria Street

1924 Photo of water tower

<b>Legal Description</b>	PLAN 92 BLK E PT LOT 1
<b>Historic Land Use</b>	Water tower (85' tall), former Police station
<b>Date of Construction</b>	1950s
<b>Heritage Value or Interest</b>	This two-storey masonry building is believed to have historical value for its former use as a police station. It is believed to have design value for its mid-century modernist details including long horizontal windows at ground level. The façade is a mix of brick and tile. Alterations include a reduction in the width of the upper storey windows.
<b>Heritage Status</b>	None
<b>Assessment</b>	(✓) Qualifies for Heritage Register

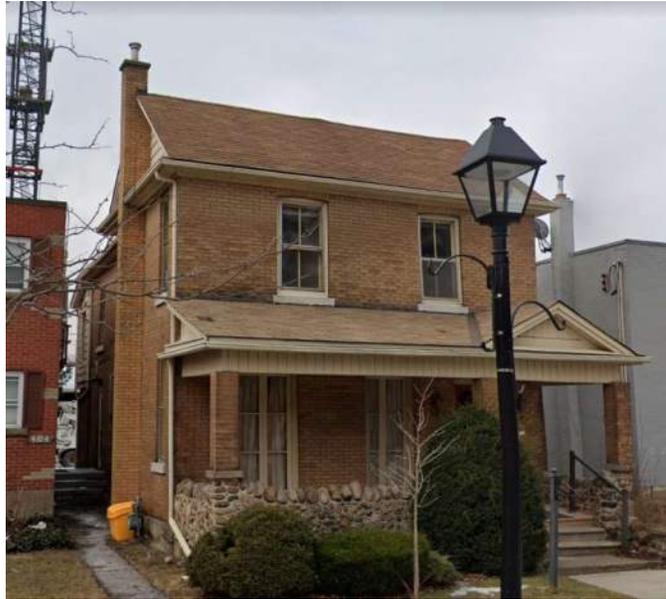
## 8. 468 Elizabeth Street

1915 Photo of Elizabeth Street looking North towards Caroline

<b>Legal Description</b>	PLAN 92 BLK F PT LOT 6
<b>Historic Land Use</b>	Residential (dwelling)
<b>Date of Construction</b>	Pre 1910
<b>Heritage Value or Interest</b>	This two storey masonry building has historical value for its age and potential to yield information about Burlington residential areas before 1910. It is believed to have design value for its vernacular homestead and craftsman details. The house is two bays wide, with entrance positioned at the side of the ground floor. The full width veranda with craftsman style stone base is original. Two-over-two sash windows feature segmental arches.
<b>Heritage Status</b>	None
<b>Assessment</b>	(✓) Qualifies for Heritage Register
