# **Item 5.4- Proposed inclusion of downtown properties on the City of Burlington Heritage Register**

Community Planning Regulation & Mobility Meeting  
September 13, 2022  
Report PL-59-22

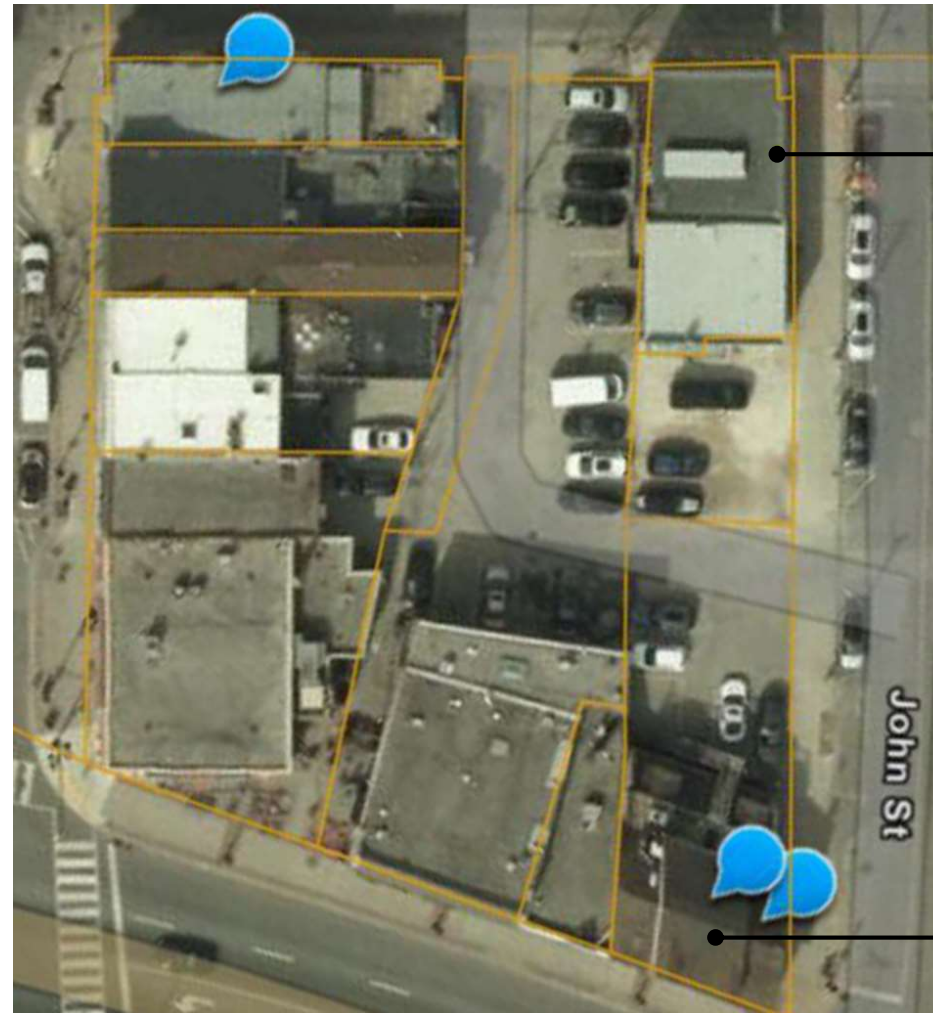
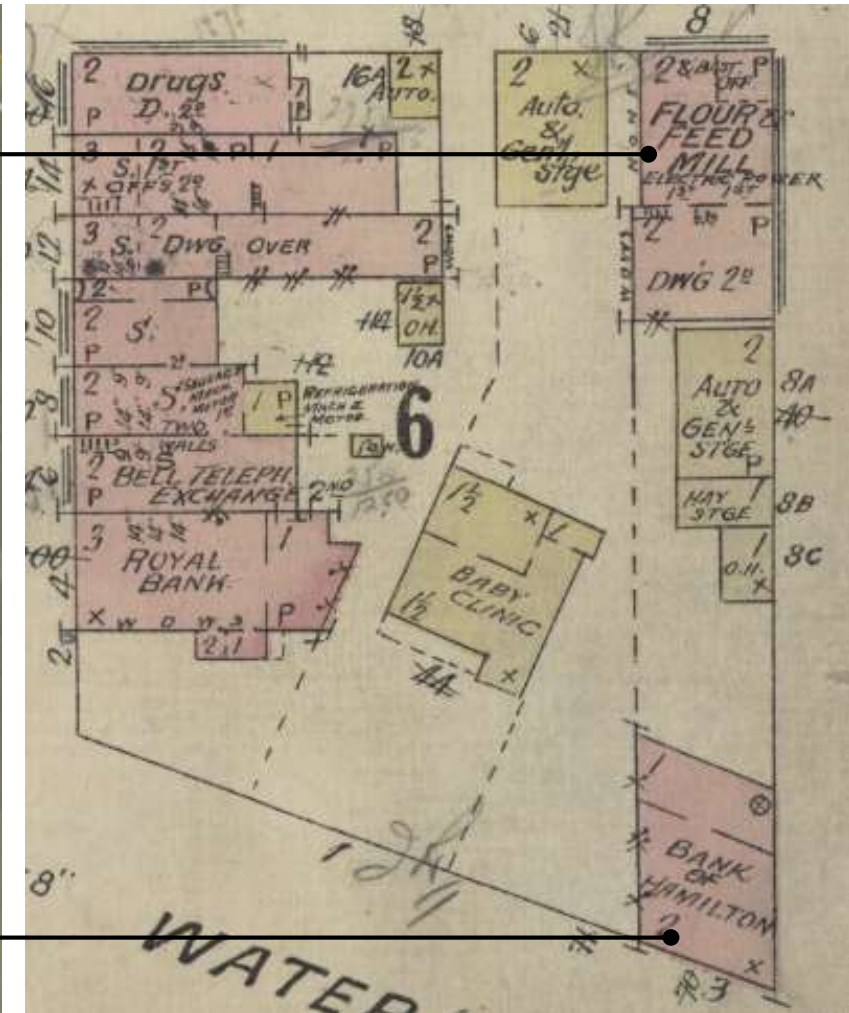
- # 1. Comparison of fire insurance maps with satellite photos

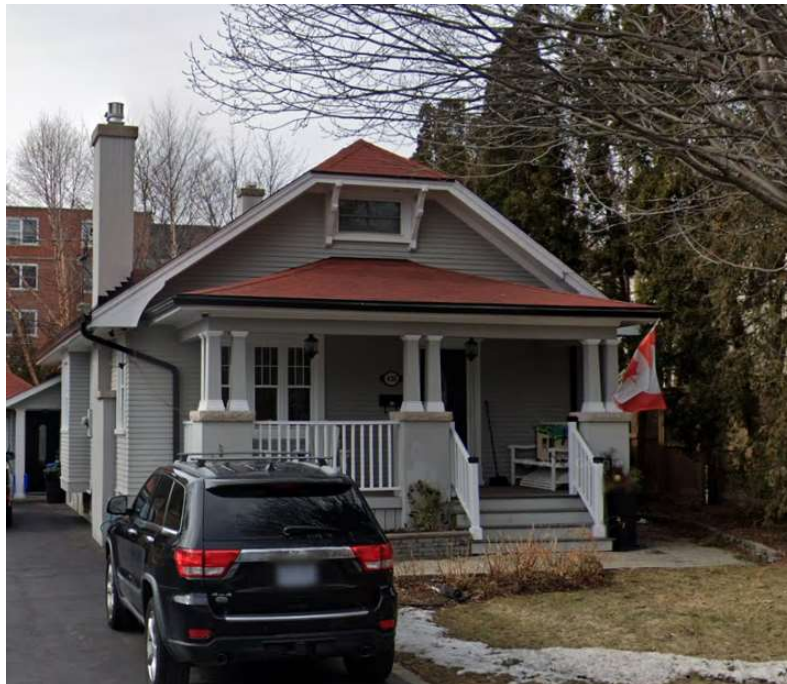
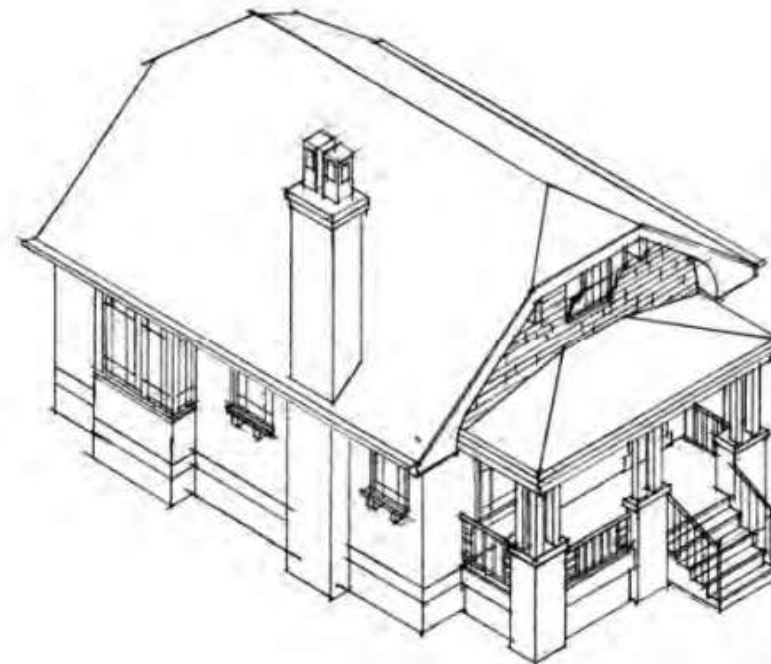
426 Burlington Avenue

CRAFTSMAN BUNGALOW  
1900-1930

Gable or "Jenkins-head" (partially hipped) roof.

Bay windows tend to be square.

Concrete Block Foundations

1 or 1-1/2 storey house.

Brick ground floor construction is common, with gable ends of cedar shingles

Asymmetrical plan, with entrance to one side.

Wood double-hung windows. Elaborate glazing patterns, sometimes leaded.

Verandah is a dominant design feature.

Rafter tails often exposed, and cut into decorative shapes.

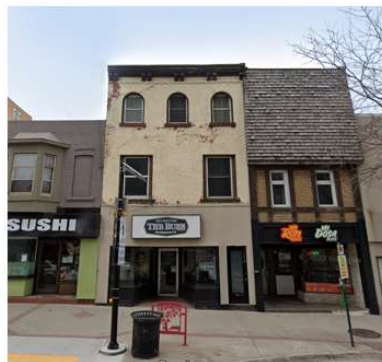
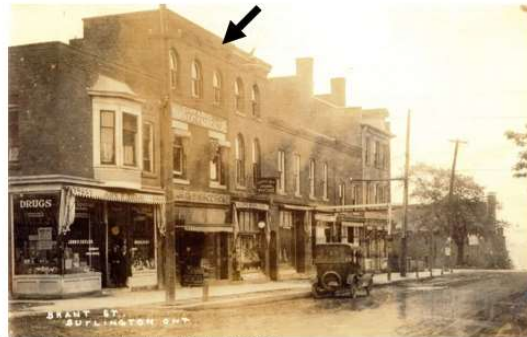
## 6. 359 Brant Street

| Heritage Value or Interest | Three-storey commercial building believed to have historical value for its age and former use as an Ontario Department of Agriculture Office. The building is believed to have design value for its Italian renaissance elements including round arched windows at third storey. The second storey originally had round arched windows and the arches and keystones of these windows are still visible in brickwork. The cornice with brackets is still intact along with the dentil course below the cornice brackets. Alterations include rectangular second storey window openings, replaced windows, painted brick and reconfigured storefront. |

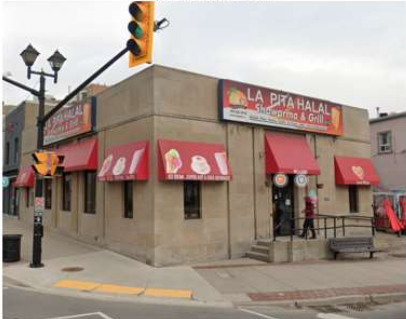
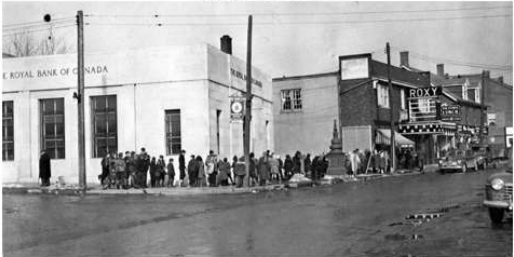
## 9. B) 2003 Lakeshore Road

| Heritage Value or Interest | Rare example of a transitional style "modernist" bank with minimalist classical references including "fluted" pilasters. The building has a simplified cornice, sandstone exterior and original fenestration. Signage and awnings obscure some details, but are removable. Style was characteristic of banks in the postwar decade as they sought to portray themselves as architecturally progressive but cautious in approach. |
