2085 PINE STREET

HERITAGE
ASSESSMENT
+
HERITAGE
IMPACT
STATEMENT
+
CONSERVATION
PLAN

REVISED APRIL 11 2019

ATA
ARCHITECTS INC.

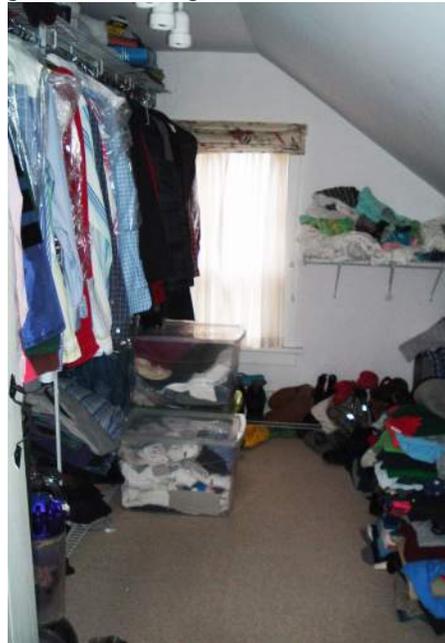
The windows in the shed-dormer roof on the north side of the second floor are single panes of glass with false snap-in muntins.
