PRE-CONSTRUCTION ARBORIST REPORT

May 5th, 2020

2477 Queensway Drive
Burlington, ON

Chris Tiseo
Ontario Arborist #400949814
Glenwood Tree Service Inc.
info@glenwoodtree.ca

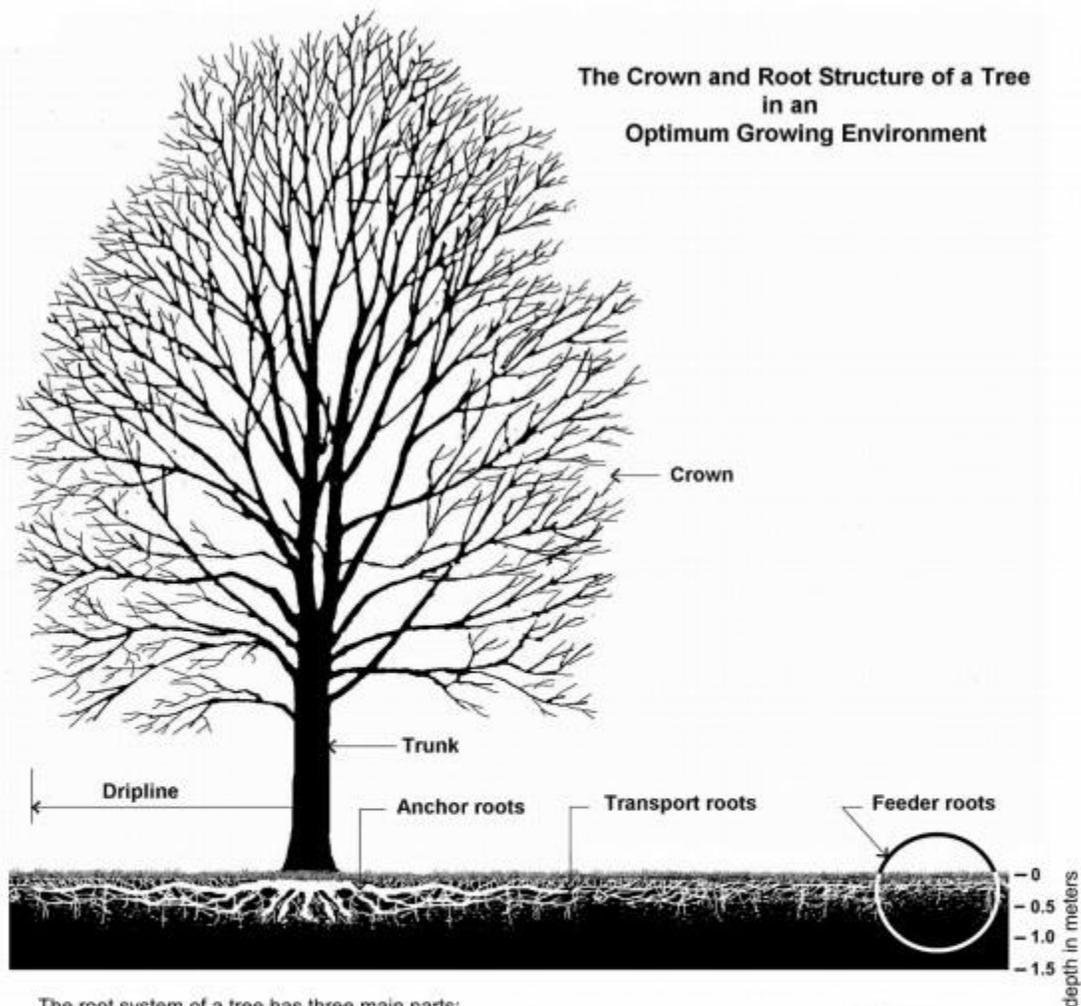
FIGURE #2

Trees are particularly susceptible to injury on construction sites due to the invasive nature of construction activities such as foundation excavation, grading, storage of excavated soil or building materials and physical injury from construction equipment. Tree roots that are cut or removed during an excavation hamper a tree's ability to obtain nourishment. Removed roots may also significantly impair the structural integrity of a tree. Soil compaction squeezes out pockets of oxygen in the soil thereby starving the roots of the oxygen necessary to survive. Bark injuries from construction equipment interfere with the delivery of nutrients to the tree as well as provide an entry point for pests and disease. Tree root systems damaged in these ways result in tree decline and mortality. (See Fig.2)
