# Arborist Report

4029 Spruce Avenue  
Burlington, Ontario  
L7L 1K1  
January 4<sup>th</sup>, 2021

RE: Arborist Report and Tree Protection Plan

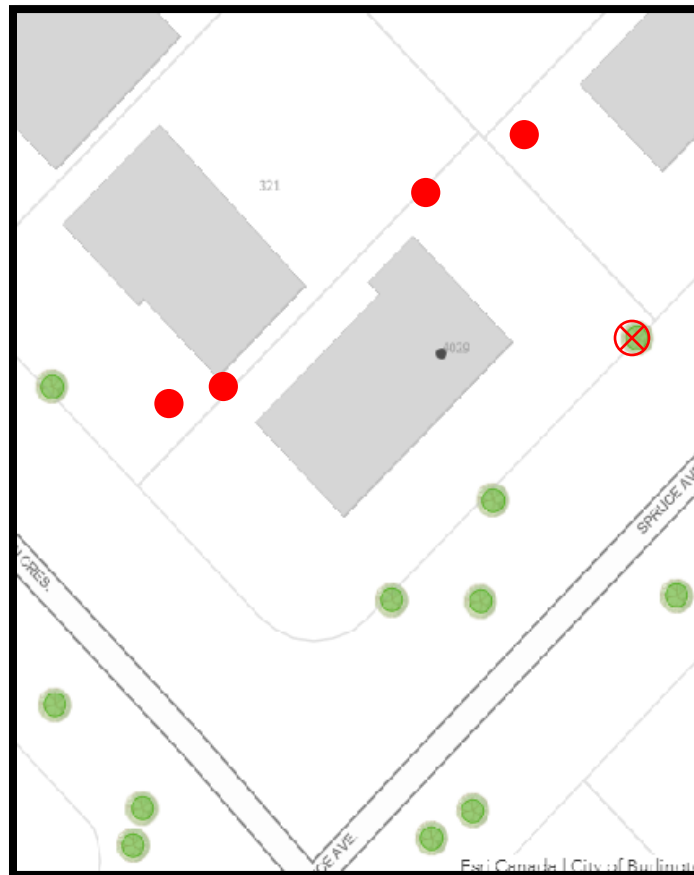
Overhead view of the property. City-owned trees marked as green circles, privately owned trees associated with this report marked with red circles.
