Cover Letter

TO: HERITAGE BURLINGTON ADVISORY COMMITTEE, CITY OF BURLINGTON
 ADDRESS: 3083 LAKESHORE RD, BURLINGTON, ON, L7N 1A3

On behalf of our clients, Gabriel Braun and Doreen De Faveri, we are pleased to submit this letter for Heritage Permit Issuance addressed as 3083 Lakeshore Rd in the City of Burlington. The application is to propose a renovation and addition to the existing dwelling at 3083 Lakeshore RD, in Burlington (Subject Site). The owners currently live at 3087 Lakeshore Rd, and purchased the Subject Site at the start of 2024 to renovate and build their forever home. The plan for the owners is to move into Subject Site once construction is complete. The owners love the character of the original dwelling and after living at the neighboring property are especially mindful of the design of the original dwelling and its importance for the neighborhood.

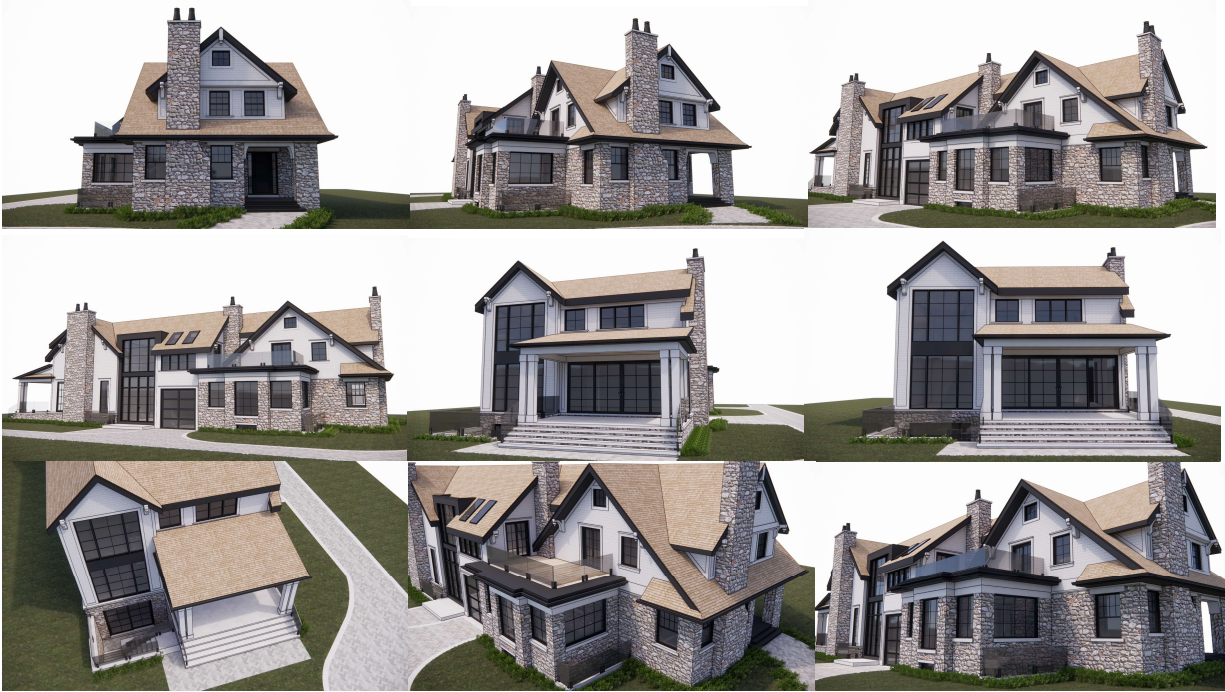
APPENDIX 2 - 3D DESIGN IMAGES

The proposed rear addition has been proposed to be architectural compatible with the original dwelling by sharing design elements including, cedar shake siding, gable roof design with the same slope as the original dwelling, random stone cladding for skirt features, and chimney, gable bracket details, and a variation in soffit heights.

The addition is highlighted with a break on the east elevation between the office and garage, from an exterior perspective the stone stops at the office and continues beyond the mudroom. The break is accomplished by bringing the siding down to grade on the garage face as well a more contemporary box feature is proposed at the mudroom which will also act as a secondary entrance for the dwelling. The hope for this break is to ensure that there is distinguished divide between the original dwelling and addition while still ensuring that all elements feel as one cohesive design.
