# Appendix A Background Information

# HAGER-RAMBO FLOOD CONTROL WORKS OPERATIONS AND MAINTENANCE MANUAL

# CITY OF BURLINGTON HALTON REGION CONSERVATION AUTHORITY

December 1997

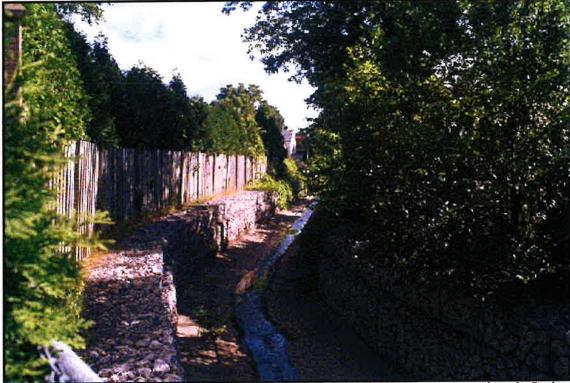
Photo 2.2 - Looking upstream at East Rambo Creek from Brenda Crescent at approximately Station 0+100

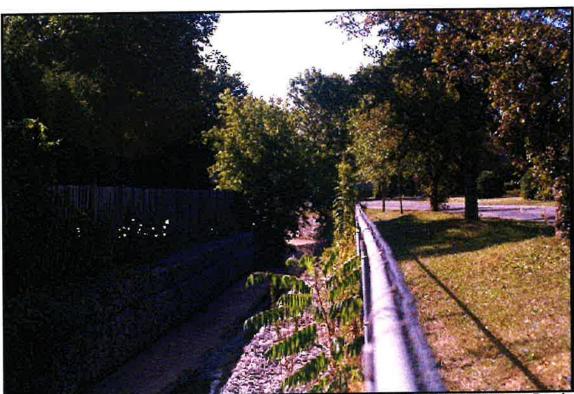
Photo 2.3 Looking downstream towards Glenwood School Drive from station 0+100 adjacent to Brenda Crescent.

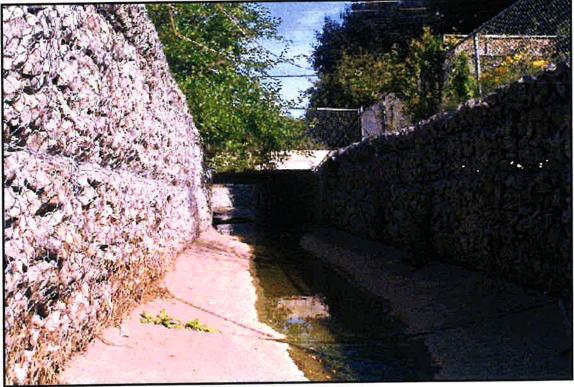
Photo 2.4 - Looking upstream towards the Glenview School Drive culvert.

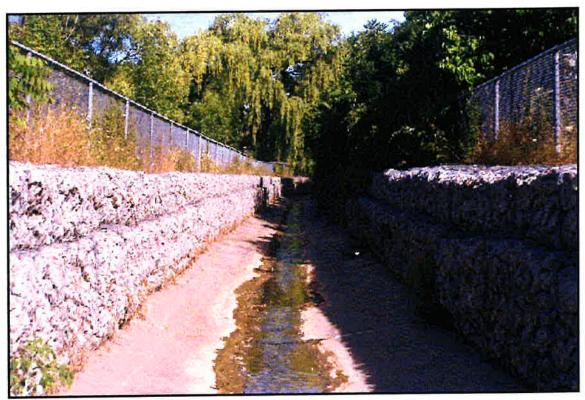
Photo 2.5 - Looking upstream from station 0+420, just north of the Fassel Avenue access gates.

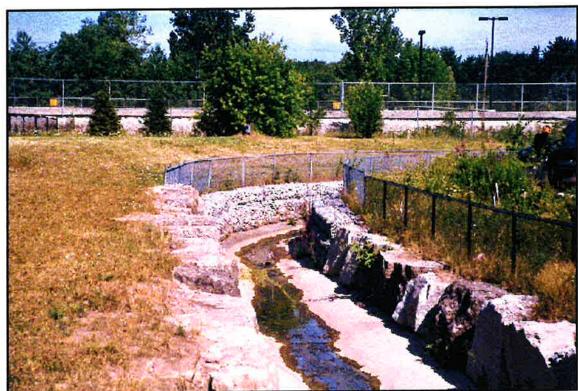
Photo 3.1 Looking upstream at the transition from the vertical gabion walled channel to the armour stone lined channel from station 0+020.

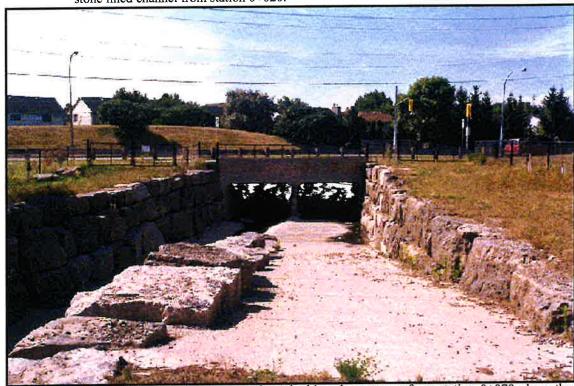
Photo 3.2 View of the Fairview Street culvert looking downstream from station 0+070 along the alignment of the access ramps.

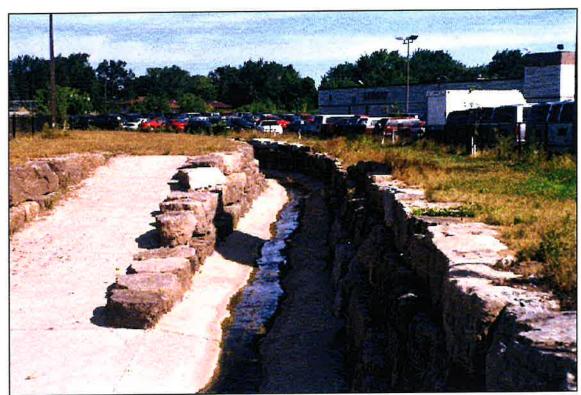
Photo 3.3 Looking upstream from atop the Fairview Street culvert.

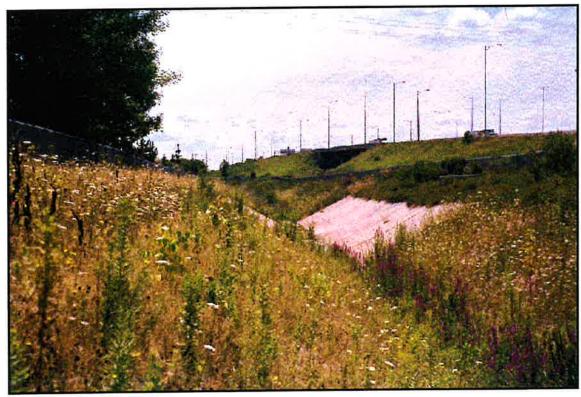
Photo 6.1 - Looking downstream from station 0+300 towards the CNR Halton crossing.

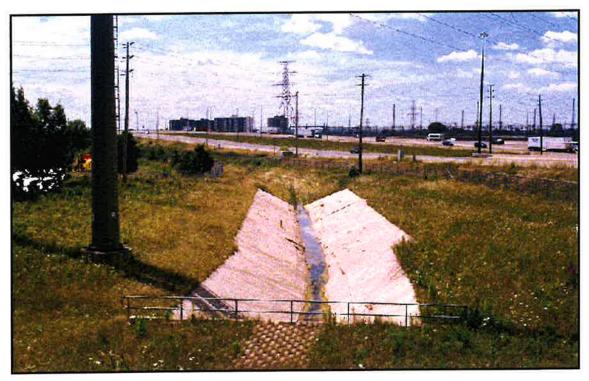
**Photo 6.4** - Looking downstream at the concrete to terrafix block channel transition from the top of berm above the outlet culvert.

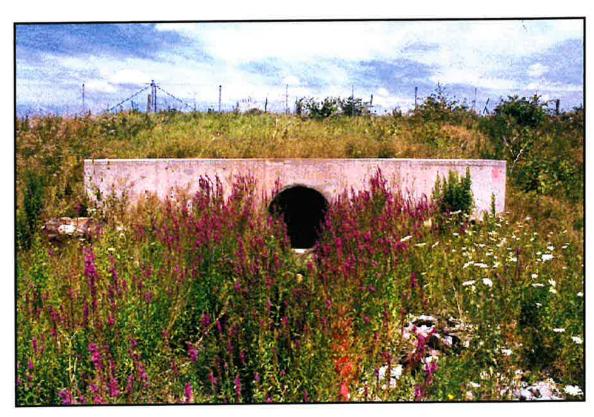
**Photo 7.7** - Downstream face of the 1350 mm concrete pipe extending for 32 metres under the 403 west to Brant Street north/south ramp, at the northeast corner of the site.

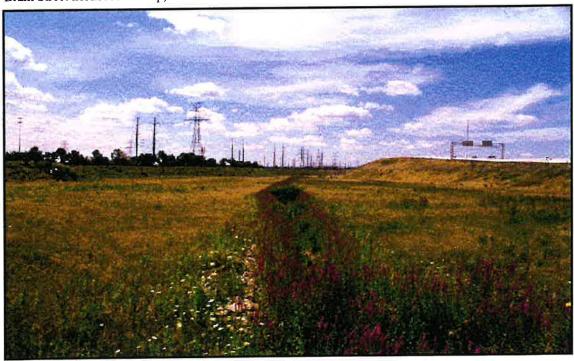
**Photo 7.8 -** Looking downstream at the Freeman Pond from the headwall of the culvert. Note how the Purple Loostrife clearly defines the channel

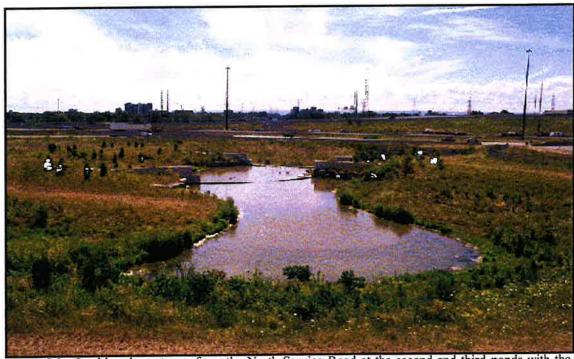
Photo 8.2 - Looking downstream from the North Service Road at the second and third ponds with the QEW in the background.

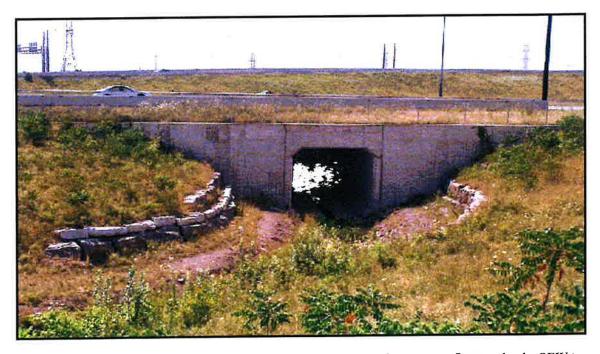
$\textbf{Photo 8.4} - \textbf{Looking downstream at the outlet culvert of the system that conveys flows under the QEW to the Upper Freeman Pond \\$

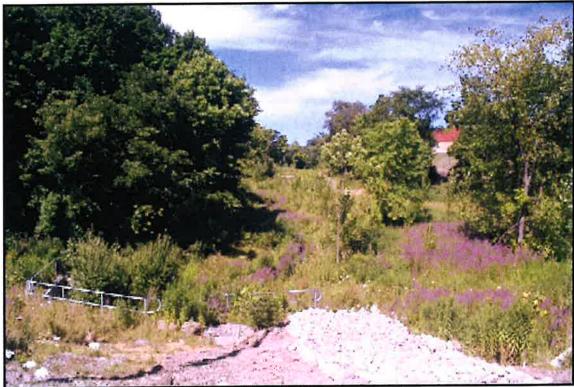
Photo 9.1 - Looking upstream at the channel from the North Service Road.

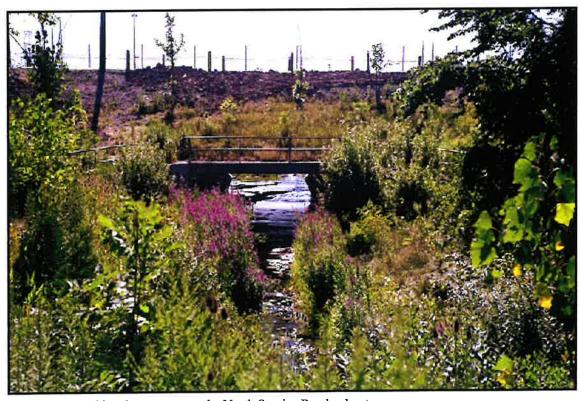
Photo 9.2 - Looking downstream at the North Service Road culvert.

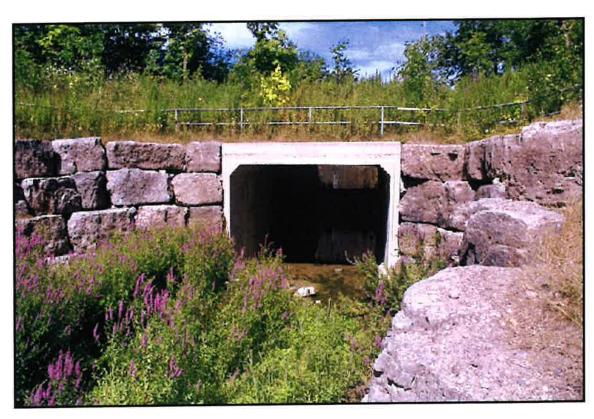
Photo 9.3 - Looking upstream towards the culvert and cut-off wall structure

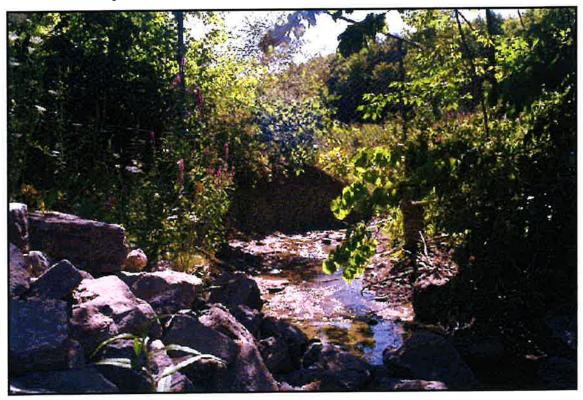
Photo 9.6 - Looking downstream from the future Highway 403 right-of-way.

At the time of the site visit on August 6, 1997, by Philips Planning and Engineering staff, the vegetation within the site appears to have grown very well (reference Section 9.5). Purple Loosestrife is the dominant species with the channel, as seen in Photos 1-4. The North Service Road culvert and the culvert and cut-off wall at the upstream limit of the site appear to be in good condition, however the handrails and fencing around the culvert and cut-off wall are damaged and in need of repair. The armour stone is in good condition and shows no sign of degradation or displacement. As seen in Photo 9.6, slight bank erosion is occurring just upstream of the cut-off wall.

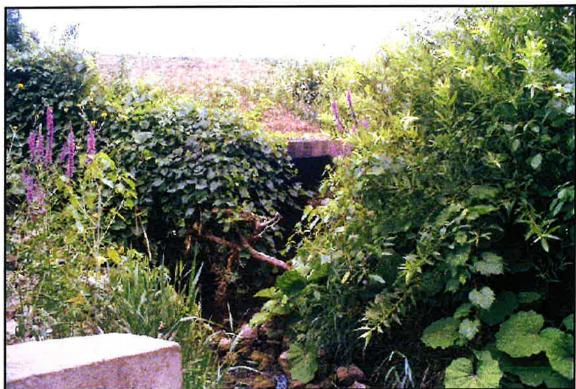
Photo 10.1 - View of the upstream side of the culvert crossing under the North Service Road. Note the debris blocking the culvert opening.

On August 6,1997, the works were inspected by Philips Planning and Engineering personnel. The valley has vegetated very well, including the infestation of Purple Loosestrife that follows the channel. The outlet culvert appears to be in good condition; however, vegetation and debris block both the outlet culvert and the existing culvert that conveys flow under the North Service Road.

As in the downstream sites, Purple Loosestrife is the dominant species within the channel and should be removed in order to ensure the efficiency Of the natural ecosystem. (Reference Section 6.6.4). Larger debris (fallen trees, etc.) that may be obstructing the culverts or channel should be removed.

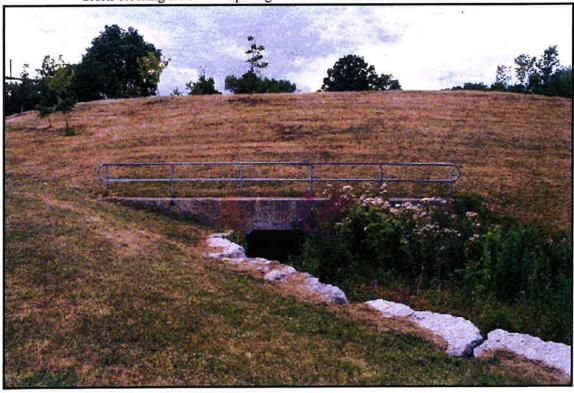
Photo 10.2 - View of the detention facilities outlet culvert from the downstream side, taken from the North Service Road.

The North Service Road and outlet culvert should be inspected annually and checked for any minor cracking or spalling that may be repaired by sealing or grouting. Any major areas of cracking (> 3mm) or displacement along expansion, control, or walls joints, requires a thorough investigation by a qualified Structural Engineer, to determine the cause and recommend remedial works.

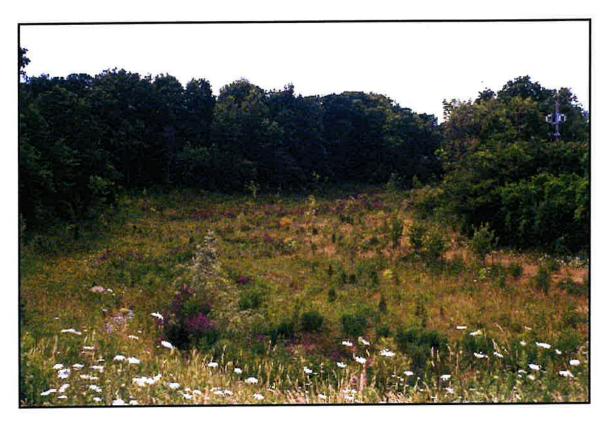
Photo 10.3 - Upstream view of the facility from atop the berm.

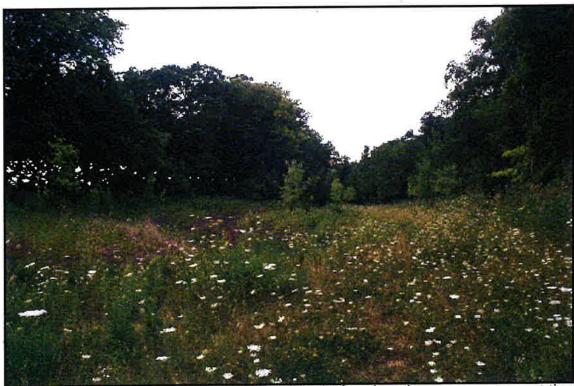
Photo 10.4 - Looking upstream towards the limit of the site from the maintenance accessway at station 0+180.

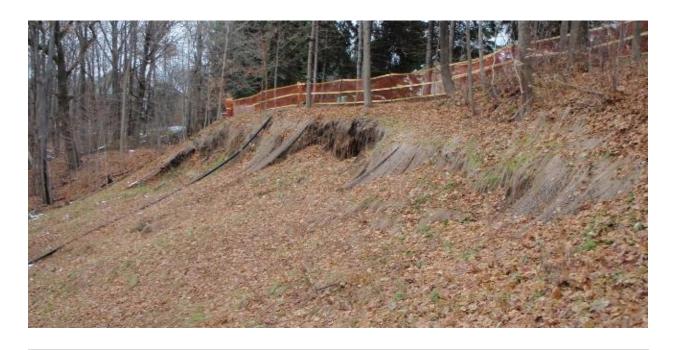
Photo 2: Hager Creek - east bank of Upper Hager Creek at 1767 Heather Hills Drive (June 2019)

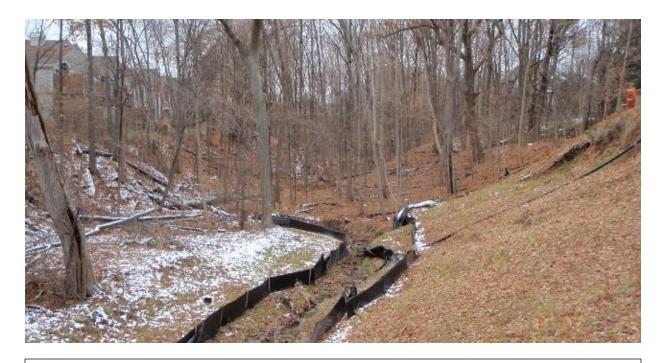
Photo 3: Hager Creek - slope toe at 1767 Heather Hills Drive (June 2019)

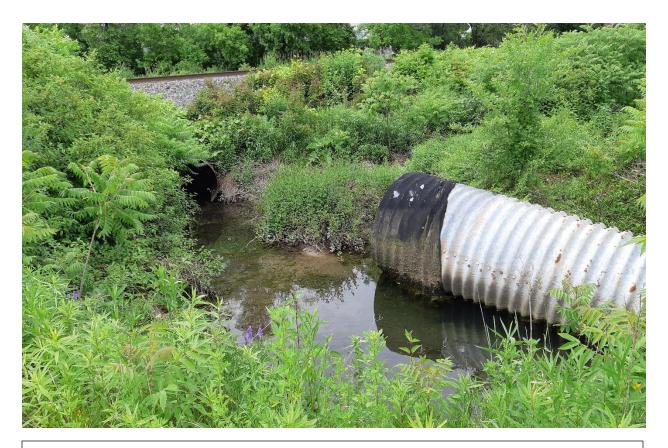
Photo 7: Rambo – culvert north to rail (June 2019)
