## HAGER-RAMBO FLOOD CONTROL WORKS OPERATIONS AND MAINTENANCE MANUAL

## CITY OF BURLINGTON HALTON REGION CONSERVATION AUTHORITY

December 1997

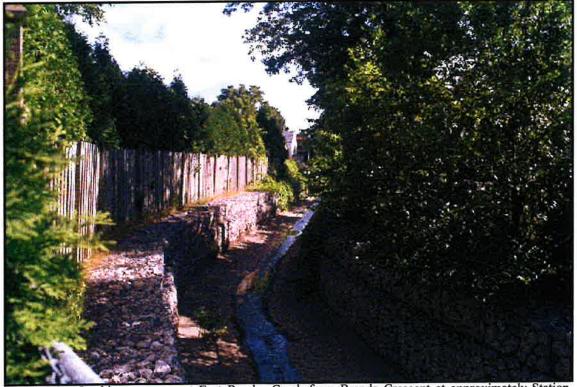
Photo 2.2 – Looking upstream at East Rambo Creek from Brenda Crescent at approximately Station 0+100

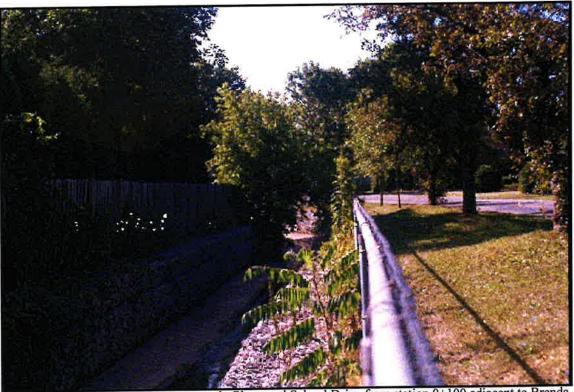
Photo 2.3 Looking downstream towards Glenwood School Drive from station 0+100 adjacent to Brenda Crescent.

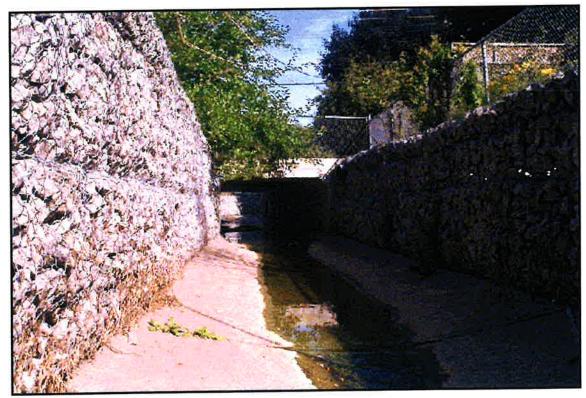
Photo 2.4 - Looking upstream towards the Glenview School Drive culvert.

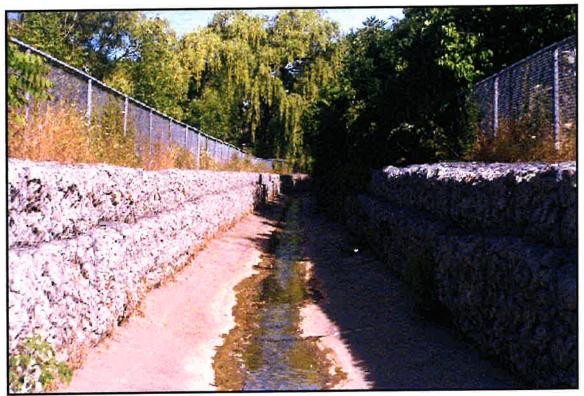
Photo 2.5 - Looking upstream from station 0+420, just north of the Fassel Avenue access gates.

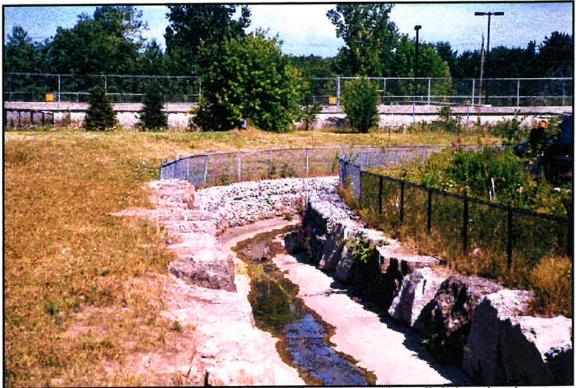
**Photo 3.1** Looking upstream at the transition from the vertical gabion walled channel to the armour stone lined channel from station 0+020.

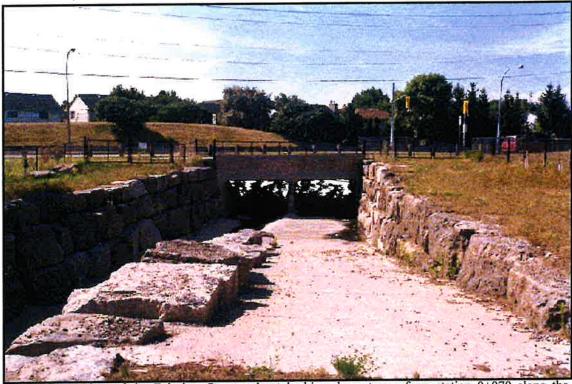
**Photo 3.2** View of the Fairview Street culvert looking downstream from station 0+070 along the alignment of the access ramps.

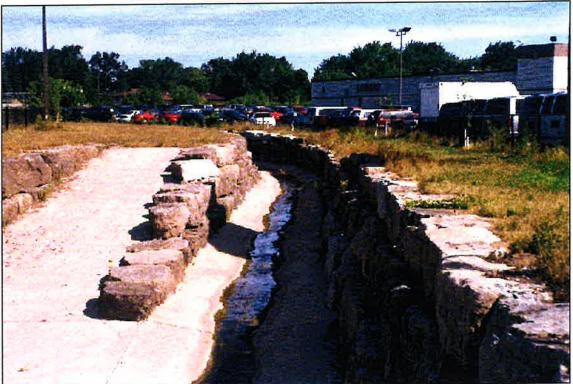
Photo 3.3 Looking upstream from atop the Fairview Street culvert.

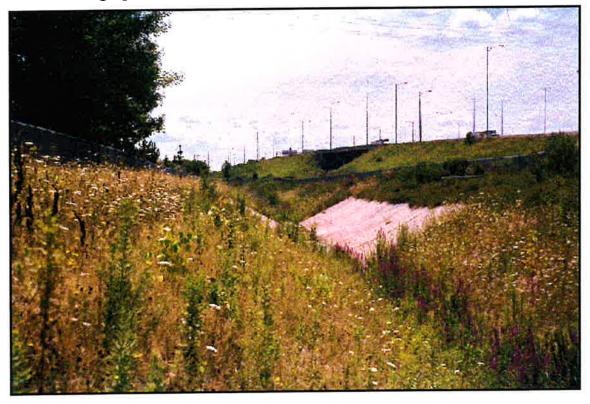
Photo 6.1 - Looking downstream from station 0+300 towards the CNR Halton crossing.

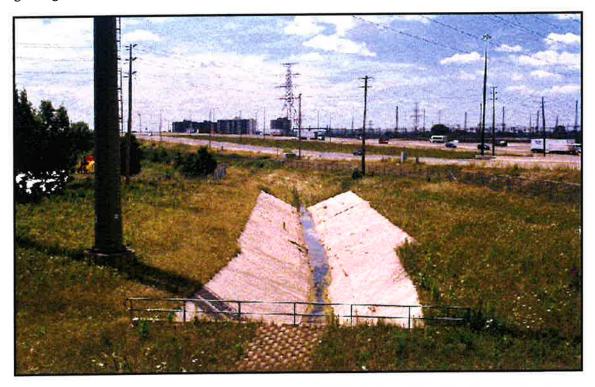
Photo 6.4 - Looking downstream at the concrete to terrafix block channel transition from the top of berm above the outlet culvert.

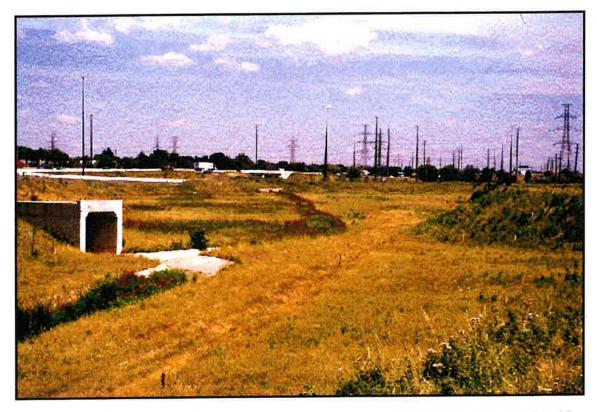
Photo 7.5 - Looking upstream at the pond from from the previous location atop the berm, with the 5.05 x 5.05 metre culvert on the left and the 1350 mm culvert in the centre.

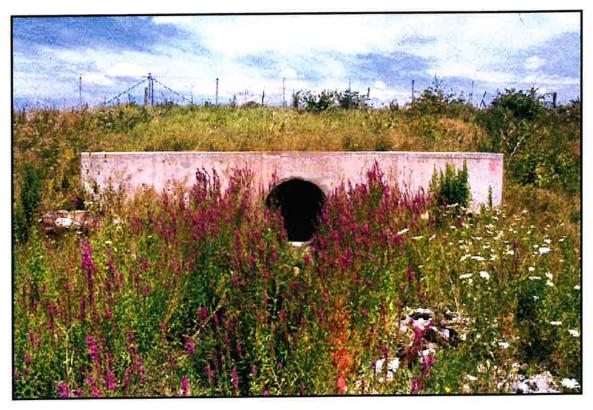
**Photo 7.7 -** Downstream face of the 1350 mm concrete pipe extending for 32 metres under the 403 west to Brant Street north/south ramp, at the northeast corner of the site.

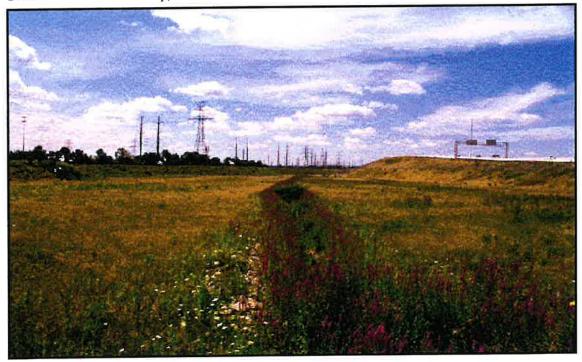
**Photo 7.8 -** Looking downstream at the Freeman Pond from the headwall of the culvert. Note how the Purple Loostrife clearly defines the channel

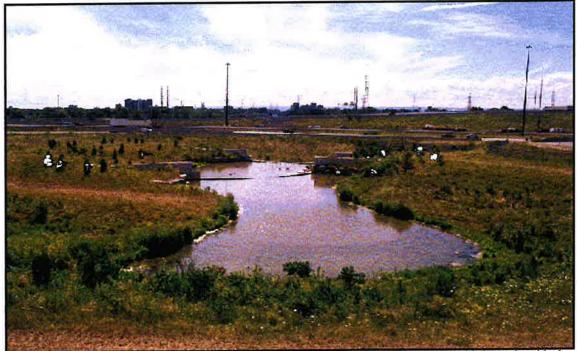
Photo 8.2 - Looking downstream from the North Service Road at the second and third ponds with the QEW in the background.

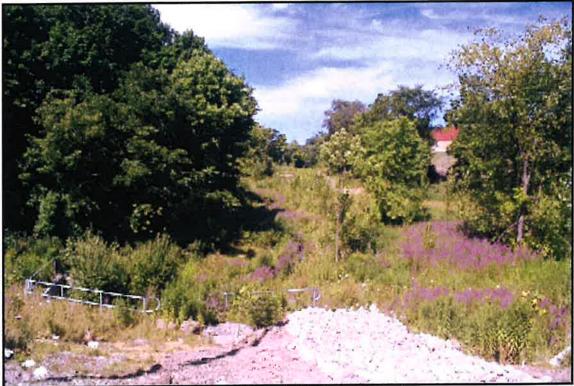
Photo 9.1 - Looking upstream at the channel from the North Service Road.

The channelization of East Hager Creek at this location utilizes the function of a "natural" channel system. As in the downstream sites, Purple Loosestrife is the dominant invasive species within the channel and should be removed in order to ensure maximum efficiency of the ecosystem. Larger debris (fallen trees, etc.) that may be obstructing the culverts or channel should be removed.

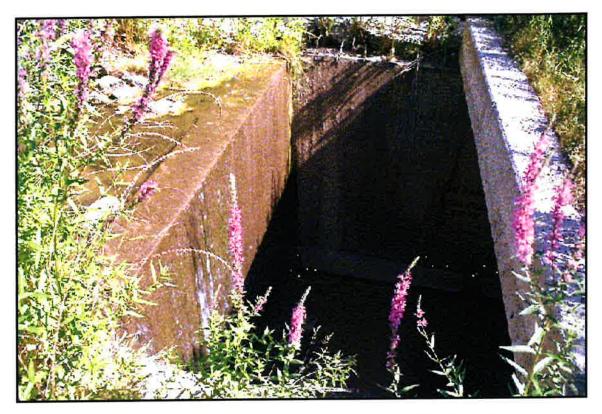
Photo 9.5 - Looking down into the cut-off wall structure at the upstream limit of the works

The concrete vertical drop structure should be inspected annually and checked for any minor cracking or spalling that may be repaired by sealing or grouting. Any major areas of cracking (> 3mm) or displacement along expansion, control, or walls joints, requires a thorough investigation by a qualified Structural Engineer, to determine the cause and recommend remedial works.

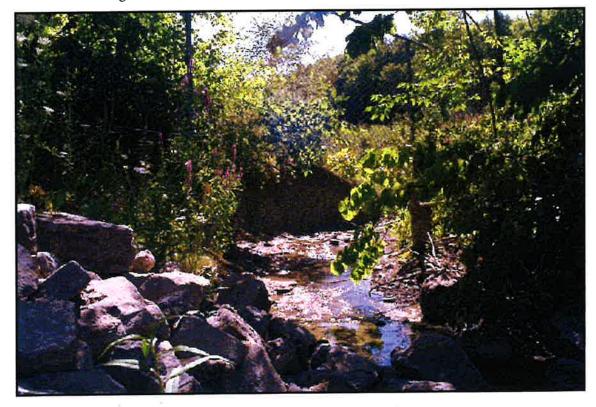
Photo 9.6 - Looking downstream from the future Highway 403 right-of-way.

At the time of the site visit on August 6, 1997, by Philips Planning and Engineering staff, the vegetation within the site appears to have grown very well (reference Section 9.5). Purple Loosestrife is the dominant species with the channel, as seen in Photos 1-4. The North Service Road culvert and the culvert and cut-off wall at the upstream limit of the site appear to be in good condition, however the handrails and fencing around the culvert and cut-off wall are damaged and in need of repair. The armour stone is in good condition and shows no sign of degradation or displacement. As seen in Photo 9.6, slight bank erosion is occurring just upstream of the cut-off wall.

During the annual inspection, the stone should be checked for any degradation or displacement. Specific items to check for include intrusive vegetation and washout of backfill material. If distress is occurring, a thorough investigation is required by a qualified Engineer to determine the cause and recommend remedial works.

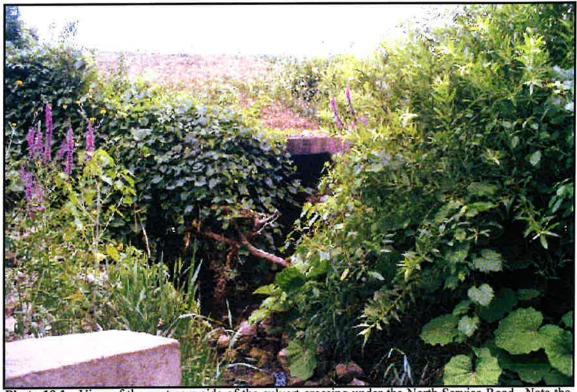
Photo 10.1 - View of the upstream side of the culvert crossing under the North Service Road. Note the debris blocking the culvert opening.

As in the downstream sites, Purple Loosestrife is the dominant species within the channel and should be removed in order to ensure the efficiency Of the natural ecosystem. (Reference Section 6.6.4). Larger debris (fallen trees, etc.) that may be obstructing the culverts or channel should be removed.
