HERITAGE IMPACT ASSESSMENT

6507 JANE STREET
KILBRIDE, ON
CITY OF BURLINGTON

20 DEC 2020

Condition Assessment and Recommendations for
6507 Jane Street, Burlington

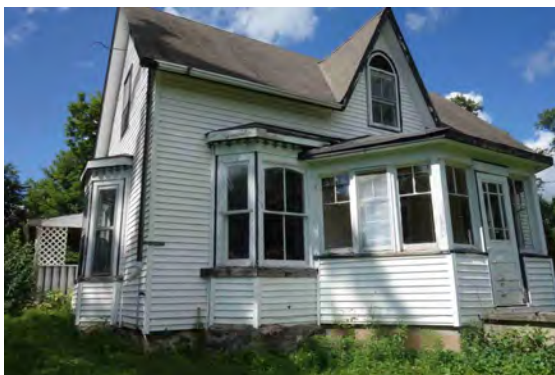
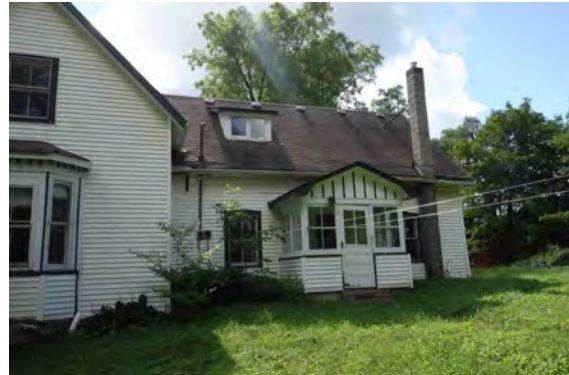
6507 Jane Street: the front of the house is oriented towards Cedar Springs Road (left) and the rear addition is oriented towards Jane Street (right) Both elevations have modern porch additions.

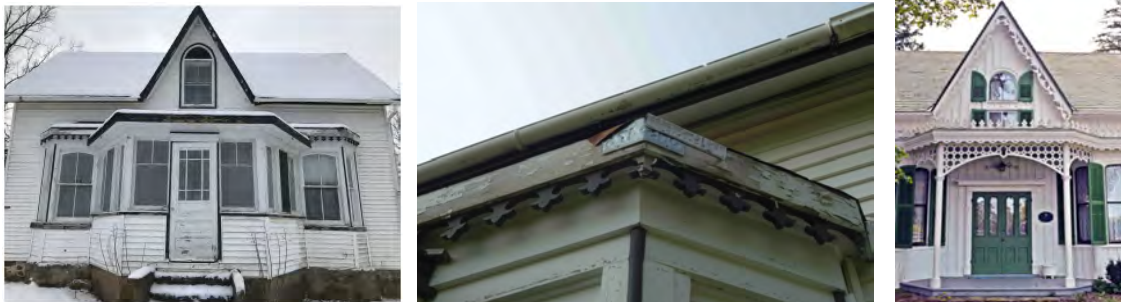
ONTARIO COTTAGE – the subject dwelling is a heavily altered example of a vernacular building that was updated in the 1870s with Italianate features associated with the Late Ontario Cottage (left & centre) – the Erland Lee Museum is a representative example of this style executed with a high degree of craftsmanship and retaining its original features

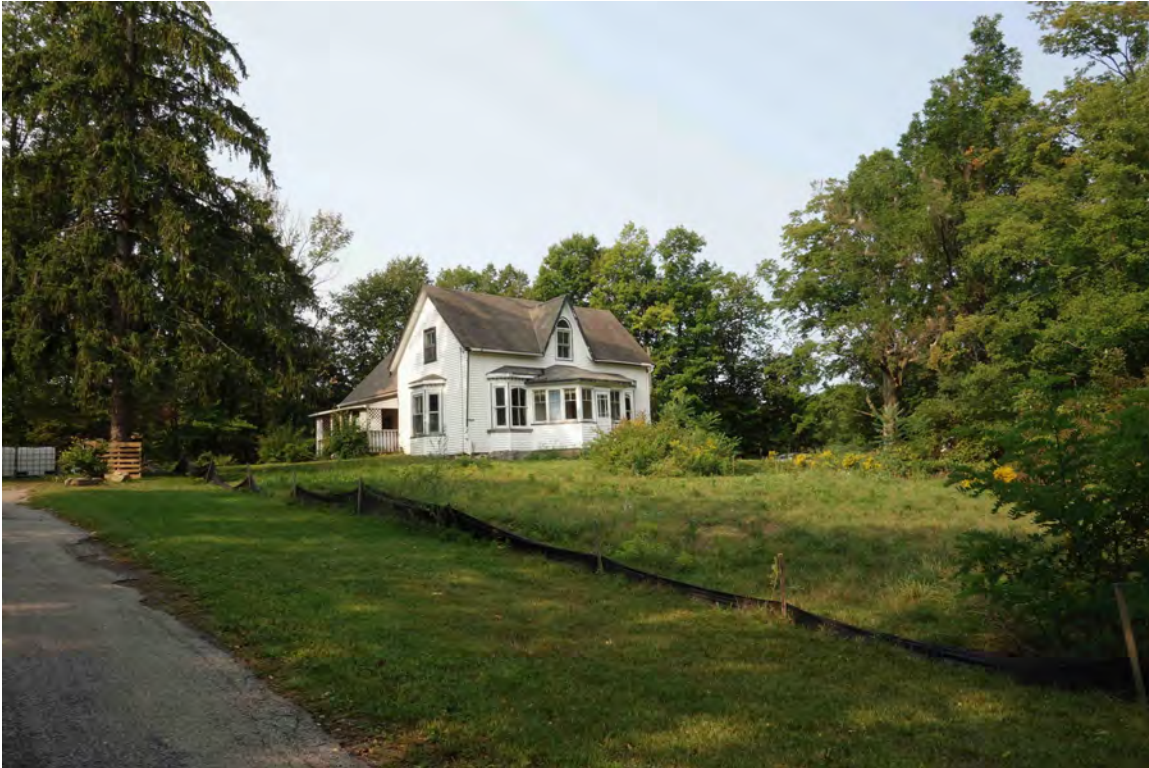
6507 Jane Street – view from Alice Street

The subject property contains a dwelling that has been heavily altered and is in poor condition. It appears to be comprised of two structures that were built c.1840-60s and joined together in the 1870s when architectural features such as the bay windows were added to give it an updated character. It may be the former Amalthy Hunt Earl (1827-1915) farmhouse that was originally located just to the south of Alice Street (formerly known as Ann Street) and possibly relocated to this site in the early 20th century.

In the 20th century a number of unsympathetic alterations were made to the subject dwelling, including the addition of an enclosed porch on the main elevation that overlaps the bay windows and re-cladding of the exterior, first with asphalt shingle and later with vinyl siding. The enclosed porch has a poured concrete foundation that is in very poor condition. In addition, the rubble stone foundation of the house has been improperly repaired with cement parging that has failed, resulting in a significant amount of rot in the wooden structural components that resting on the foundation. The floors, the main staircase and the bay windows have been adversely affected by these conditions.

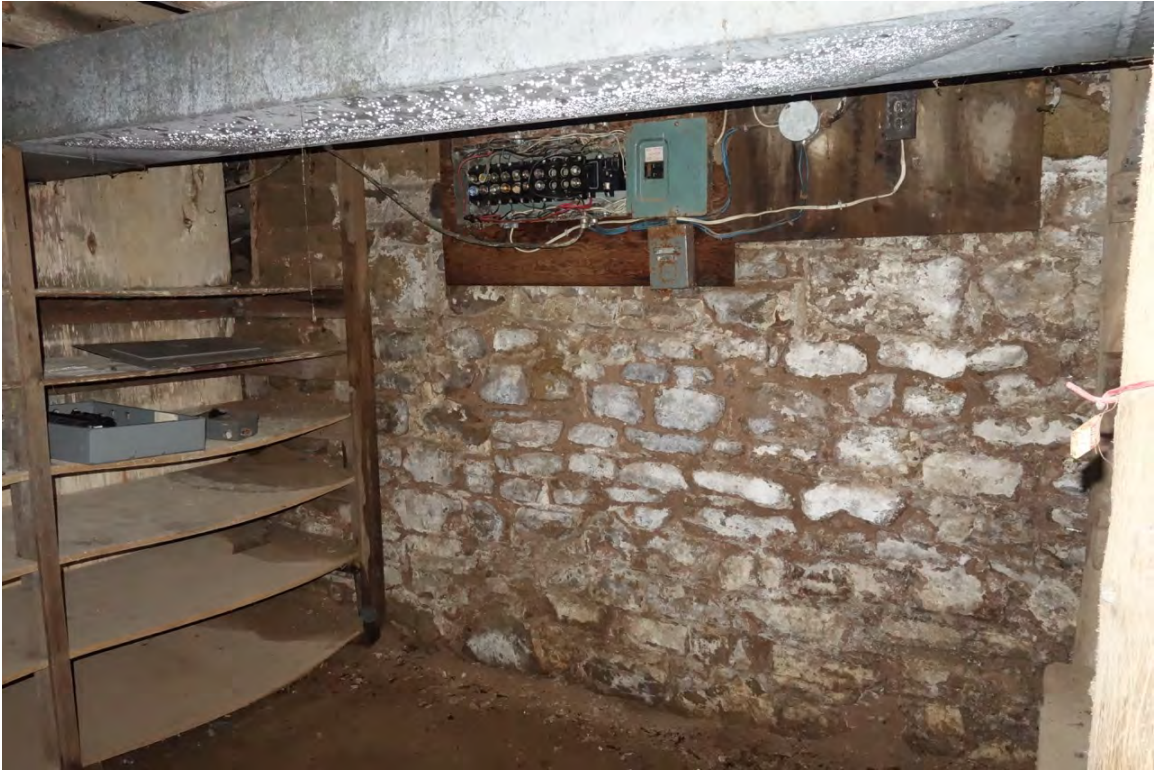
BASEMENT & RUBBLE STONE FOUNDATION BELOW BACK PART

The stone basement of the house is in as good condition as any of the foundation, which is not to say it is good. The space is barely sufficient for utilities and cannot be used for storage because it is very damp. The dampness has been bad enough and prolonged enough to rot floor joists, plates, and floorboards.

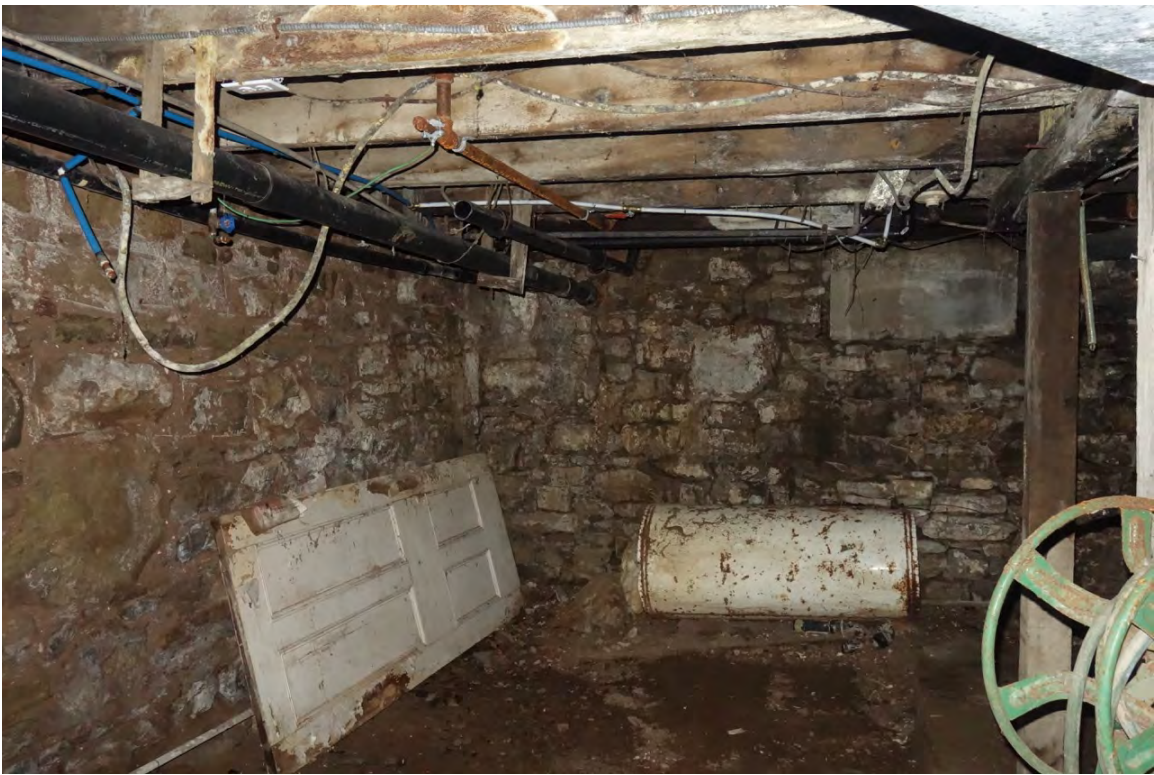
BASEMENT & RUBBLE STONE FOUNDATION BELOW BACK PART

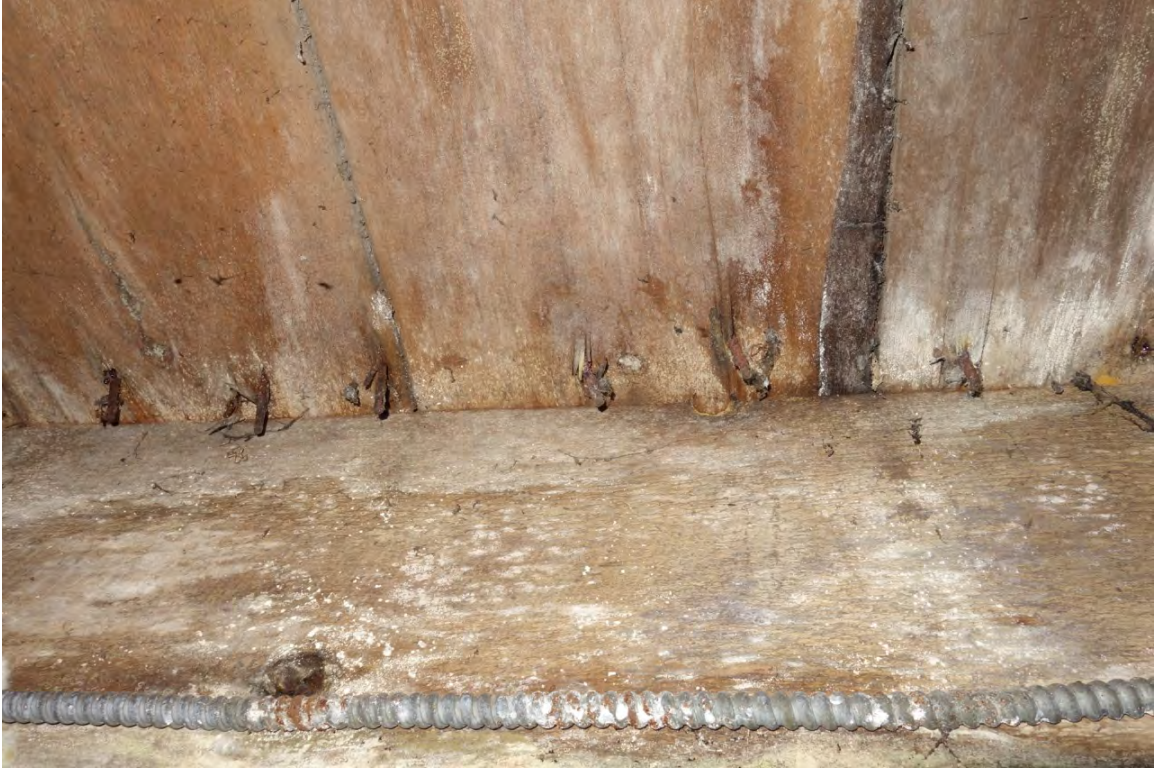
FLOOR FRAMING BELOW BACK PART – square nails

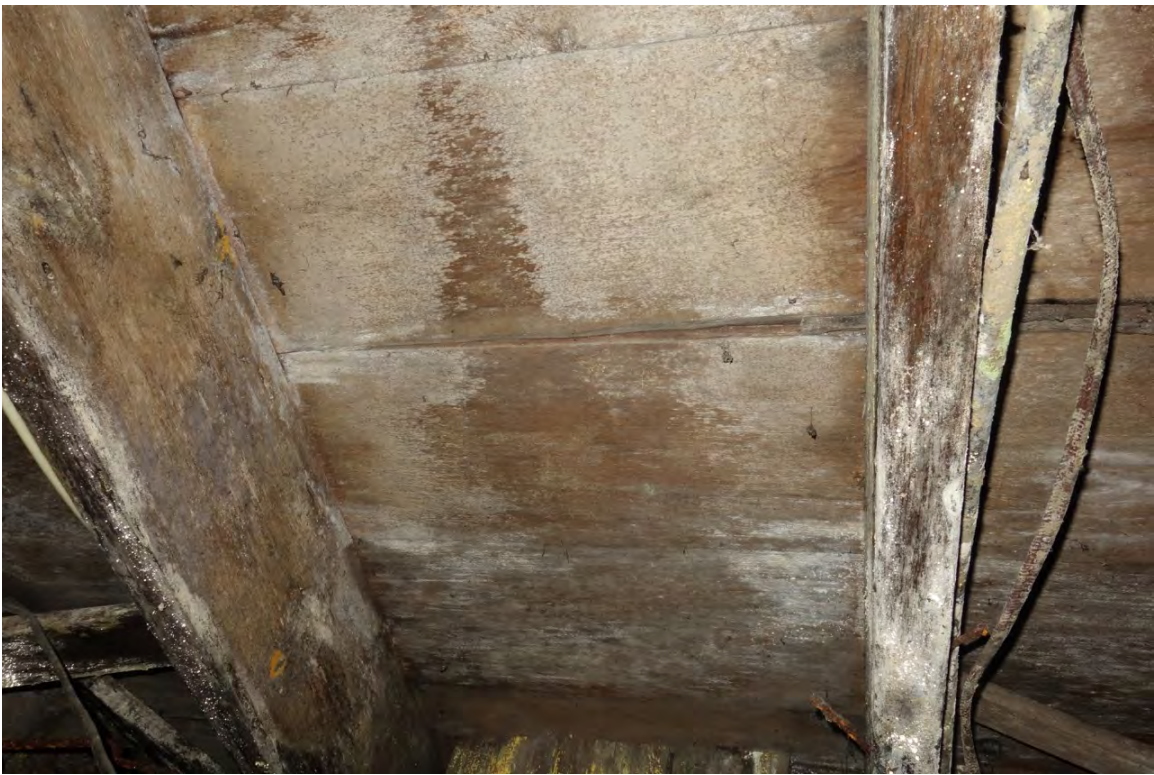
FLOOR FRAMING BELOW BACK PART – wide boards

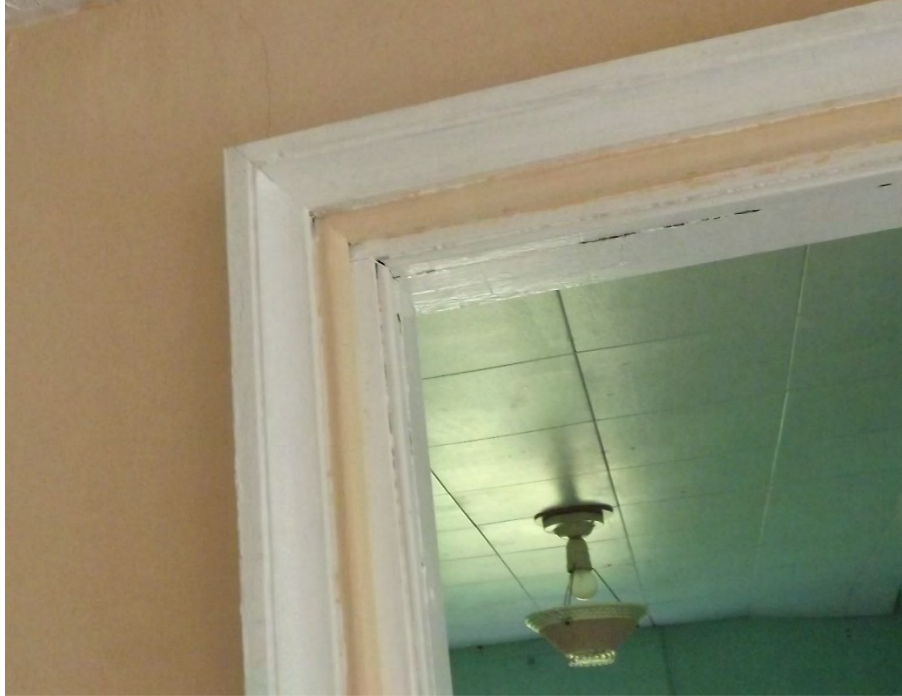
Victorian backband on early beaded casing

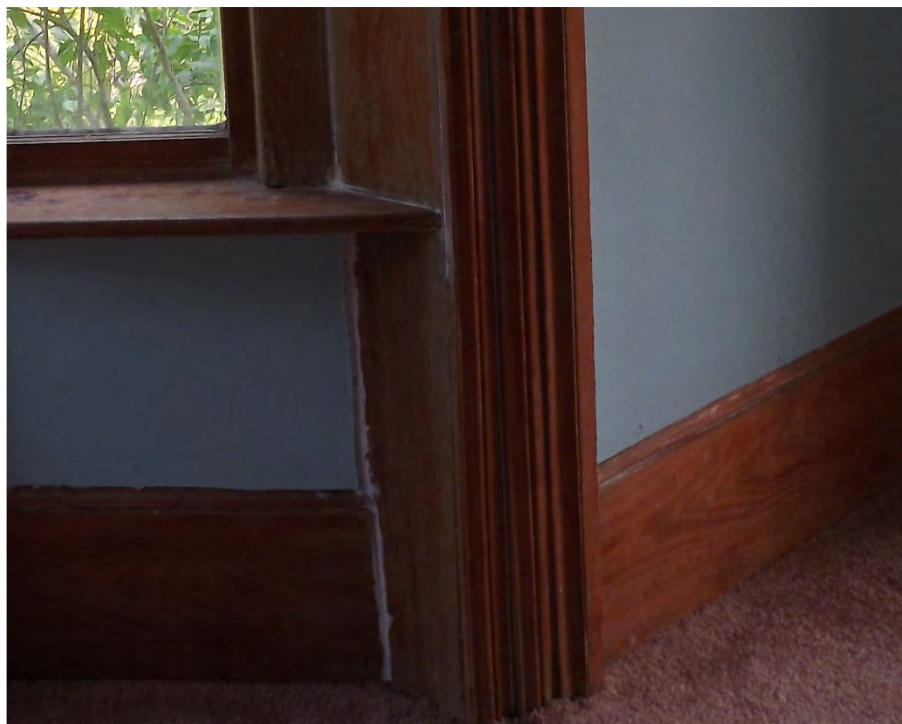
Stripped pine trim in bay window

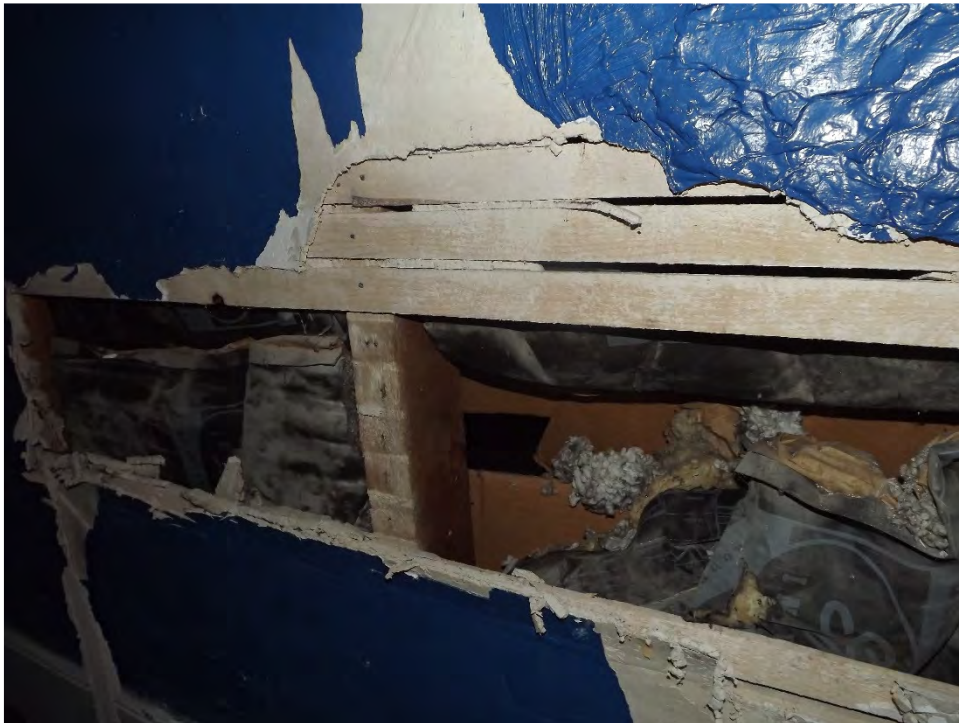
Circular sawn lath and framing in the rear wing
